## Update to CA 1671

CA 1671 Photos

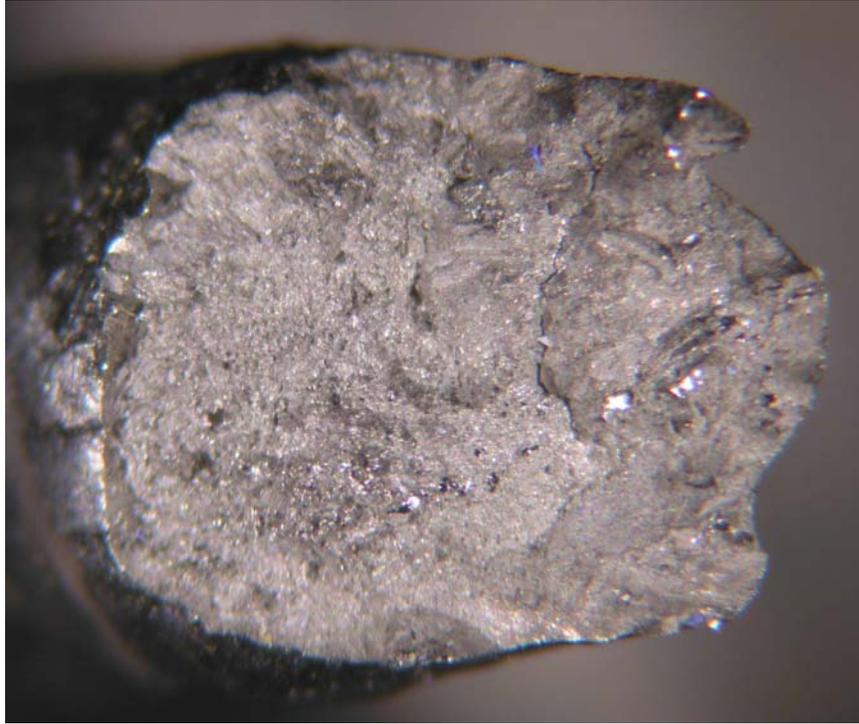
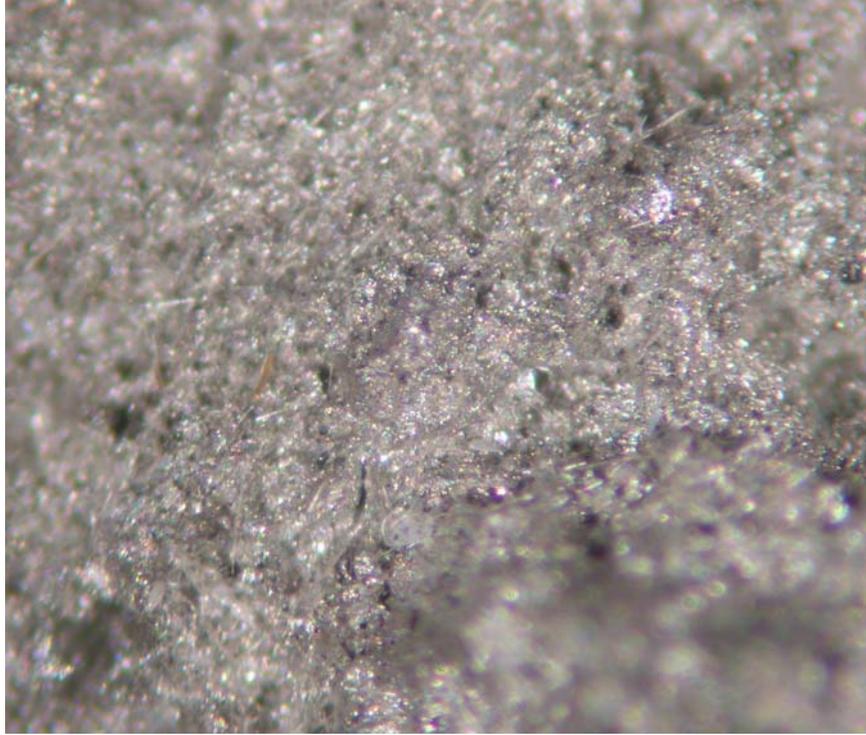
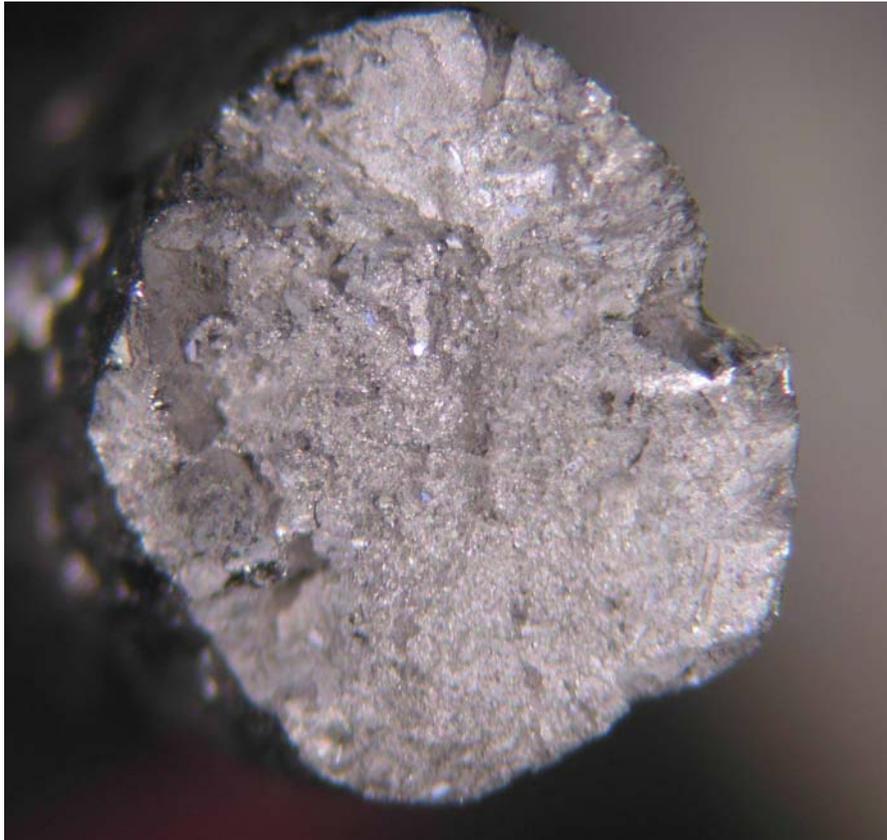
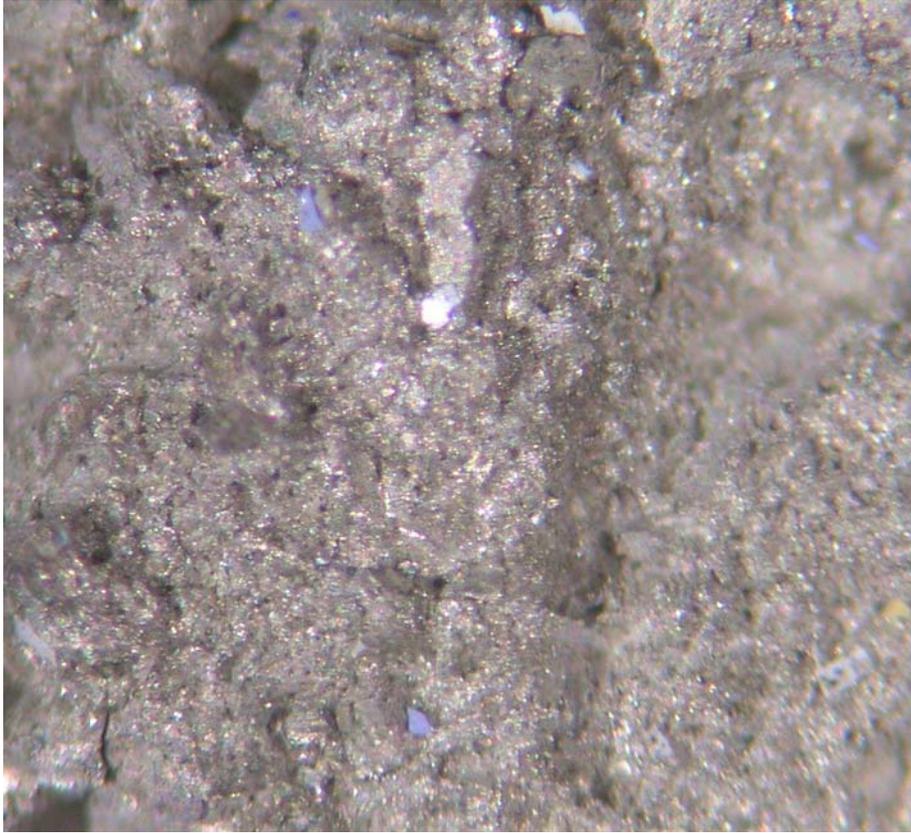
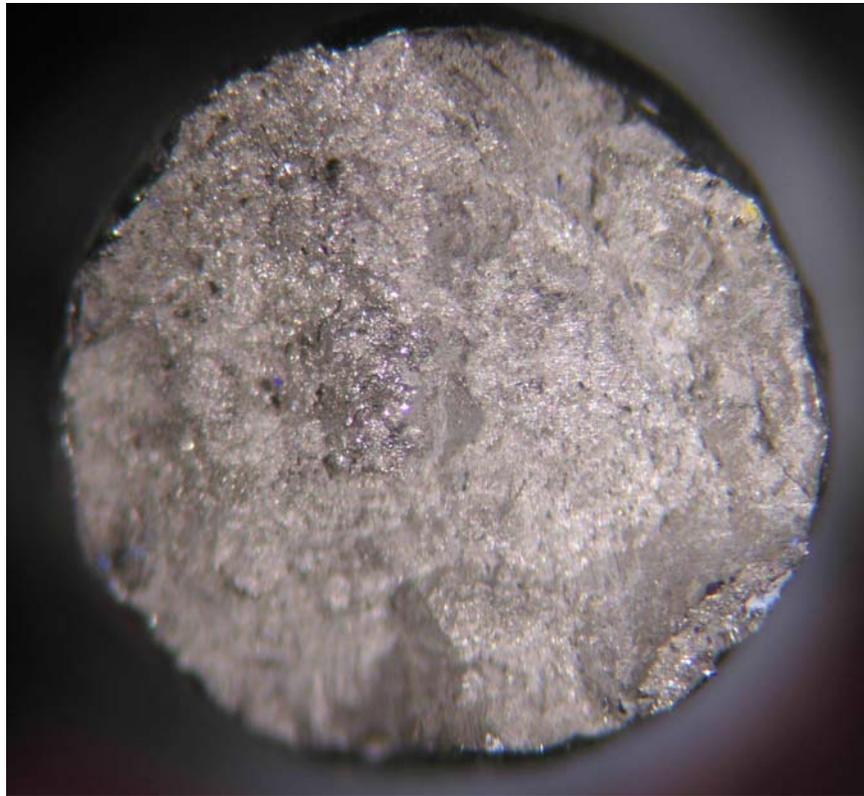
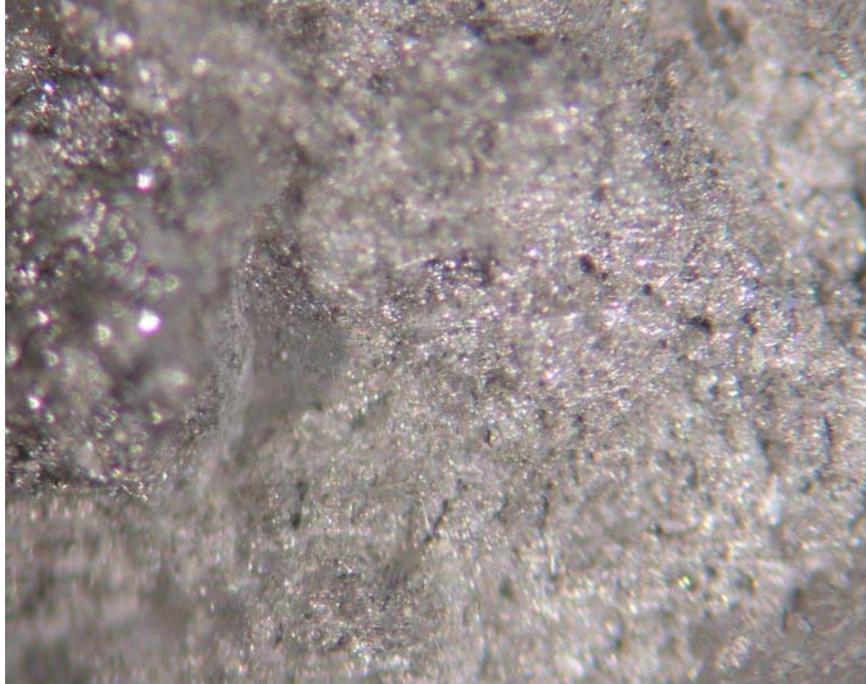
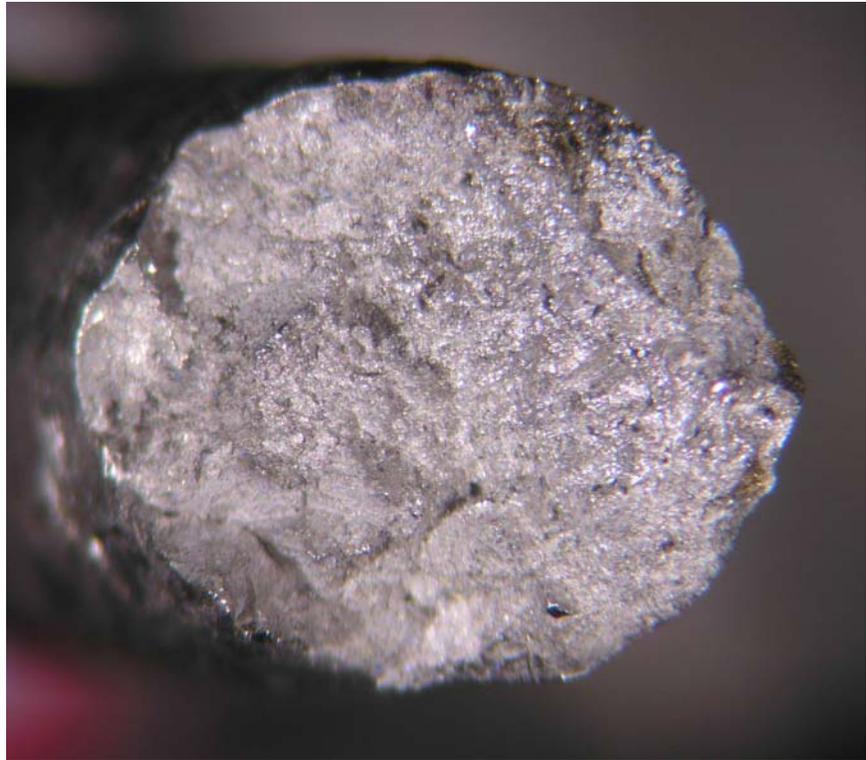
These photos were sent to Bob Keilback for his assessment (see e-mail below). Based on this update, this CA is now considered CLOSED; as Bob indicated, the test bars did, indeed contain flaws that contributed to the lower test values exhibited.

1. The test specimen failure surfaces appear to be not homogeneous, with some evidence of pores and inclusions.
2. We do not have a qualified WPS. However, the addition of tack welds would likely hold the nut in place for tightening; even if the weld(s) cracked, the obstruction caused by the weld on the Stelalloy should prevent the nut from turning.

1) The attached ZIP file contains photos of the test bars for A6, which had the lower elongation values. Could you please give me your opinion as to the quality of the test samples? Originally MTK said the lower values were due to defects in the bars. Unfortunately the half of the bars that they based this opinion on were discarded by the test lab. "
