Part: SE141-116 / MODULAR COIL WINDING FORM TYPE

Problem: NON-CONFORMANCE 1

Attachment I: Disposition of NCR # 18715 for MCWF C-2

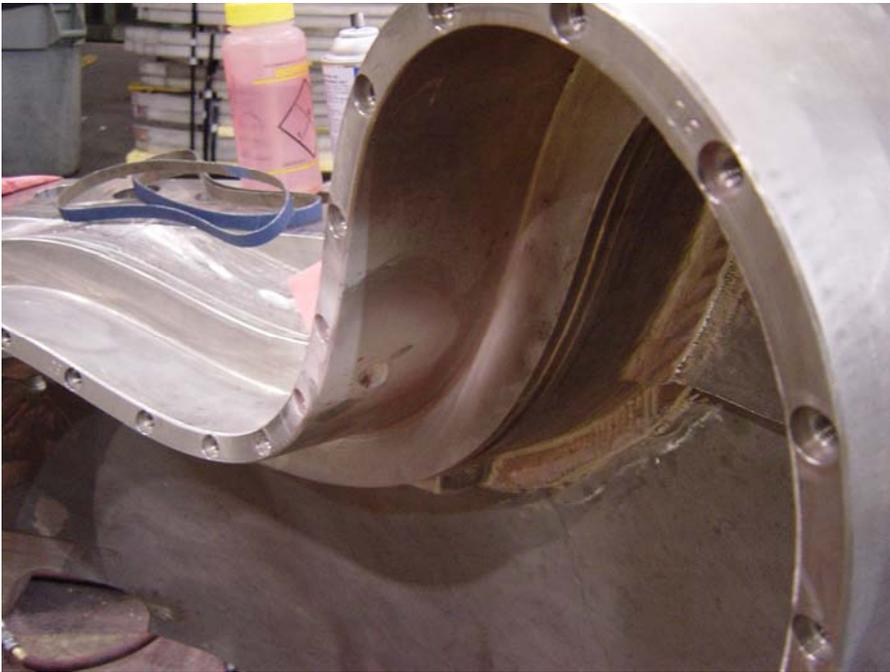
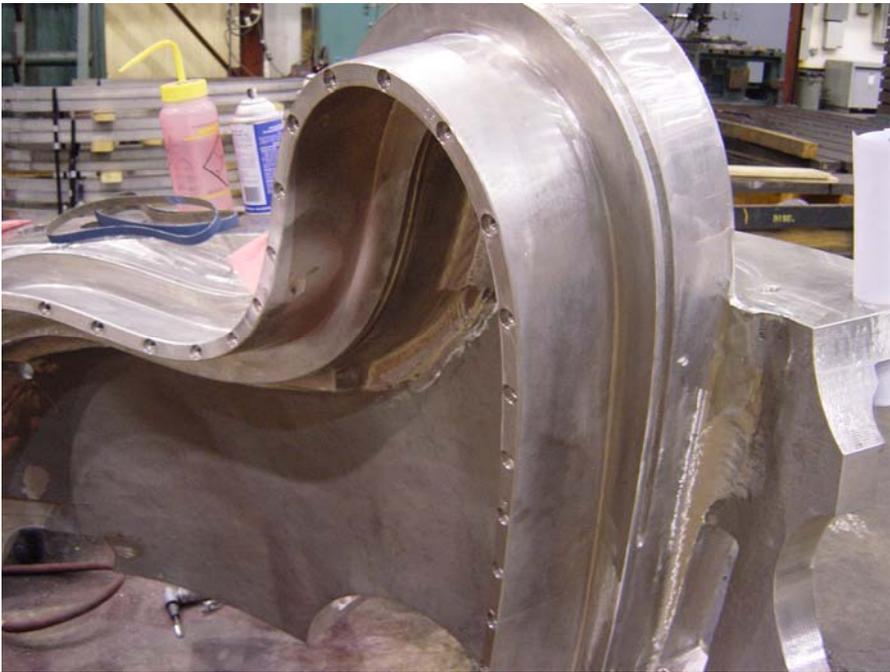
Non-conformance 1

PART IS REJECTED PER ASTM A903/A903M Level I. INDICATION IS V-SHAPED AND IS APPROXIMATELY .450" IN LENGTH ON THE LONGEST LEG (SEE PICTURES). INDICATION IS ON THE THIN SECTION OF THE T, LOCATED BETWEEN HOLES 84 AND 85. SEE ACCOMPANYING PHOTOS.

NCR #1: Disposition: Accept AS IS.

The recommendation to accept “AS IS” is based on the adequacy of the fracture lifetime with an 11 mm initial flaw in the T with a stress of 60 MPa. The plot below is from an internal NCSX Project Power Point slide set entitled “fracture story-3”. The plot shows that an initial flaw size 3 x 9 mm would meet 4 x life to crack through the T for a stress level of ~180 MPa. The 60 MPa – the stress in the area of this flaw- is well off to the left of the vertical axis of the graph. Based on this, we feel it is reasonable and in the best interest of the project to accept this flaw “as is”.

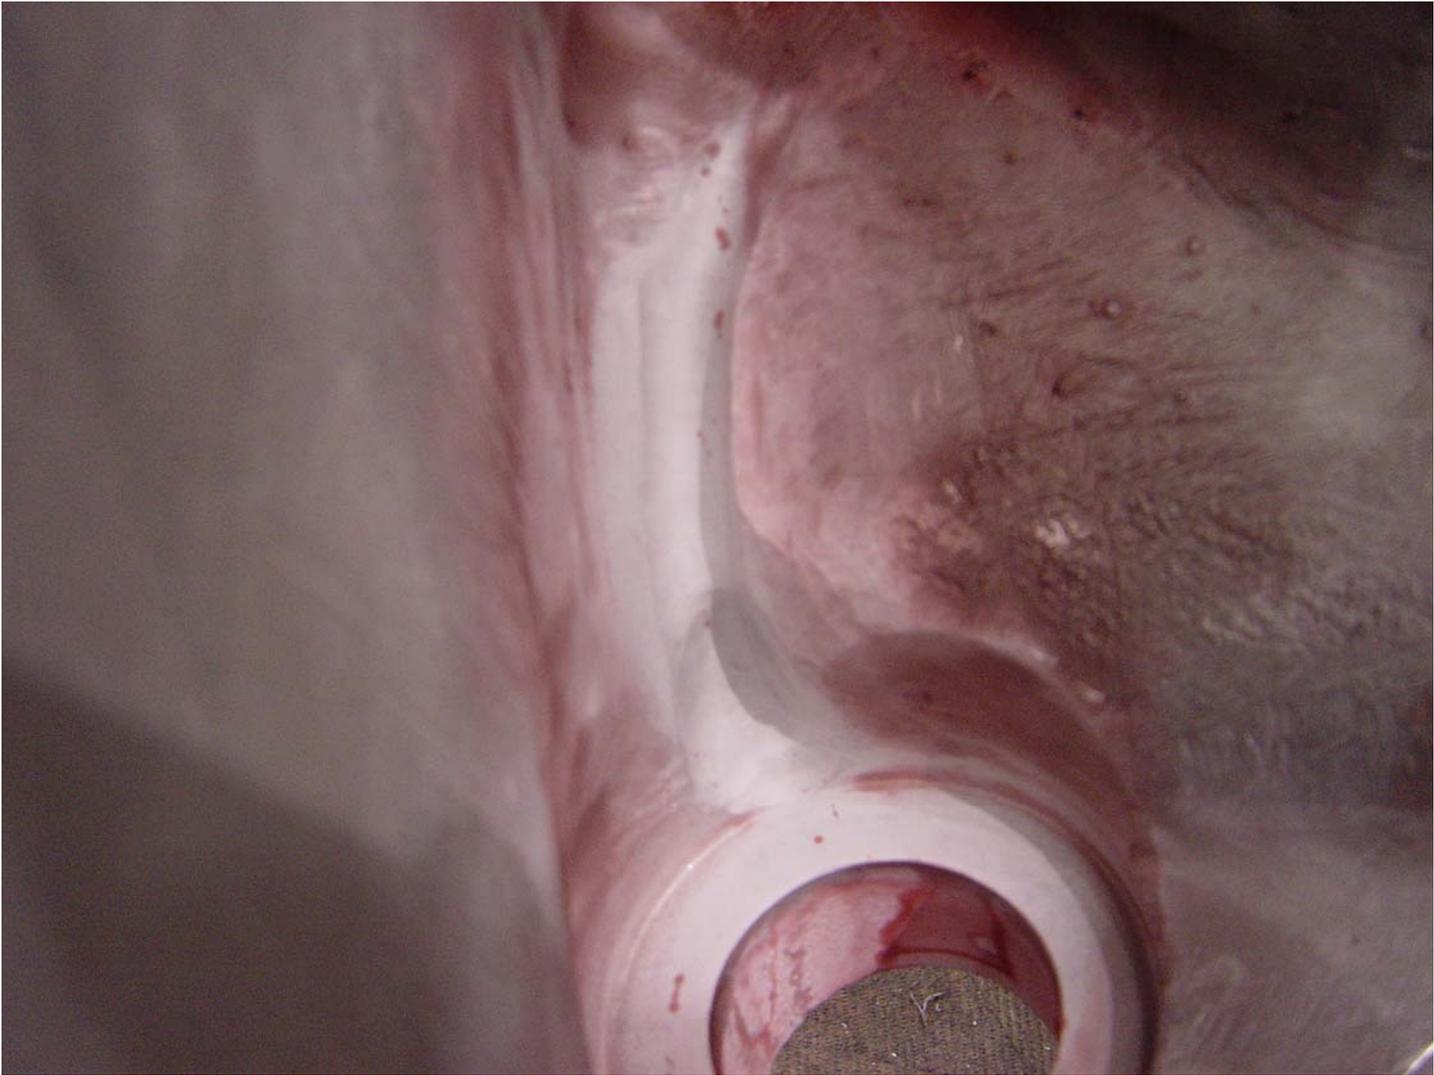
Non-conformance 2

PART IS ALSO REJECTED PER ASTM A903/A903M LEVEL II. INDICATIONS ARE JUST OVER THE ACCEPTABLE SIZE RANGE. SEE ACCOMPANYING PHOTOS.

NCR#2: Disposition: Accept AS IS. This indication is in a region where the stress is low – in the range of 60 MPa (see the figure below – virtually all of the leg region is ~60 MPa). The fatigue curve shown for NCR 1 is for a pre-existing crack to grow through a 3/4” thickness and, as in NCR1, the 60 MPa stress is far to the left of the vertical axis. It is in a heavy overcast area near the region where the leg, shell, and flange all come together; consequently, this indication can be accepted as is. The thickness that the flaw would have to “grow” through is significantly bigger for this flaw: the leg is ~1 3/8” thick; the shell is ~1 3/8” thick; the flange is 1 1/4”

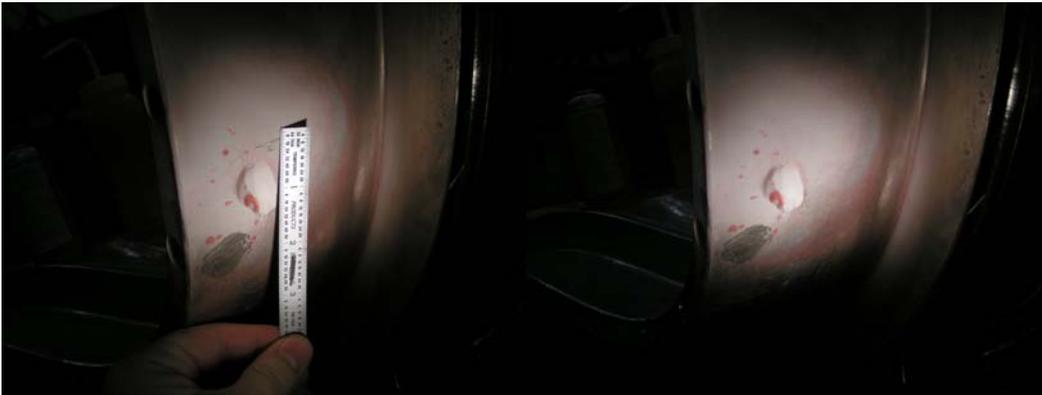
As can be seen in the photos below, the non-conforming linear indication

(in the ground depression) is ~11 mm long. It is located between bolt holes 84 and 85. The stress in this region is ~60 MPa, but it is adjacent to an area where the stress is ~120 MPa.
