Part: SE141-116 / WINDING FORM TYPE-C

Drawing ID: SE141-103 Revision: 3
Links: 1-Type:W: 65707/4.0 Sub: 0 Op: 20

Problem: There are several miscellaneous machining defects in various locations on the castings. The attached summary shows the sizes and locations of the defects.

Miscellaneous Machining and Casting Issues

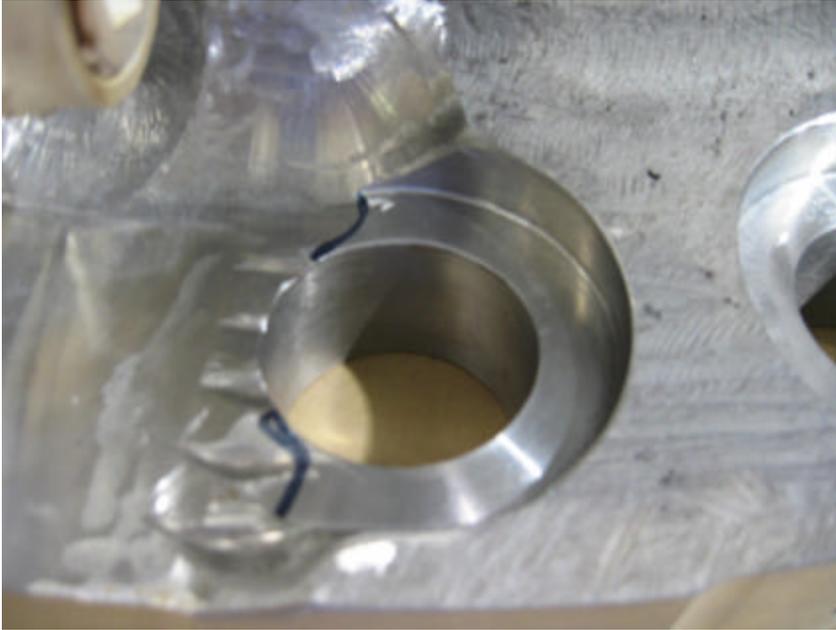
Counterbore adjacent to Poloidal Break on E Flange.JPG

Counterbore is next to Poloidal Break on the E flange. Approximately 60% of counterbore cleaned up 100%. The area of non cleanup has tooling gouges and is approximately .050" in depth.

The list of indications were reviewed during a joint NCSX and EIO conference call on 3/24/06. Based on that review, all were accepted as is.

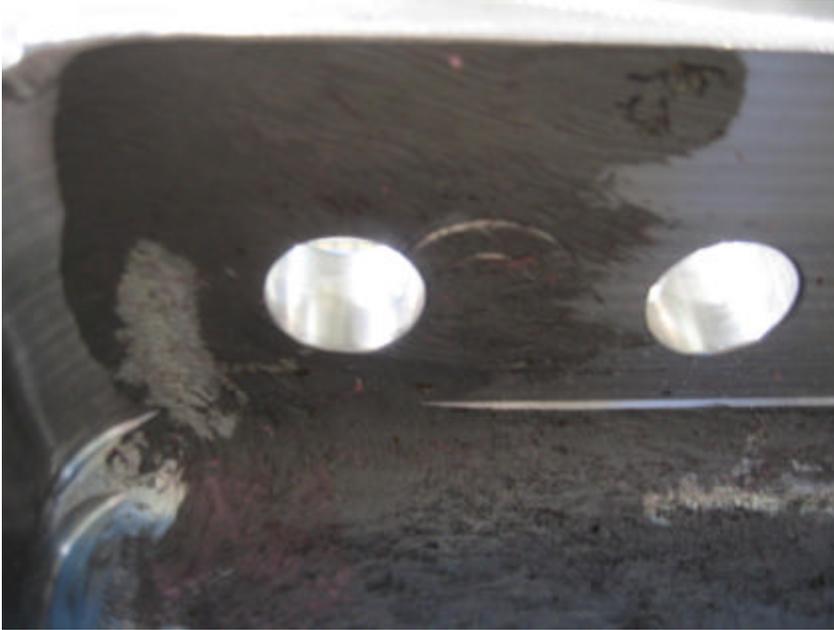
Noncleanup of foot on back side of D flange.JPG

This area is beneath the leg shown on sheet 4, zone C5. Instead of the 2.38" spot face on the back side, we typically machine this entire surface to a full cleanup. The two holes in this view do not have a 100% cleanup. The photo below shows that the flange thickness in this area is approximately 1.100" in the thinnest cross section.

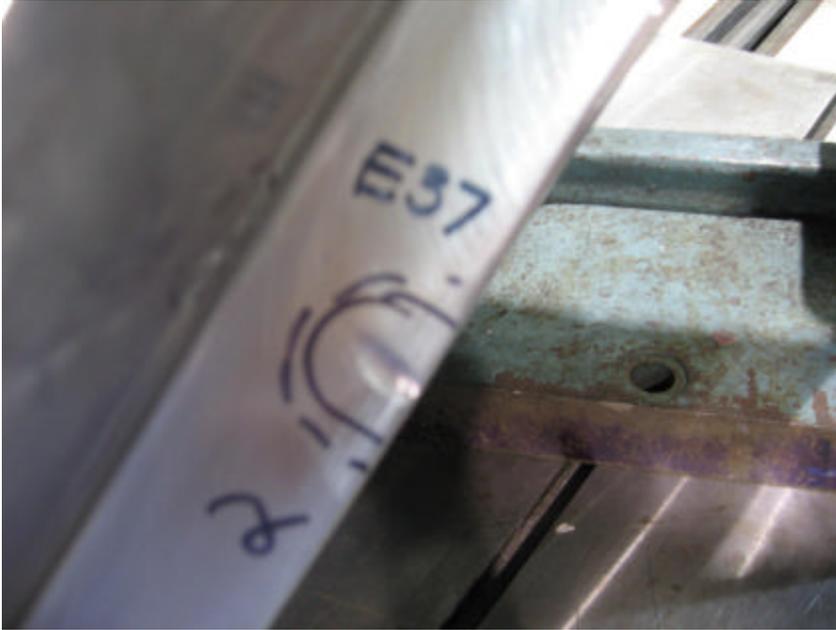
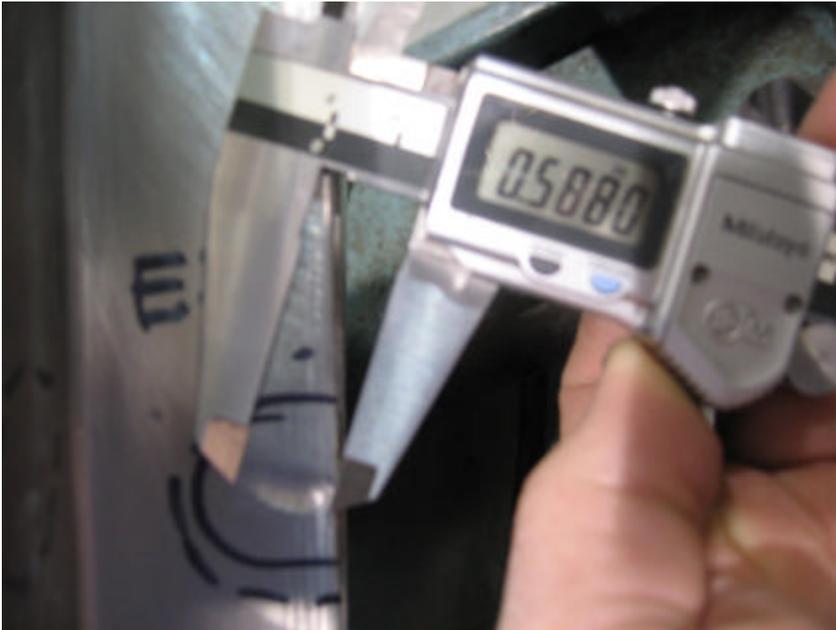
Tool Gouge short leg E37 wide view.JPG

This is a tooling gouge on the short leg of the “T” on the E flange side located close to hole 37. The gouge is approximately .590” in length by .200” wide and .005” in depth.

Tool Gouge short leg E side adjacent to hole 37.JPG

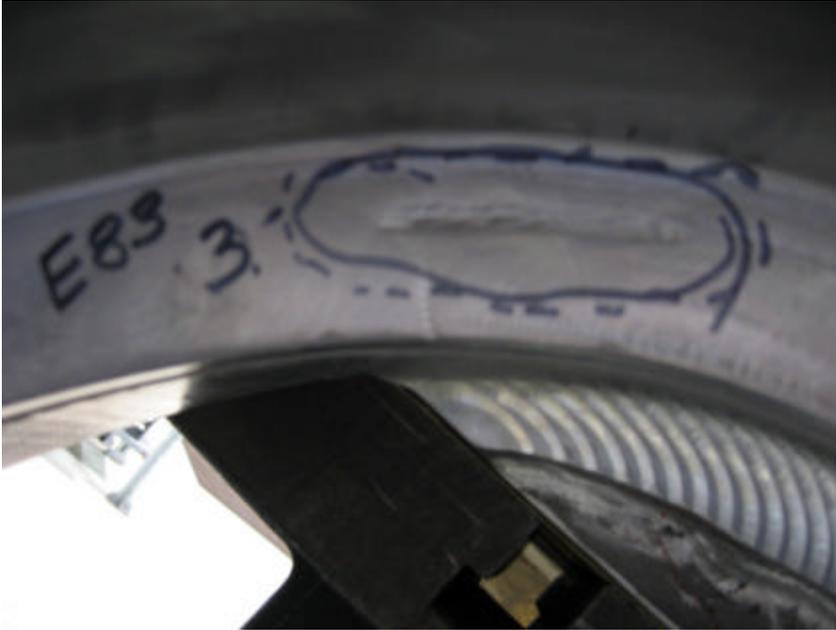
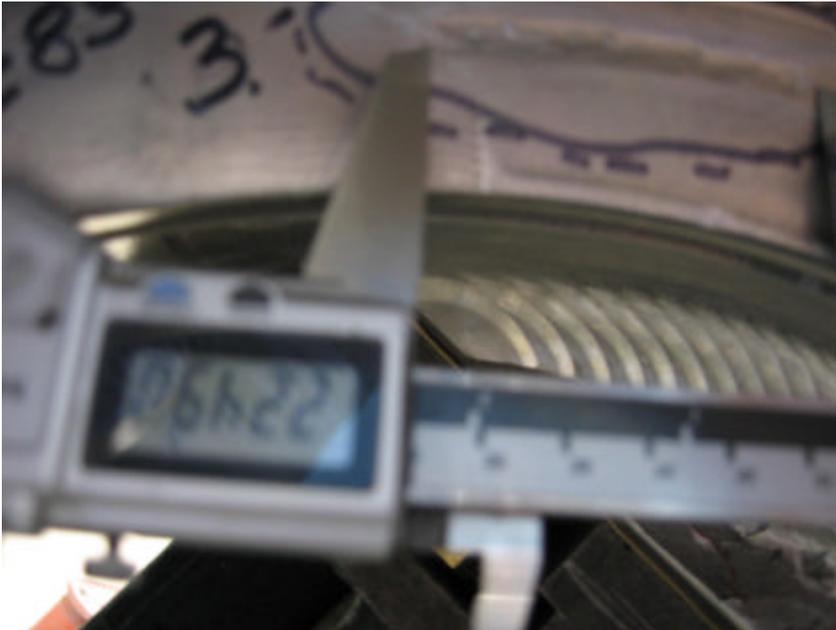
Tooling Gouge short leg E83 wide veiw.JPG

This is a tooling gouge on the short leg of the "T" on the E flange side located close to hole 83. The gouge is approximately 2.200" in length by .200" wide and .008" in depth.

Tooling Gouge short leg E side adjacnet to hole 83.JPG

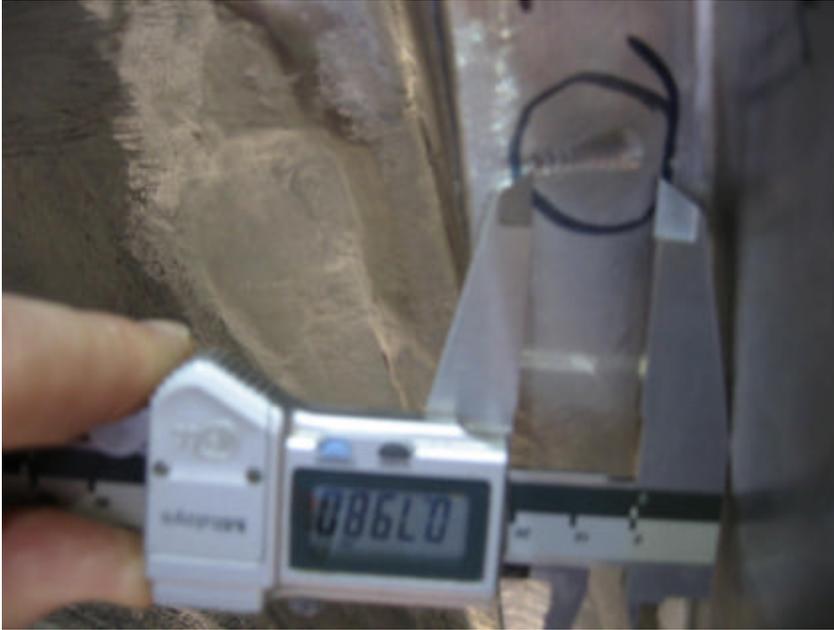
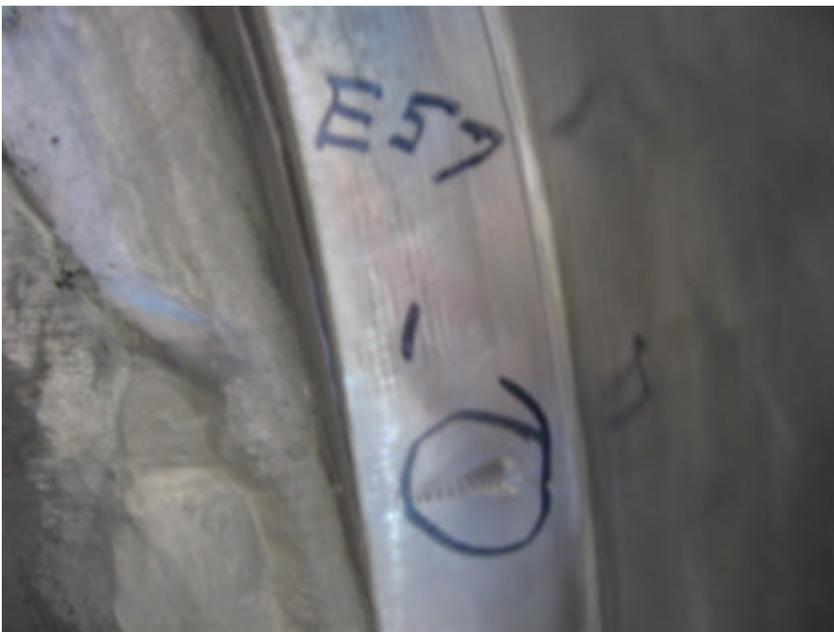
Tool Gouge short leg E side adjacent to hole 57.JPG

This is a tooling gouge on the short leg of the “T” on the E flange side located close to hole 57. The gouge is approximately .800” in length by .200” wide and .010” in depth.

Tool Gouge short leg E57 wide view.JPG

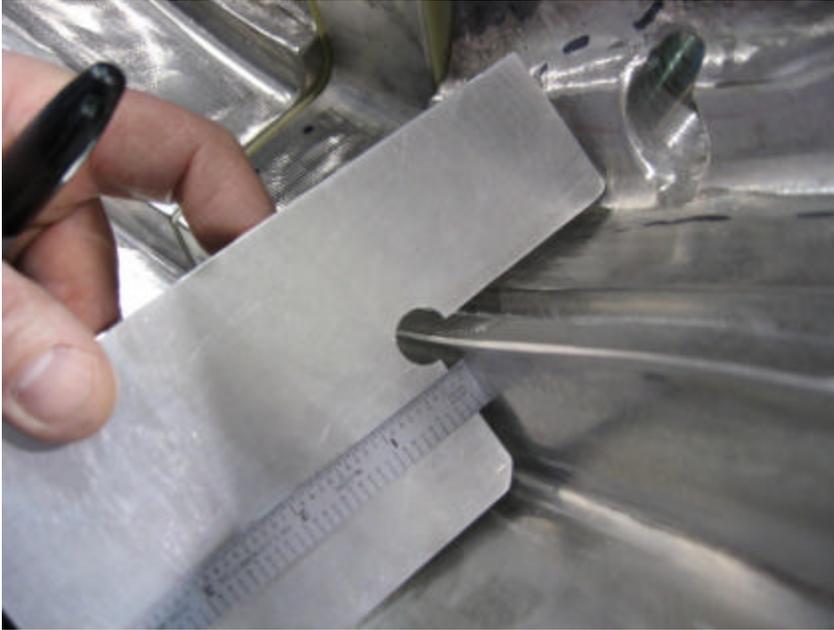
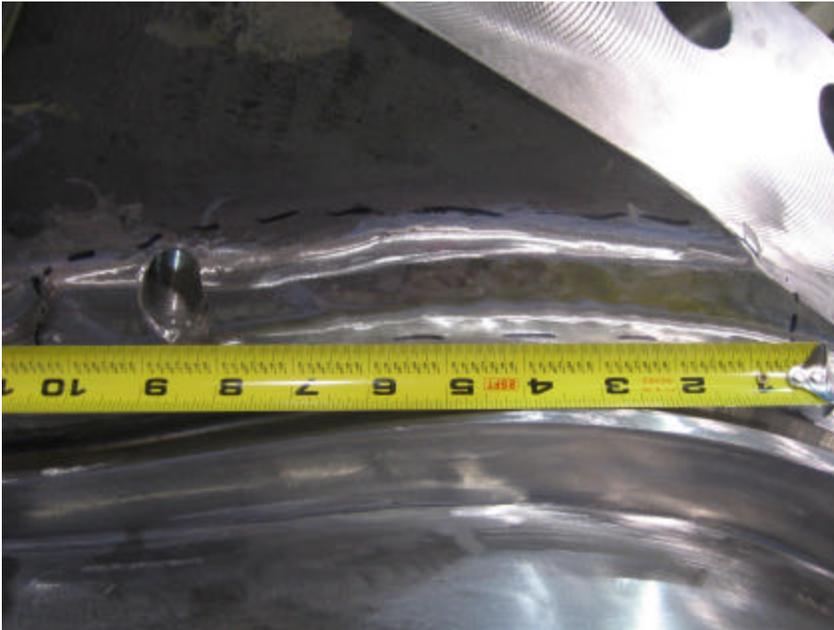
D side interference below VPI groove location 1.JPG

These pictures show the interference below the VPI groove located adjacent to poloidal break on the D side from hole 11 to 13. The interference to the gage is approximately .100" - .200" over a length of about 10".

D side interference below VPI groove location 1 wide view.JPG

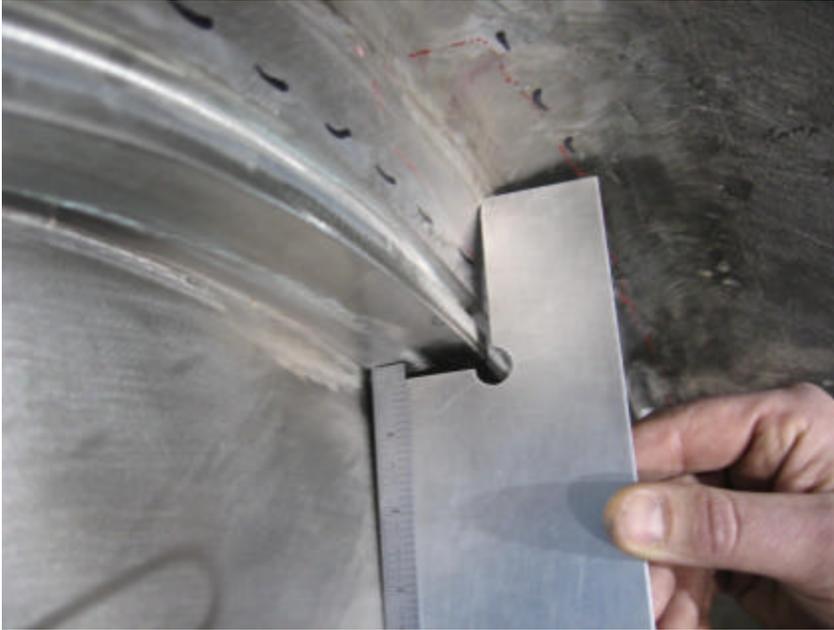
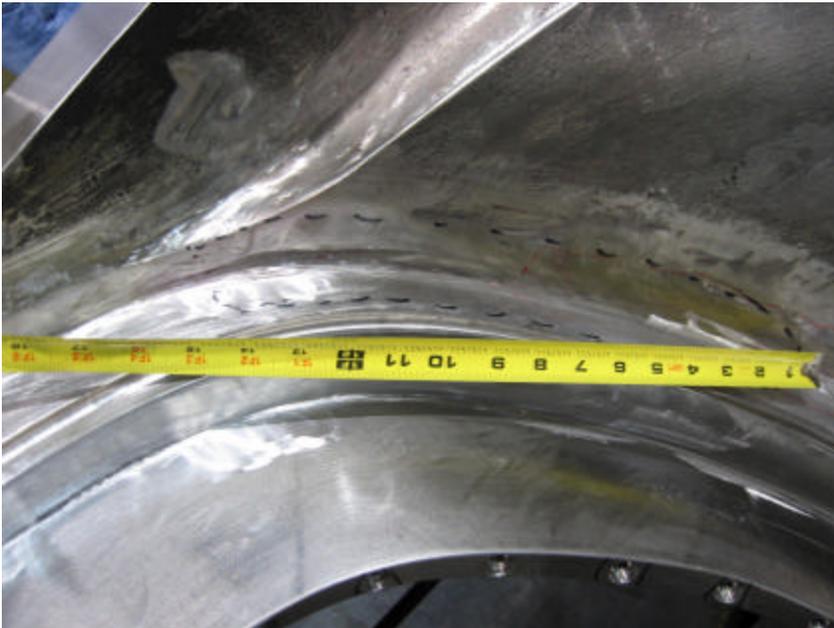
D side interference below VPI groove location 2.JPG

These pictures show the interference below the VPI groove located on the D side from hole 45 to 50. The interference to the gage is approximately .200" - .300" over a length of about 15".

D side interference below VPI groove location 2 wide view.JPG

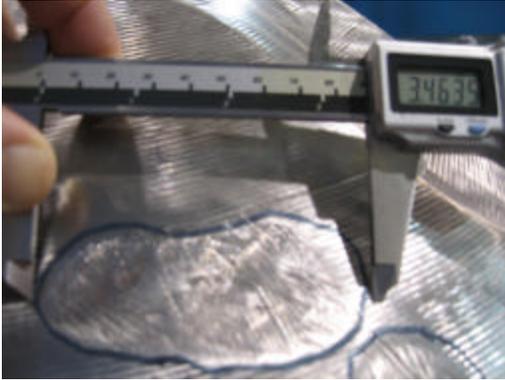
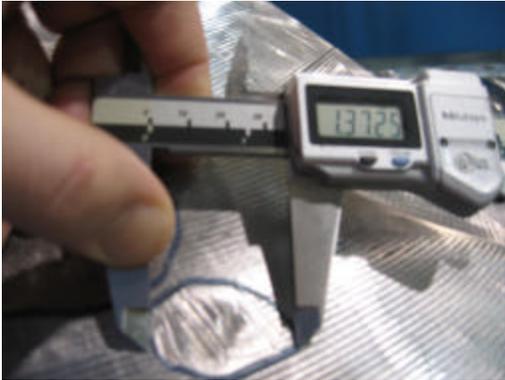
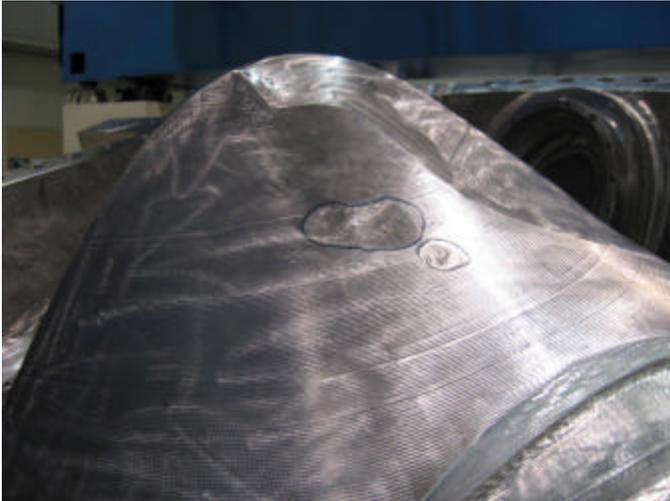
Casting noncleanup on D side large wing.JPG

Casting noncleanup on D side large wing 2.JPG

Casting noncleanup D side large wing wide view.JPG

The above pictures show noncleanup after final machining on the large flange of the D side. The depths are approximately .02 - .04".

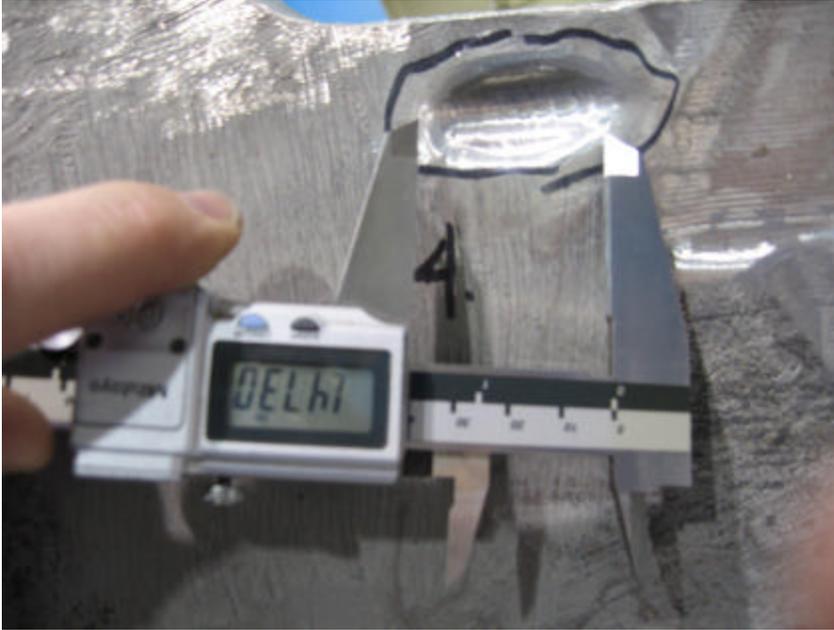
Tool Gouge in cast wall D side section PT11 sheet 7.JPG

This photo shows a tooling gouge in the cast wall located below the 6.5" opening shown on sheet 7 section view PT11. Gouge is approximately 1.470" x .800. The casting wall in this area measures 1.3". The gouge is approximately .25" in depth.
