**Part: SE141-114 / MODULAR COIL WINDING FORM TYPE**

Drawing ID: MCWF TYPE-A XRAY MA Revision: 1  
W/O Links: 1-Type:W: 65709/5.0 Sub: 1

**Problem: X RAY FAILURE ON:**

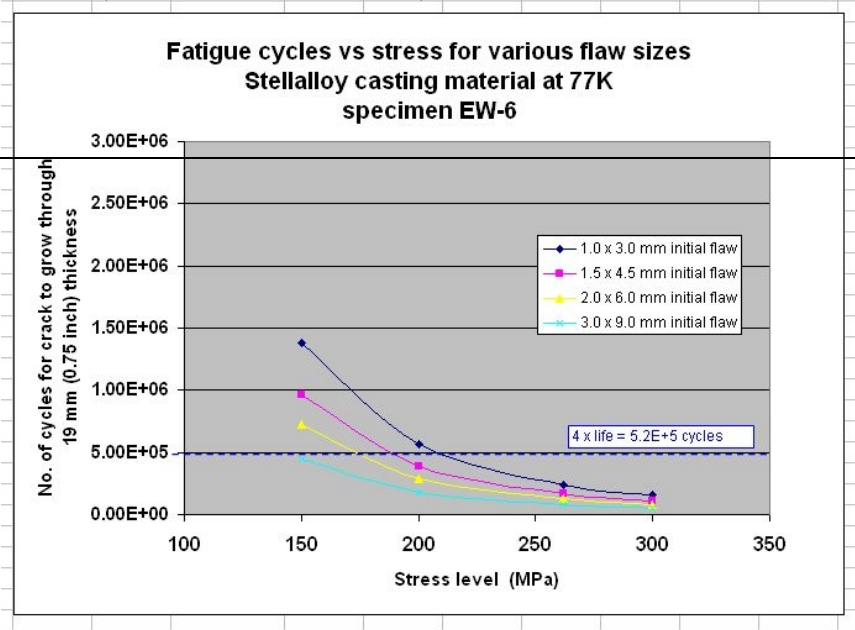
The attached RT indications were reviewed by D. Williamson and discussed during a conference call attended by J. Chrzanowski, L. Sutton, F. Malinowski, L. Dudek, D. Williamson, T. Brown, and P. Heitzenroeder on 2/28/07. Dave notes that the stress in this region varies from 9-20 ksi. (62-138 MPa). As can be seen in the fracture plot, the region will meet the fatigue life criteria with these flaw sizes. (max. size is 0.090" : 1.5 mm)

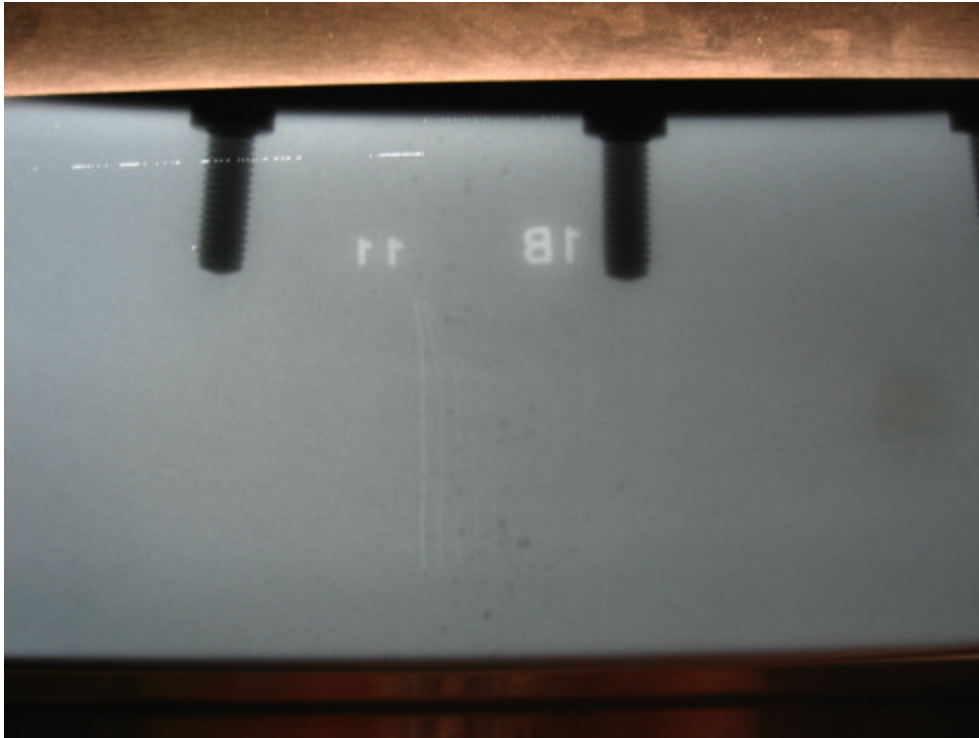
## NC21264 – RT Rejections

"T AREA", VIEW 41-45, POROSITY CLUSTER, LARGEST PORE MEASURES .090", AVERAGE PORE SIZE .060". APPROX. 15 PORES IN A 1 INCH CIRCLE. LOCATED BETWEEN TAPPED HOLE 43 AND 44. STRING OF POROSITY LEADING OFF OF CLUSTER APPROX. 4 INCHES.  
(see attachment)

View above is of a cluster of porosity between holes 43 and 44. The largest was sized at approximately .090”.

**Customer Disposition:**    ☒ Use As Is    ☐ Rework    ☐ Repair    ☐ Scrap    ☐ Replace
