**Customer: ENERGY INDUSTRIES OF OHIO**

**Part: SE141-103-1 / MOD COIL WINDING FORM ASSEMBLY**

Drawing ID: SE141-103  
W/O Links: 1-Type:W: 65707/6.0 Sub: 1

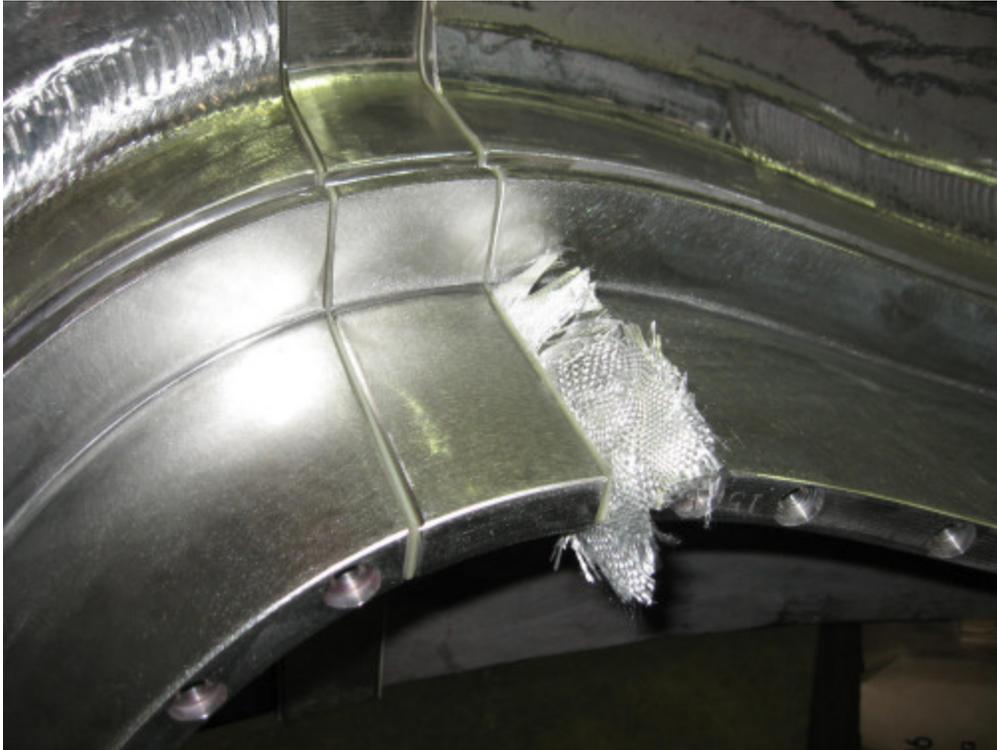
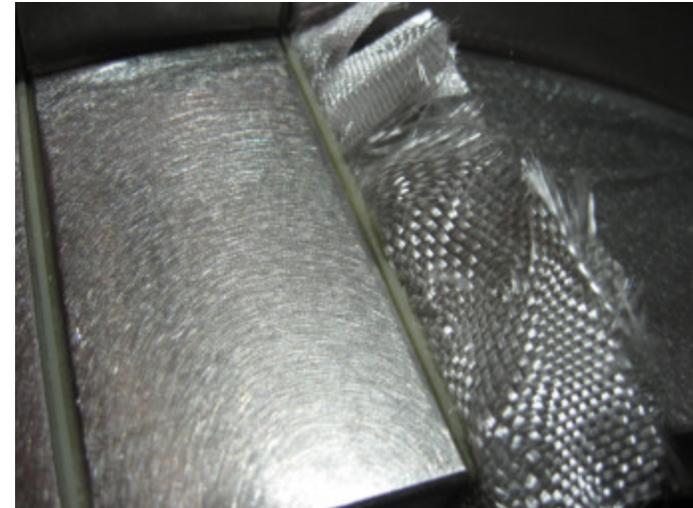
Problem: An .018" shim will pass through one half of the 3/4" section of the T. All other gaps around the break are within specification.

One side of the  $\frac{3}{4}$ " section of T accepted a .018" shim. The maximum allowable gap is .005". This area was repaired using fiberglass filler and now a .005" shim will not pass through this area.

MTM proposes that gap be repaired using fiberglass filler as shown in attachment. After addition of filler the gap check is acceptable.

The proposed disposition was reviewed by J. Chrzanowski – this is fix is acceptable because the added fiberglass cloth will be impregnated when the coil is vacuum-pressure impregnated.
