Customer: ENERGY INDUSTRIES OF OHIO

Contact: NANCY HORTON
E-Mail: NKHFlowen@aol.com

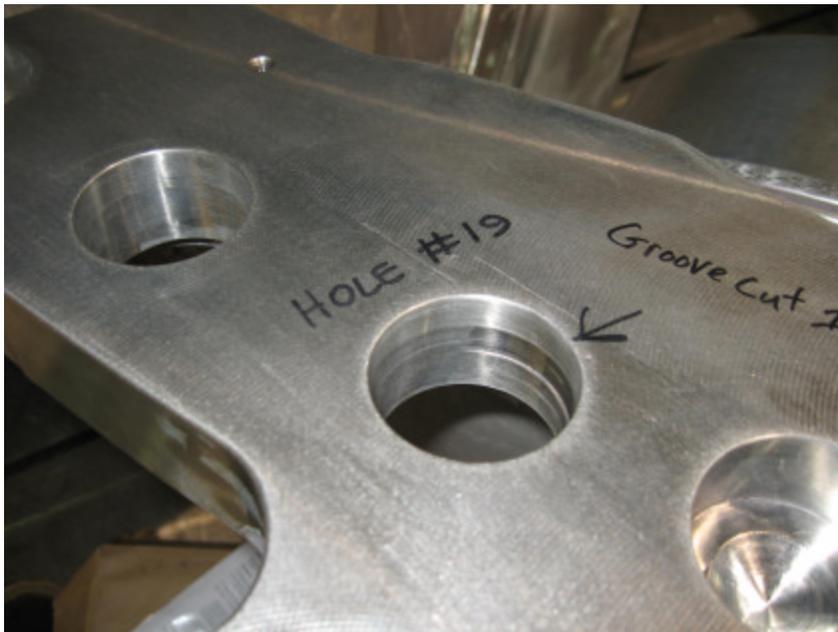
SE141-115 B2
NC20670 attachment

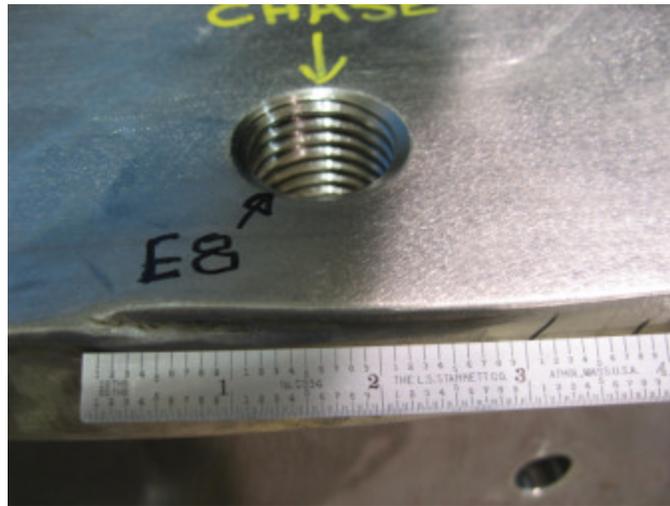
8. The pictures below are of the flange holes repaired under NC20449. There is no nonconforming condition to report but I felt this was worthy of documenting.

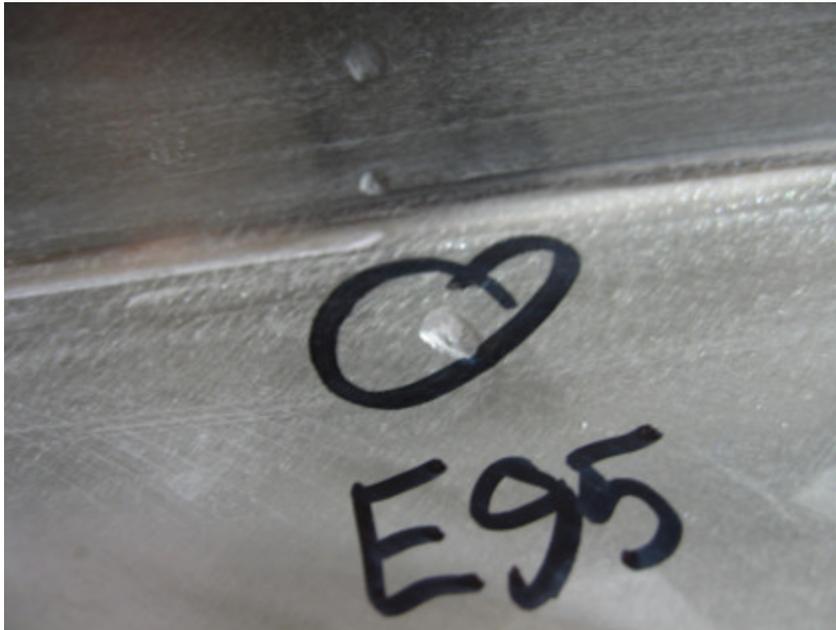
10. Tool gouge located on short leg of T near hole 77 on E datum side.
