Status	2 - Disposition Needed		Trend	01-Deviation From Doc/Proc	
Department	NCSX		Division	WBS 141	
Source/Org	FABRICATION, OPERATIONS & MAINTENANCE				
Item Dwg/Part#	SE142C-270 Rev. 0	Procurement #		Cost Center	
RAP#	3234	Job Doc #	D-NCSX-MCF-004	Vendor	VARIOUS
RAP Title	Modular Coil Fabrication - Post VPI Activities

NCR 3639 ATTACHMENT, R3 (p. 1 of 2)

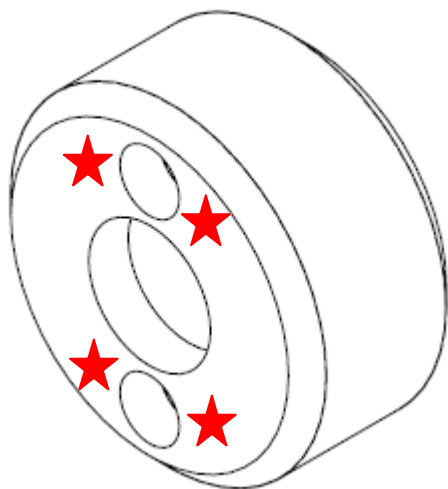
REV 3: 10/4/07 – Upon further discussion and investigation with NCSX Engineering an additional sample of remaining “keeper screws” (pt. #6) was conducted with the intention of better defining specifically which areas of these parts are exhibiting high magnetic permeability. See details of sampling and drawing below.

<u>Sample #</u>	<u>Number of spots >1.02 Mu</u>	<u>Permeability of spots</u>
1	2	Both spots >1.02, <1.03 Mu
2	Entire top face	Entire top surface >1.02, <1.03 Mu
3	2	1 spot >1.02, <1.03 Mu; 1 spot >1.03, <1.04 Mu
4	2	Both spots >1.02, <1.03 Mu
5	3	All spots >1.02, <1.03 Mu
6	0	Entire part <1.02 Mu
7	4	3 spots >1.02, <1.03 Mu; 1 spot >1.04, <1.05 Mu
8	3	All spots >1.02, <1.03 Mu
9	3	2 spots >1.02, <1.03 Mu; 1 spot >1.03, <1.04 Mu

10	5	4 spots >1.02, <1.03 Mu; 1 spot >1.03 , <1.04 Mu
11	6	5 spots >1.02, <1.03 Mu; 1 spot >1.03, <1.04 Mu
12	6	4 spots >1.02, <1.03 Mu; 1 spot >1.03, <1.04 Mu; 1 spot >1.04, <1.06

The worst case possible from the data above appears to be the entire top surface of the part at just under 1.06 Mu. Only the outer surfaces of the part was able to be measured due to the configuration of the gauge and part, none of the threads exhibited any permeability and most of the pieces sampled only had a few spots on the top surface around the spanner wrench holes, see drawing below.
