PPPL NONCONFORMANCE REPORT NO: 3739 Open Date 12/12/07

Item Dwg/Part# SE140-101-R0 **Procurement #** _____

RAP Title Modular Coil Fabrication - Post VPI Activities

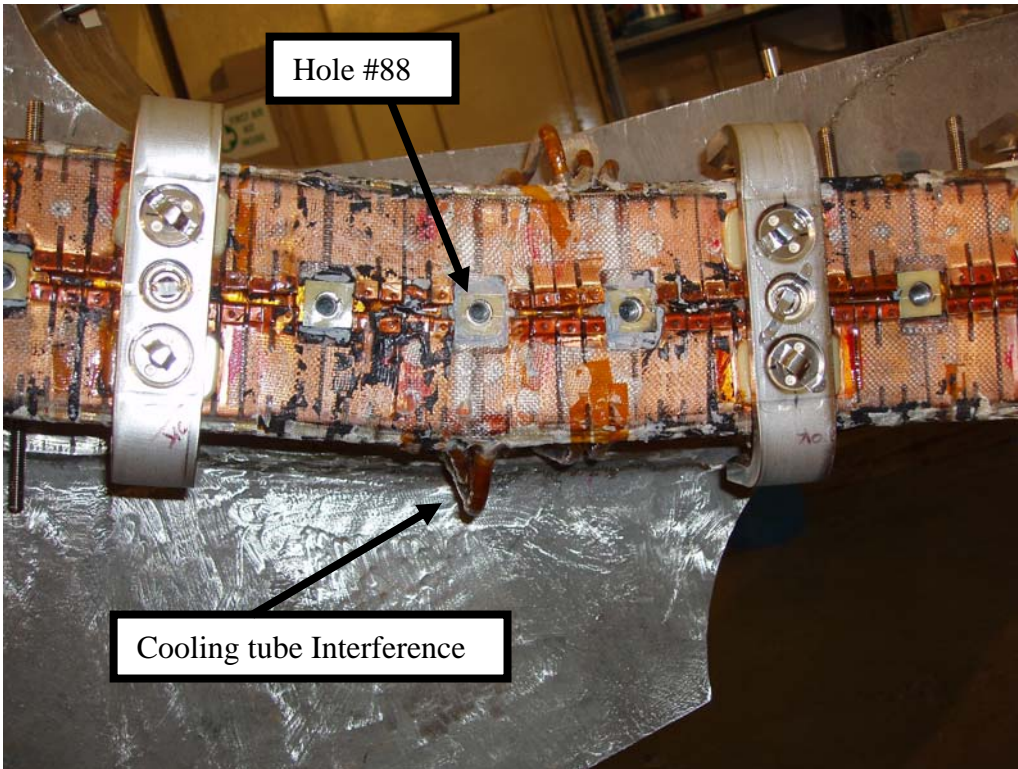
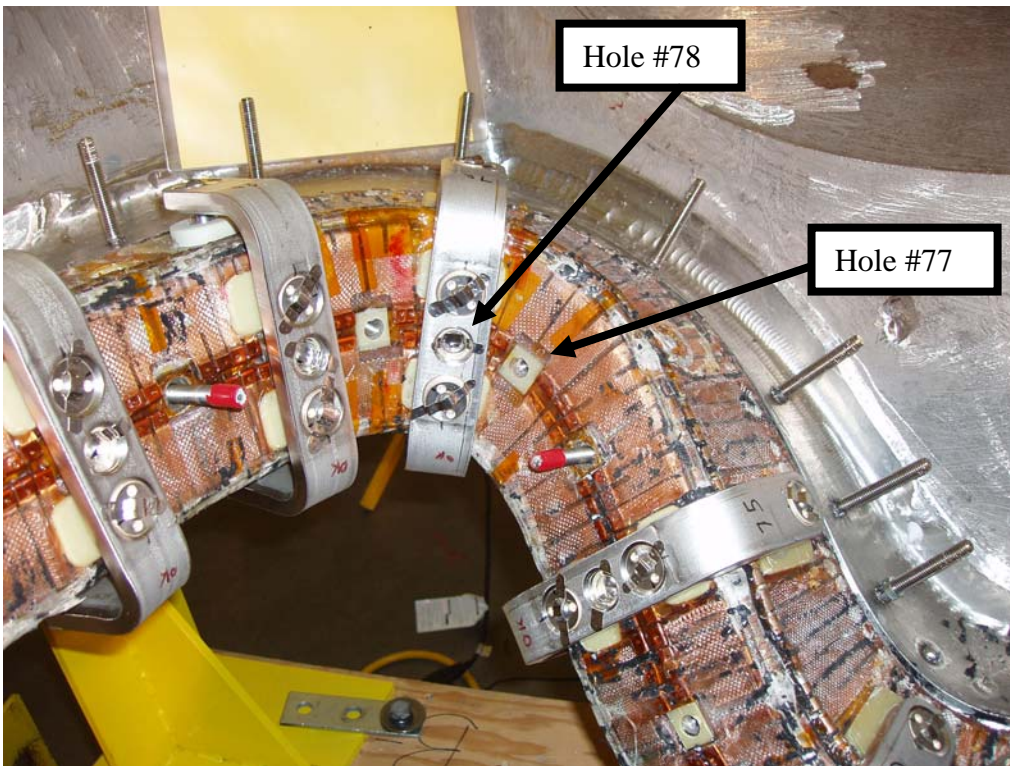
MCWF-A2: There are two deviations in the locations of the final winding clamps installed on the A2 modular coil per drawing SE141-101-R0. First is at hole #88, the cooling tubes interfere with installing the winding clamp resulting in no winding clamp being installed at this location. Second, a winding clamp is installed at hole #78 as opposed to hole #77 indicated on the above referenced drawing, this is due to the G-11 clamp pads being installed in the wrong location prior to VPI epoxy impregnation. See attached pictures for details.
