Customer: PRINCETON PLASMA PHYSICS LAB

Drawing ID: SE120-004 Revision: 2
Links: 1-Type:W: 65678/2.0 Sub: 5 Op: 243

Nonconformance Report: Major Tool NC19562

This is for SE120-004 VVSA #2 end flange fit up and weld.

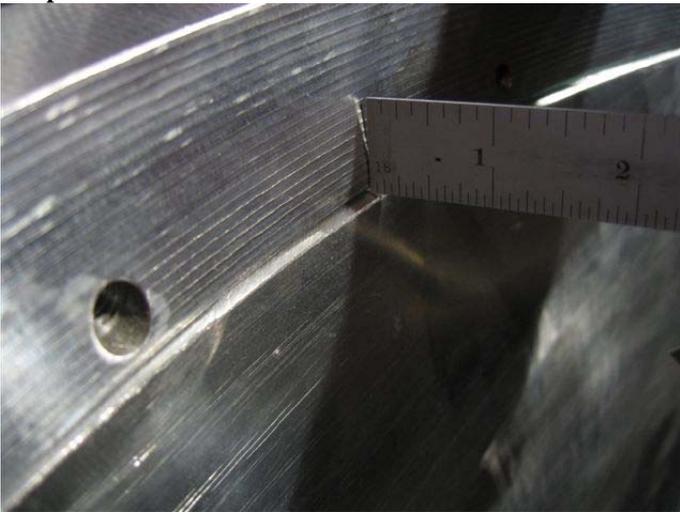
THE RESULT OF PROFILE DEVIATION ON THE VESSEL ENDS CAUSES A MIS-ALIGNMENT TO THE VESSEL FLANGES. REFER TO PHOTOS FOR ADDITIONAL DESCRIPTION.

8 O'clock Inside of Flange B

RECOMMEND LEAVING THE VESSEL WALL IN ITS CURRENT POSITION AND ALTERING THE WELD SCHEME TO BLEND THE TWO SURFACES TOGETHER IF NO ASSEMBLY OR PLASMA INTERFERENCE EXIST

Rework as Recommended by MTM.
Ensure weld size is equal or greater to original.

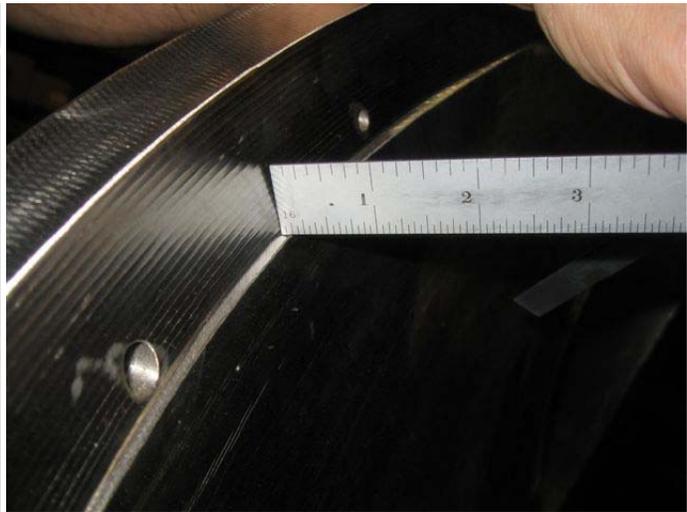
8 O'clock Inside of Flange B

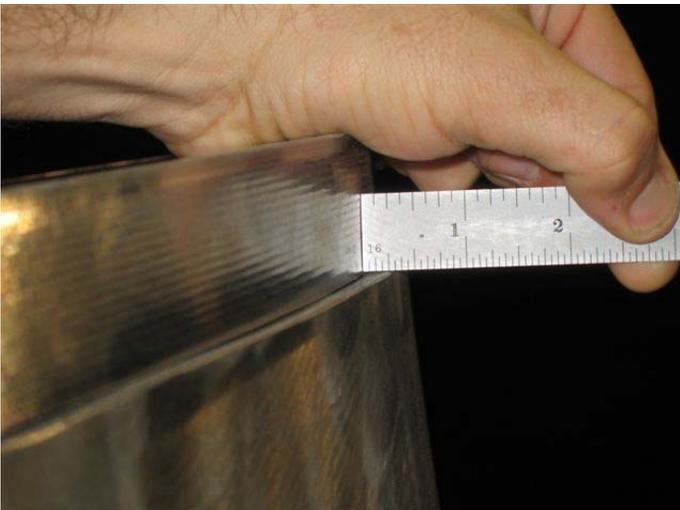
2 O'clock Outside of Flange B

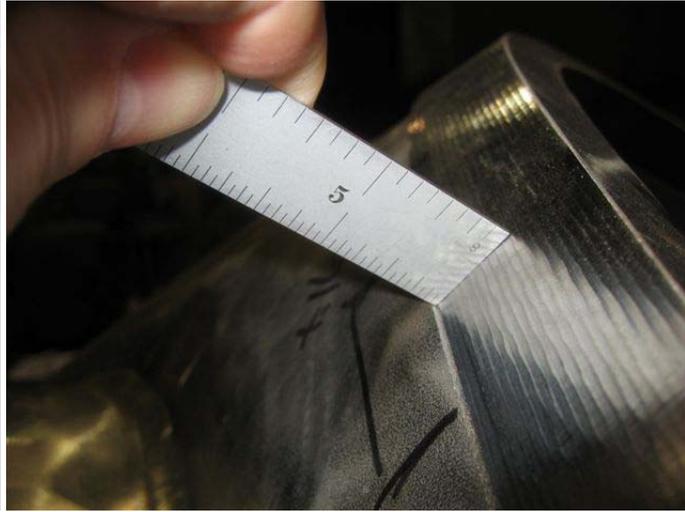
10 O'clock outside of Flange A

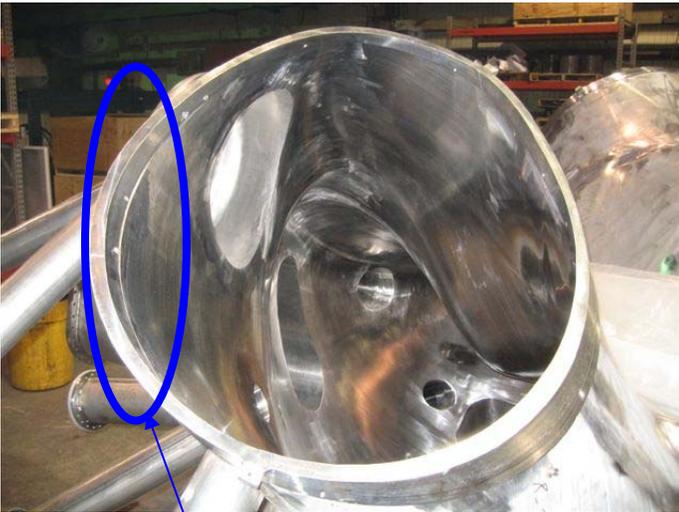
- The current flange fits up to the vessel within the profile of the vessel shell everywhere but a few locations (need to add pict.)

Flange to the outside of the vessel by ~0.125-0.188 “ over a length of ~ 12 “

Will probably lose fiducial holes and clamp holes to “buttering” weld. These welds would have to be made without heavy cover plate welded on to heat sink & hold flange. Consider doing “buttering” as part of field weld process

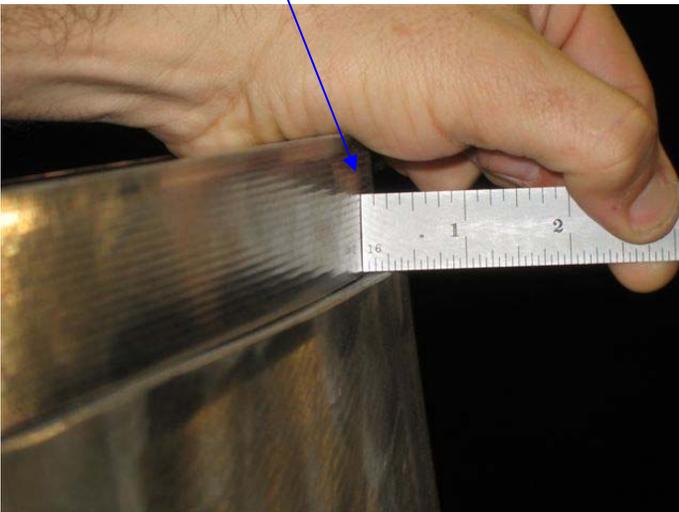
If the vessel max. outwards tolerance coincided with the flange maximum inwards tolerance, this would be the condition

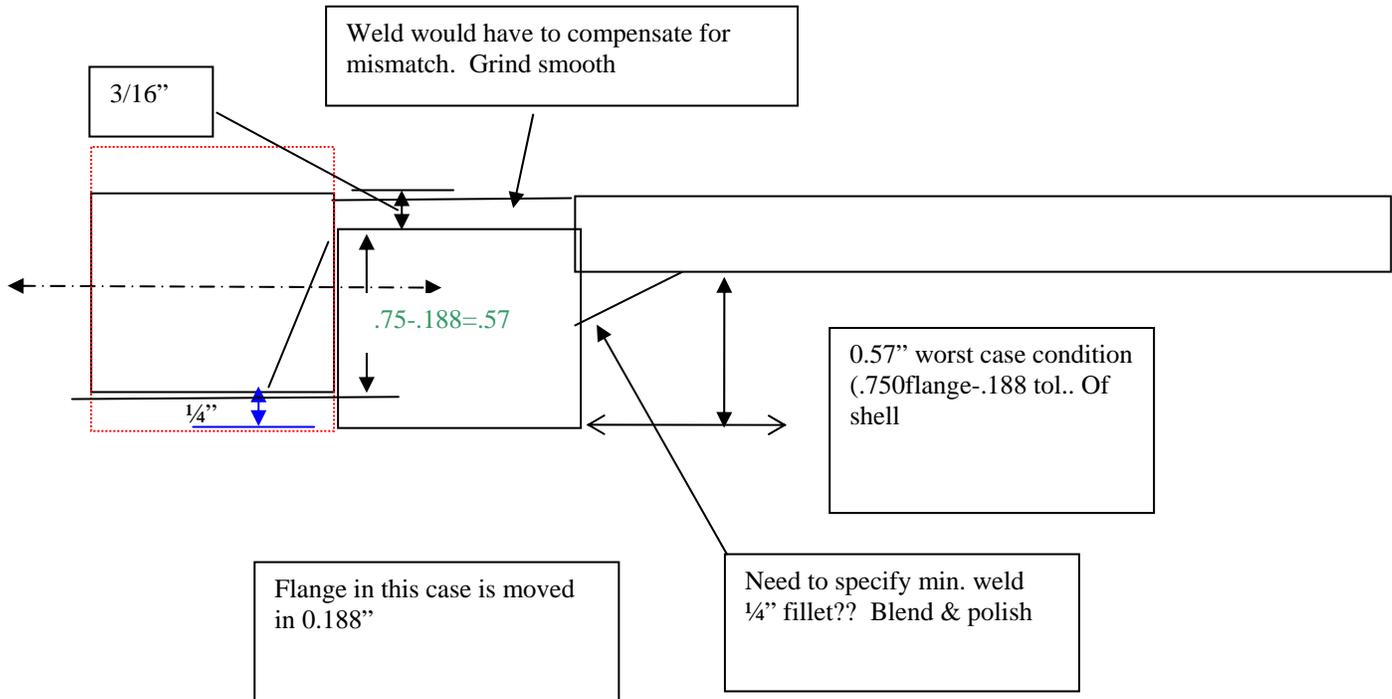
For VVSA2, end A, this maximum encroachment was evaluated by Art and is acceptable in the pre-welded condition.

Assuming that field weld shrinkage might move the wall and flange inwards by another 0.010'', this would still be acceptable.
