Major Tool & Machine, Inc.
1458 East 19th Street
Indianapolis, IN 46218-4289

MTM N/C: 19209

Part: SE141-116 / MODULAR COIL WINDING FORM TYPE

Drawing ID: SE141-116

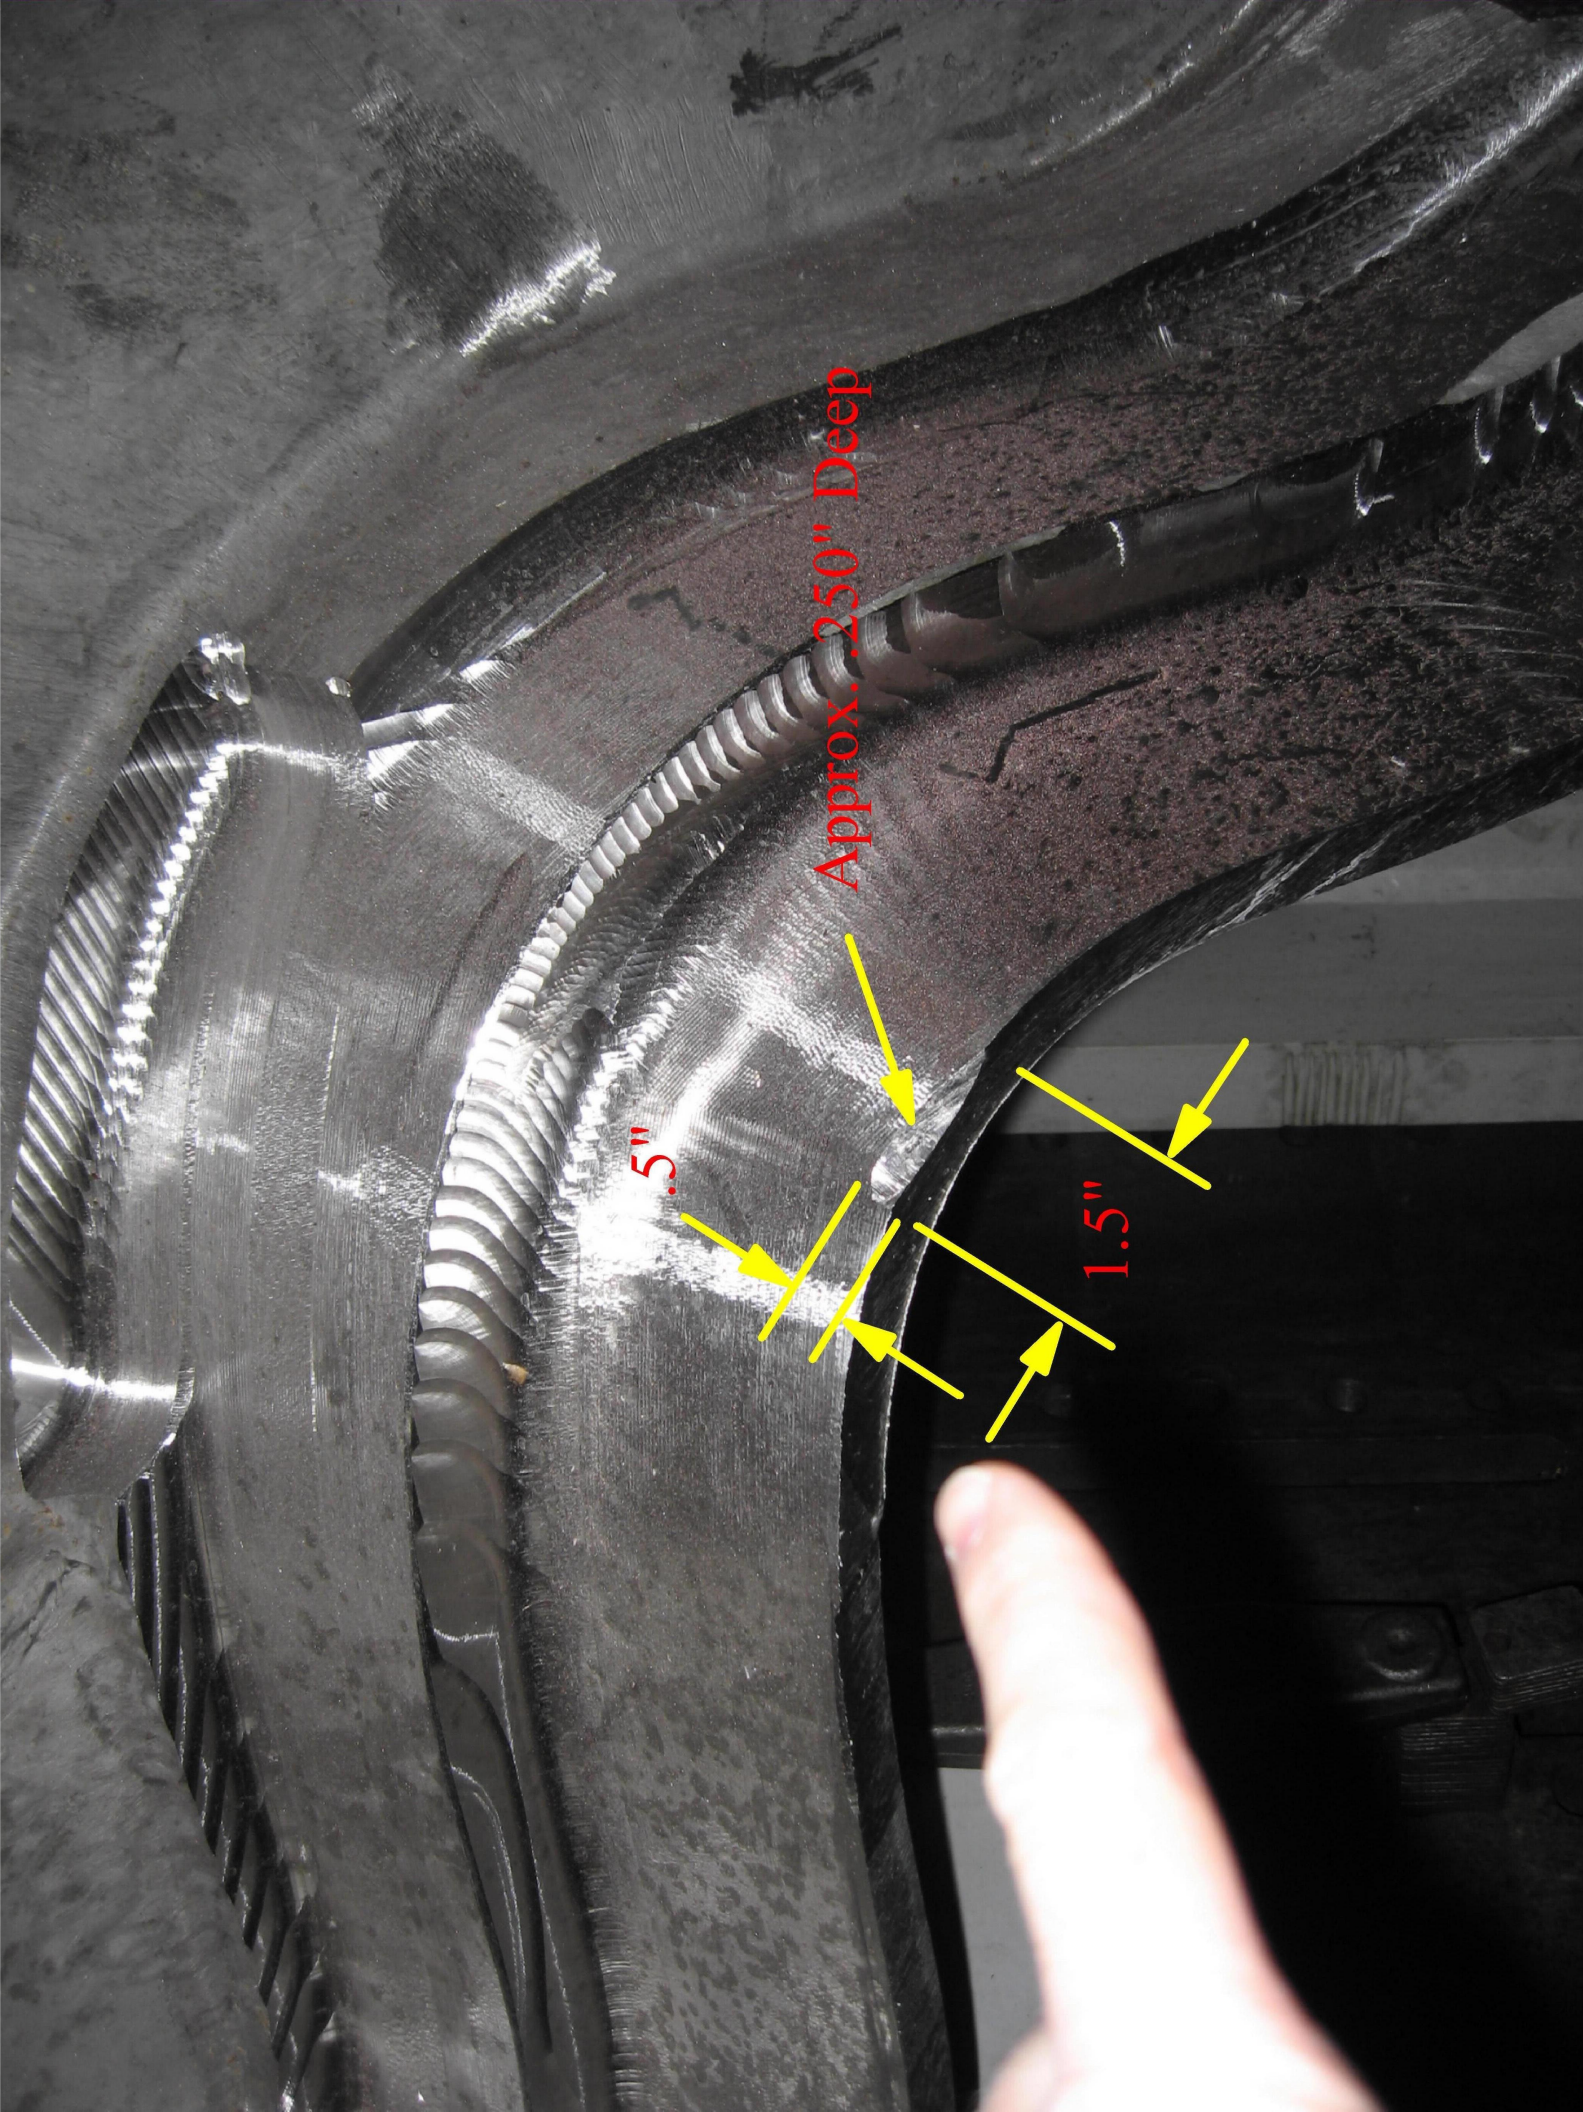
Problem: TOOL GOUGE APPROXIMATELY 1.5" LONG X .5" WIDE AND .250" DEEP ON THE CORNER OF THE T.
GOUGE IS LOCATED ON THE DATUM -D- SIDE (SEE PICTURES).

Resource: CAD/CAM – LARGE MILLING Equipment:
Description: THE TOOL-GOUGE OCCURRED AS A RESULT OF A PROGRAMMING ERROR. PROGRAMS HAD BEEN MODIFIED TO HELP REDUCE MACHINING CYCLE. THE NEW PROGRAM WAS VERIFIED USING VERICUT PRIOR TO RELEASING TO THE MACHINE. THE PROGRAMMER AGAIN VERIFIED THE PROGRAM AFTER THE GOUGE OCCURRED AND DISCOVERED THAT THE ERROR HAD BEEN DETECTED BY VERICUT. THE PROGRAMMER WAS NOT CORRECTLY INTERPRETING THE RESULTS FROM THE VERIFICATION PROCESS.

Approx. .250" Deep

.5"

1.5"

RECOMMEND WELD REPAIR OF DEFECTIVE AREA PRIOR TO FINISH MACHINING.
ALSO RECOMMEND REPAIR TO BE INSPECTED USING PT AND MAG PERMEABILITY CHECK WITH
WAIVER OF THE X-RAY REQUIREMENT.

Description: THE PROGRAMMER HAS BEEN GIVEN ADDITIONAL TRAINING ON THE USE OF VERICUT AND FULLY UNDERSTANDS HOW THE ERROR WAS MISSED.
