Part: SE141-114 / MODULAR COIL WINDING FORM TYPE

Drawing ID: SE141-114 Revision: 6
Links: 1-Type:W: 65709/1.0 Sub: 1 Op: 50

Problem: Reference sheet 4, zone G7.

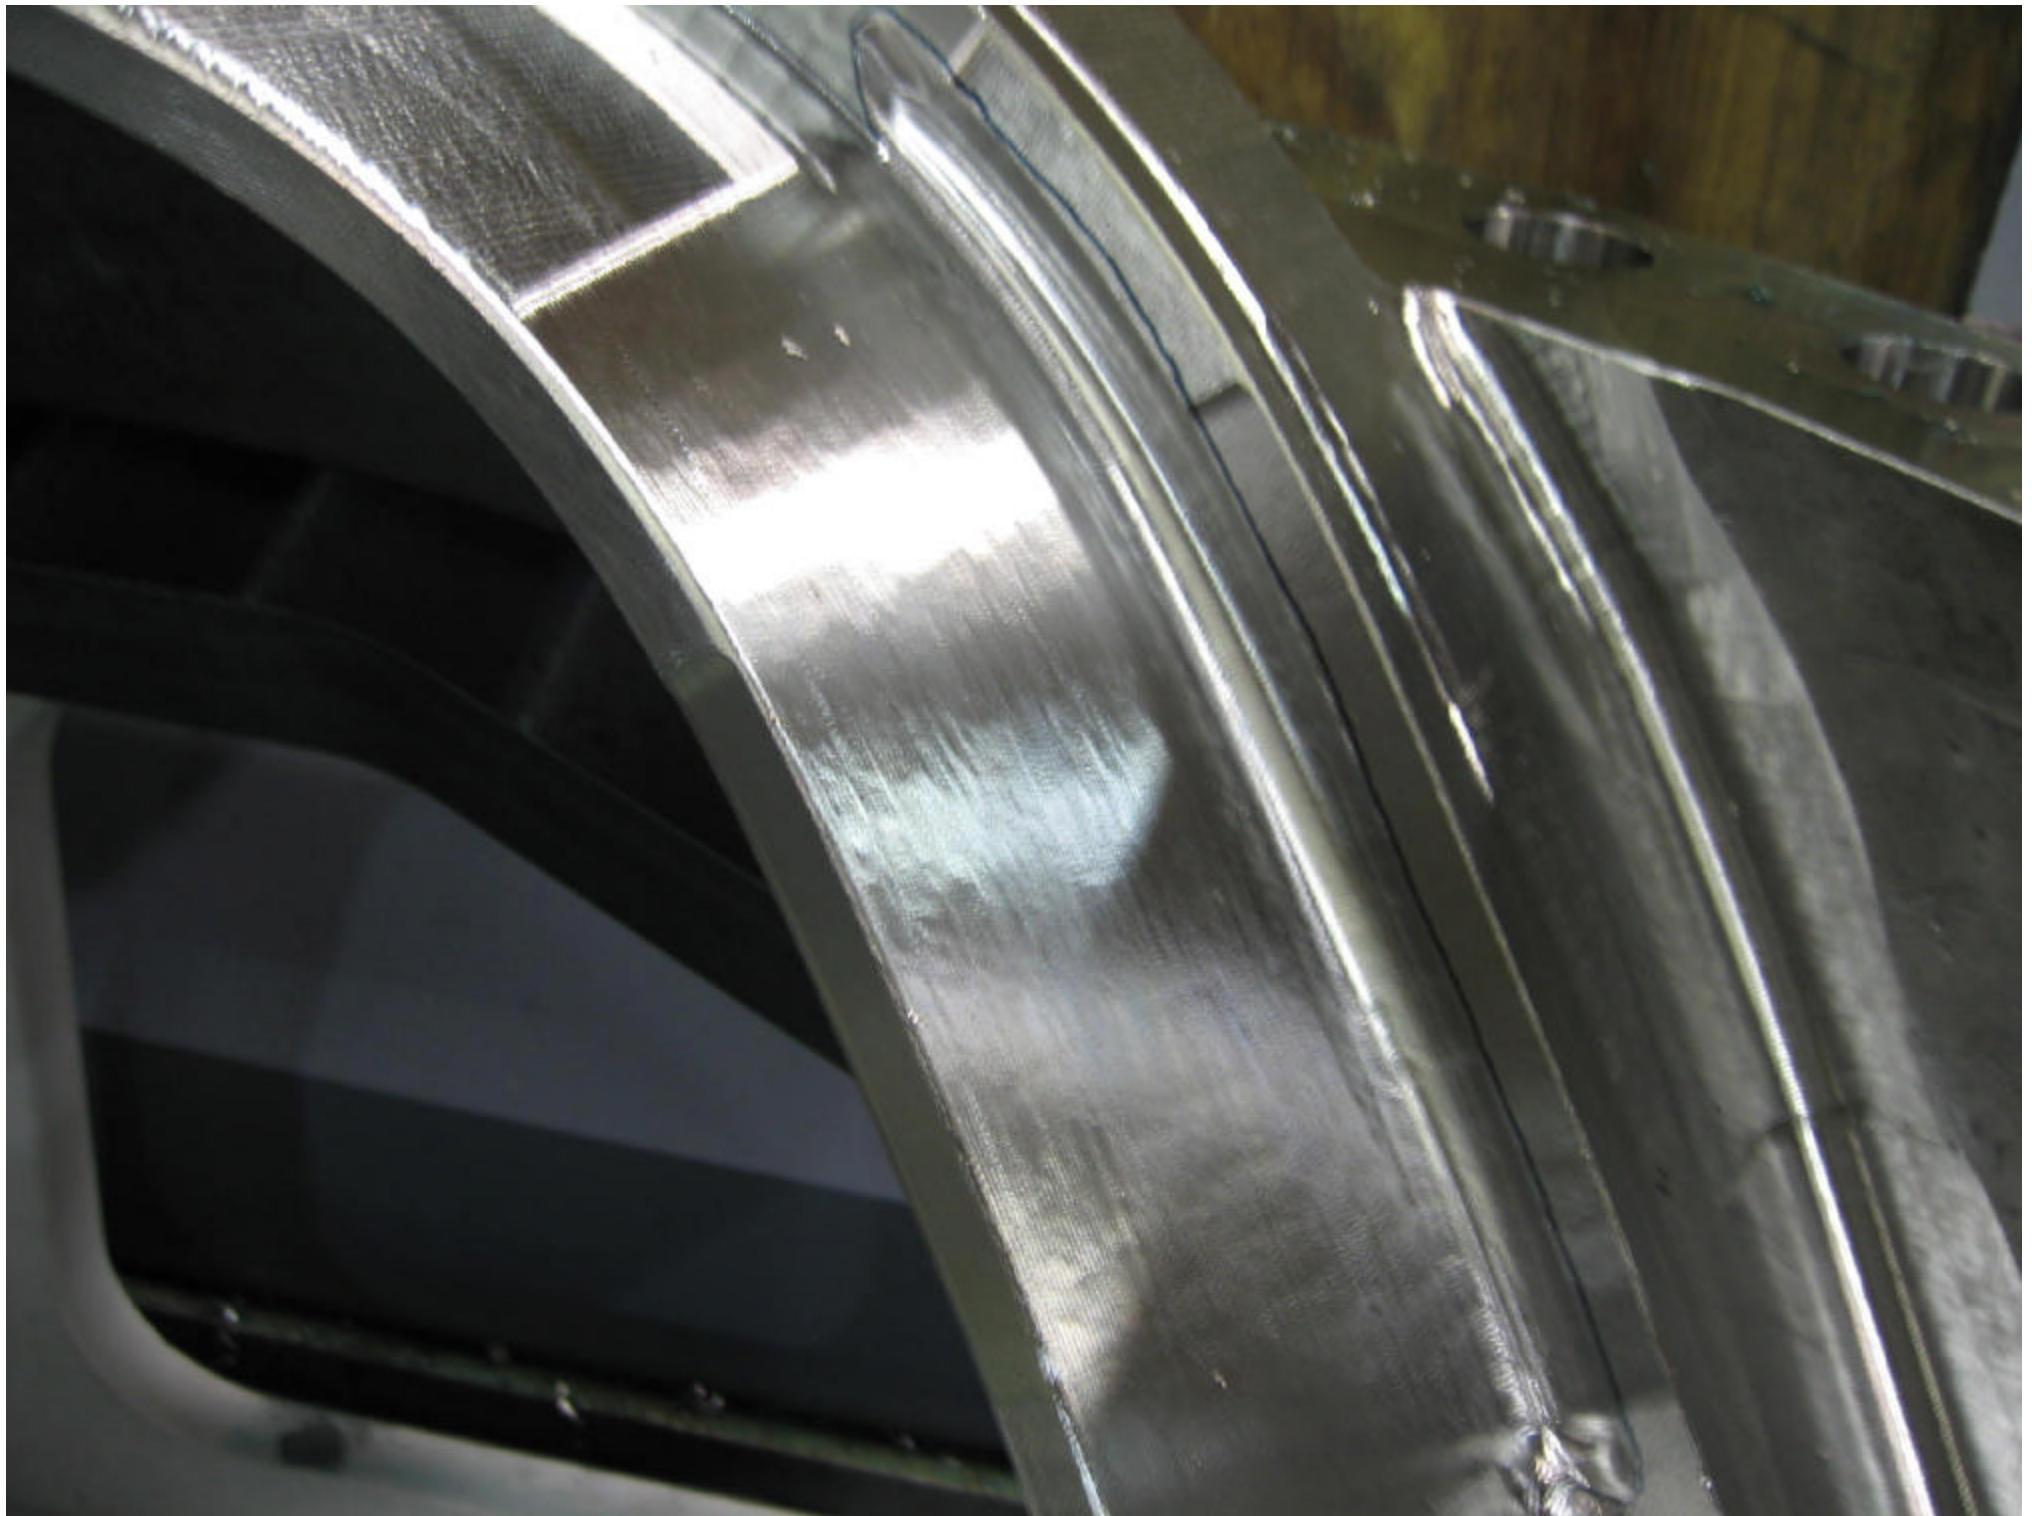
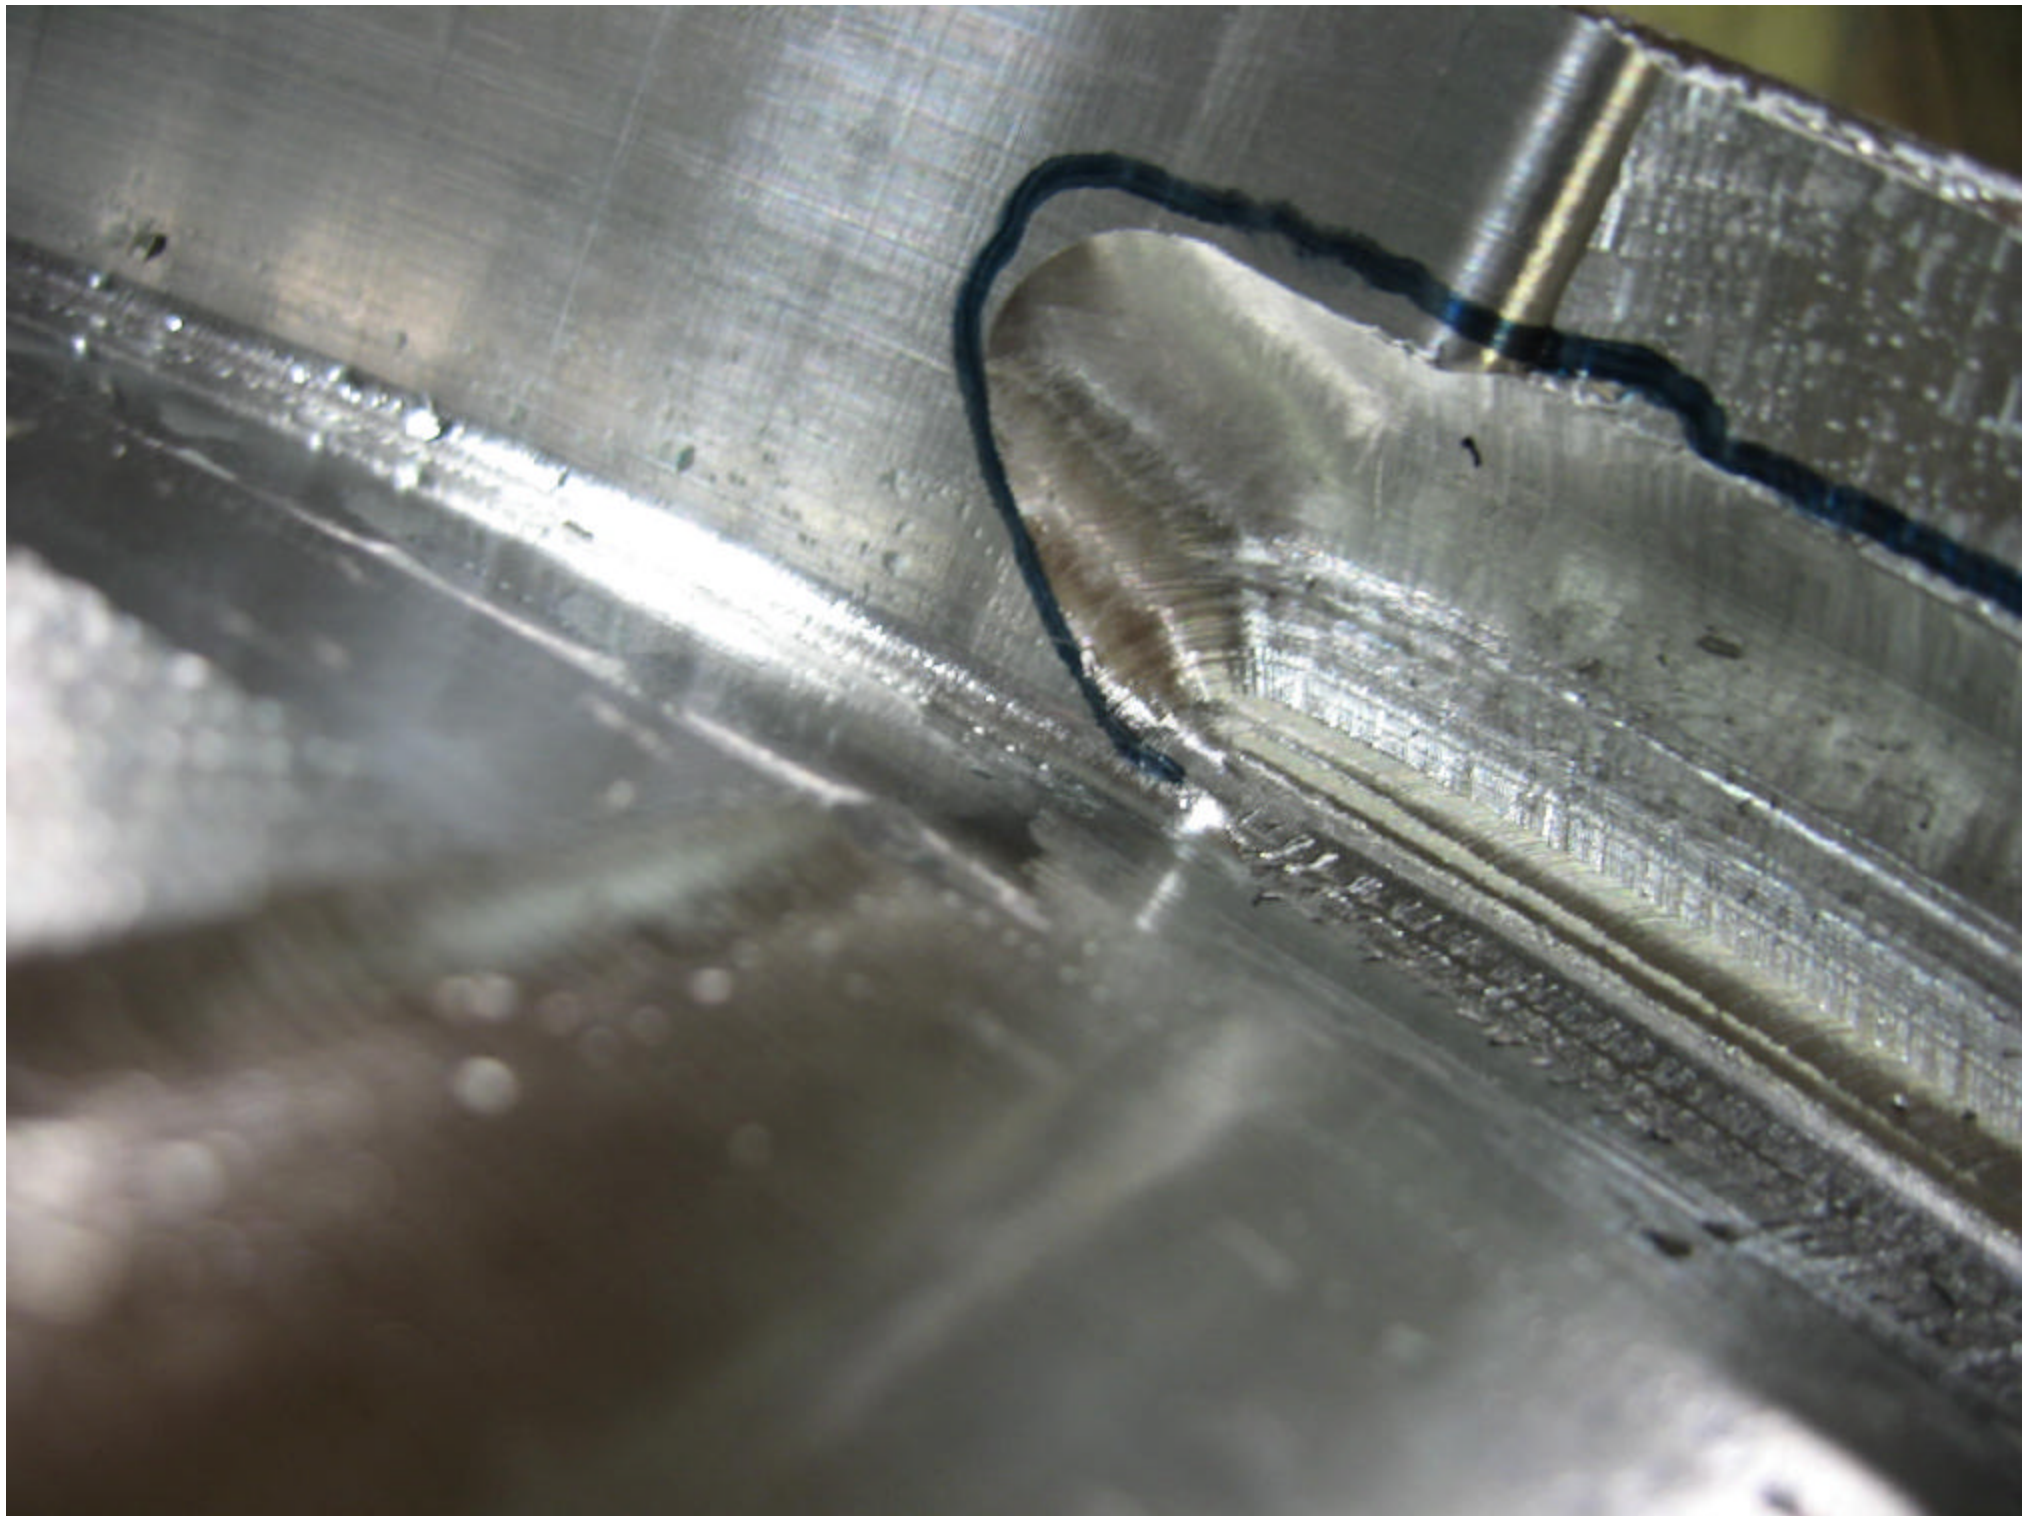
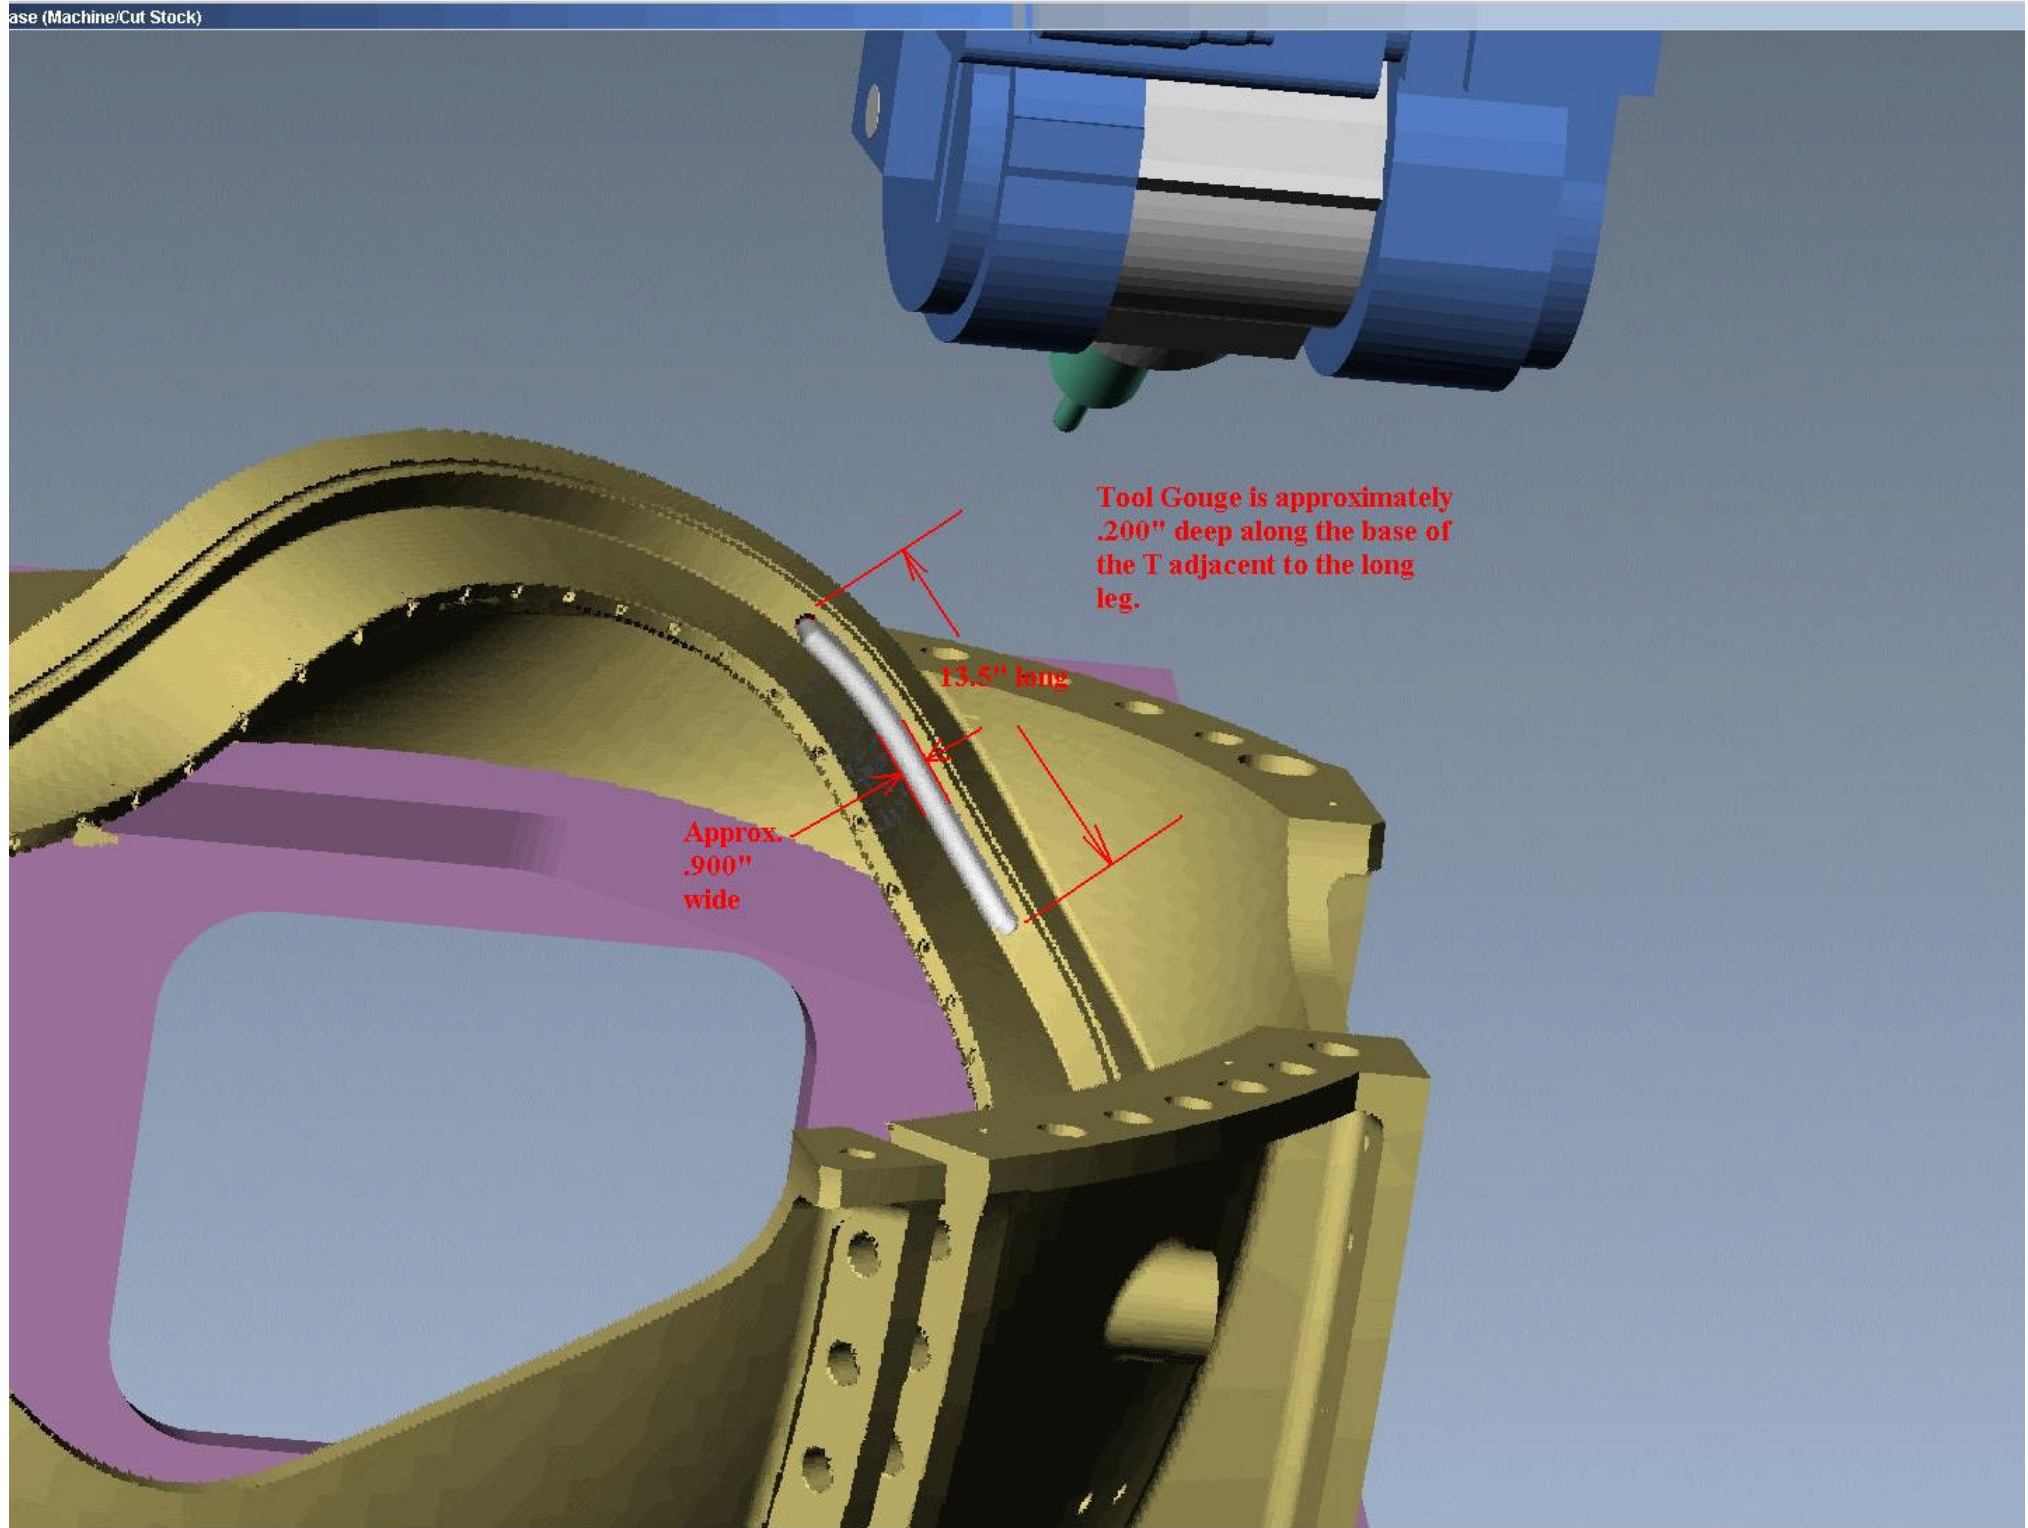
There is a tool gouge along the short leg of the T section on the Datum -D- side. The gouge is approximately 13.5" long, .900" wide and .200 deep. See attachments for clarification.

Description: There are 2 root causes here.

1) The tool gouged the wall because the toolpath was generated incorrectly. The check surface (back wall) was not selected and therefore the toolpath gouged the back wall.

2) The toolpath (n/c program 31501) was released as a good program because the verification did not show / flag an error of the toolpath violating the design model.

Propose to weld repair the tool gouge. Indicators would be applied on and around the T section to monitor any part movement caused by welding. The welding process would altered as needed to minimize movement. A local mag permeability and PT inspection would be performed. This gouge is located on the short leg in the area designated as "High Stress". During the RT of the High Stress area an additional shot would be taken of the repaired area. It is likely that this RT shot would prove inconclusive due to it's location.

NCSX agrees with MTM's recommended disposition to weld repair, followed by local mag. perm. Inspection, PT inspection, and RT during the RT of the high stress area. MTM is requested to provide documentation after the repair is completed.
