Part: SE141-114 / MODULAR COIL WINDING FORM TYPE

Drawing ID: SE141-114 Revision: 6

Problem: SEVERAL MISCELLANEOUS ITEMS WERE FOUND DURING THE FINAL VISUAL INSPECTION OF THE PART. SEE ATTACHMENT FOR DETAILS.

SE141-114 A1
NC19933 attachment

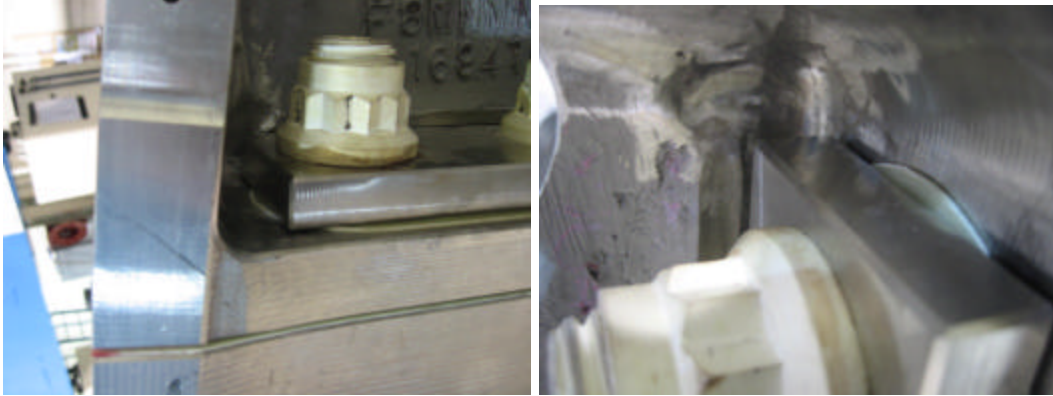
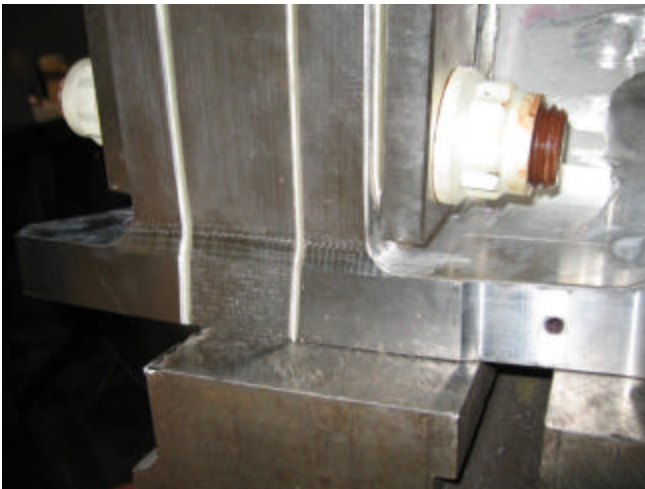
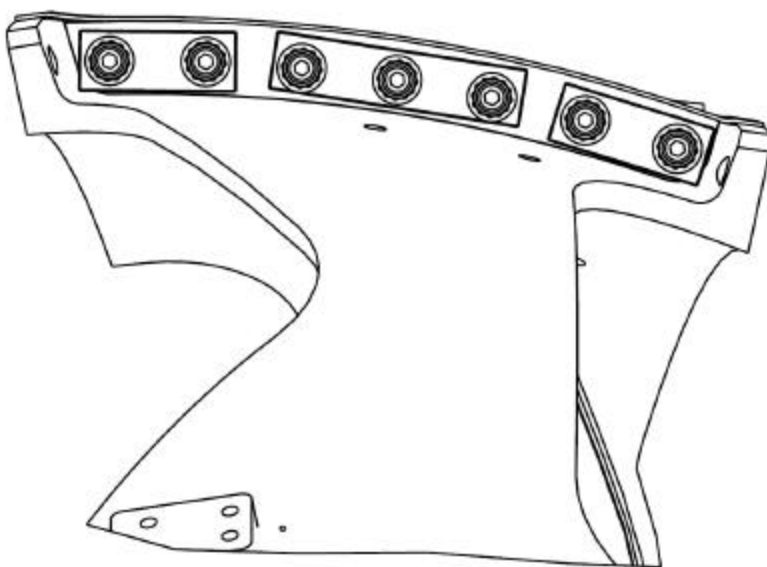
1. G11 shim between break flanges and bearing plates.

G11 shim has a full radius on both ends. The drawing shown below shows only the radius toward the inside cast wall.

#1-Accept as is; PPPL will install Gl/Ep in the gaps after VPI is completed. MTM agreed to make remaining insulators extend to the edge of the parts.

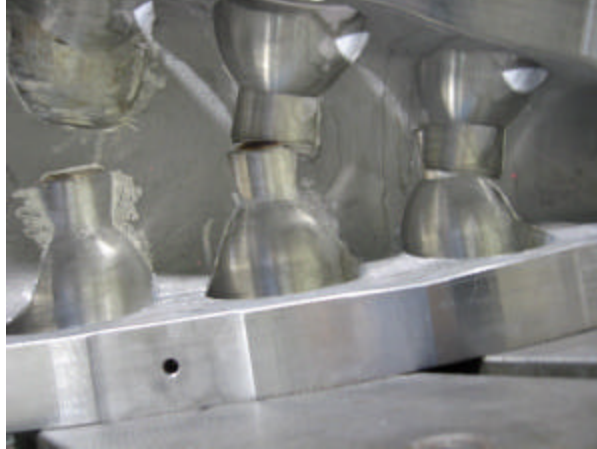
2. Photo below shows areas where counterbore clearances were cut heavy into the casting wall. These areas will not accept the 3" diameter clearance gage. These areas and others were identified and reported on RFD 14-020.

#2-Accept as is.

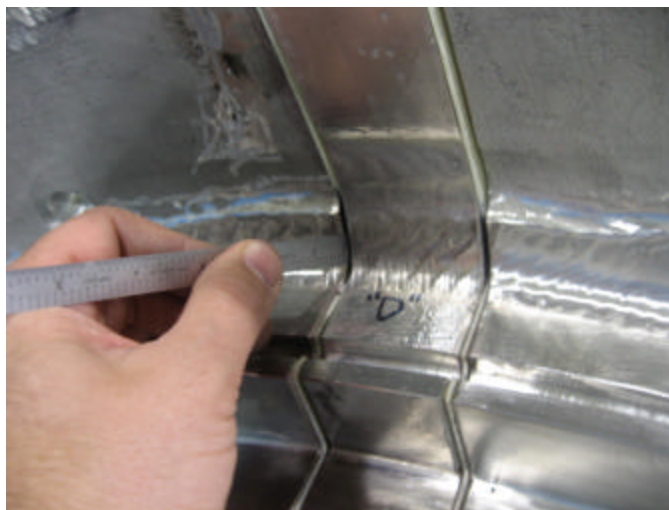
3. Poloidal Break, Datum D side. Casting radius between T section and inner wall extends beyond the G11 shim approximately .300" on each side.

#3-Accept as is; PPPL will install Gl/Ep in the gaps after VPI is completed. MTM agreed to make remaining insulators extend to the edge of the parts.

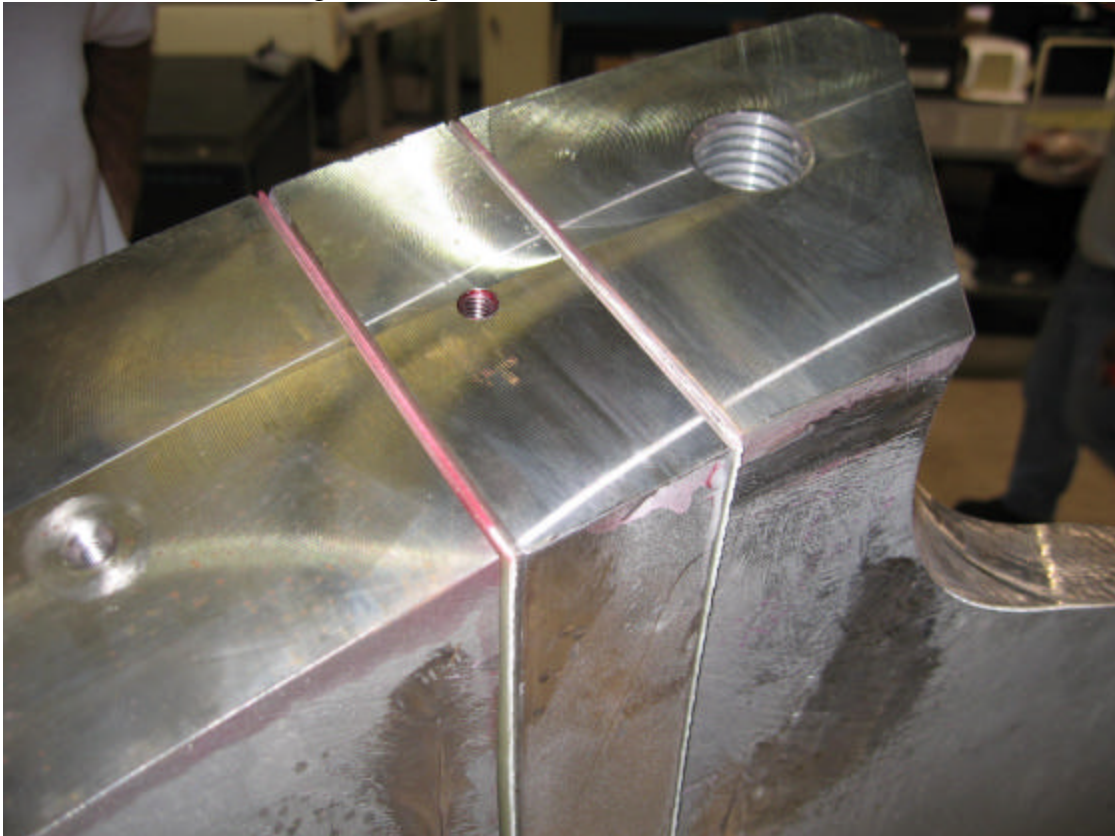
5. One of the G11 shims from the Datum D view is contaminated with the Liquid Penetrant used during the PT process.

#5-Accept as is. PPPL will verify that dye will not degrade G-10.

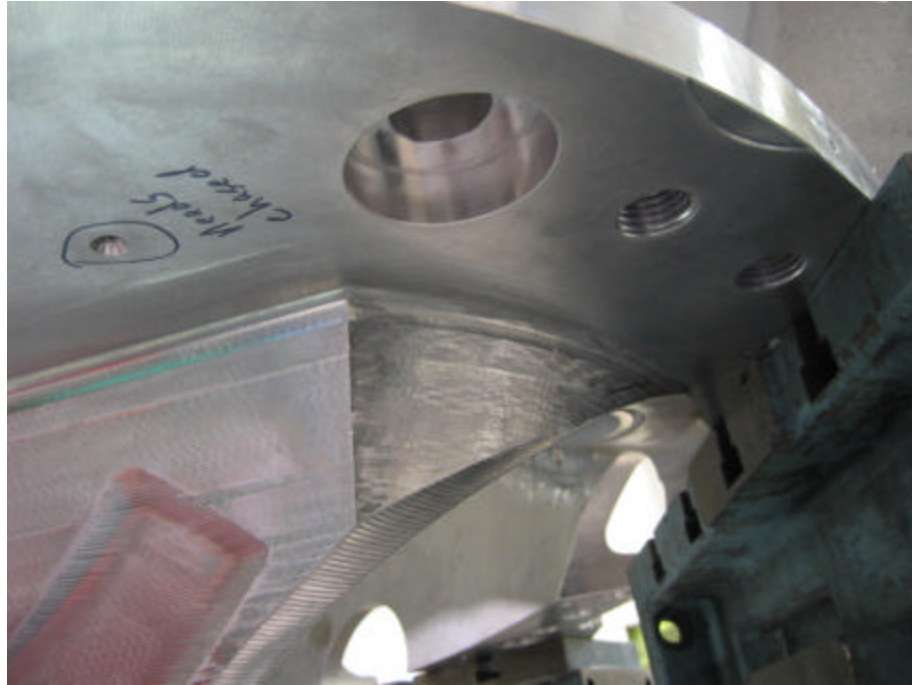
6. Tool gouge on datum E flange. Gouge measures .038" deep by 3.25" long by .50" at its widest point. Radial gouge from 6" face. The gouge is located on the datum E flange in section C5 on sheet 5 of the drawing.

#6-Accept as is.

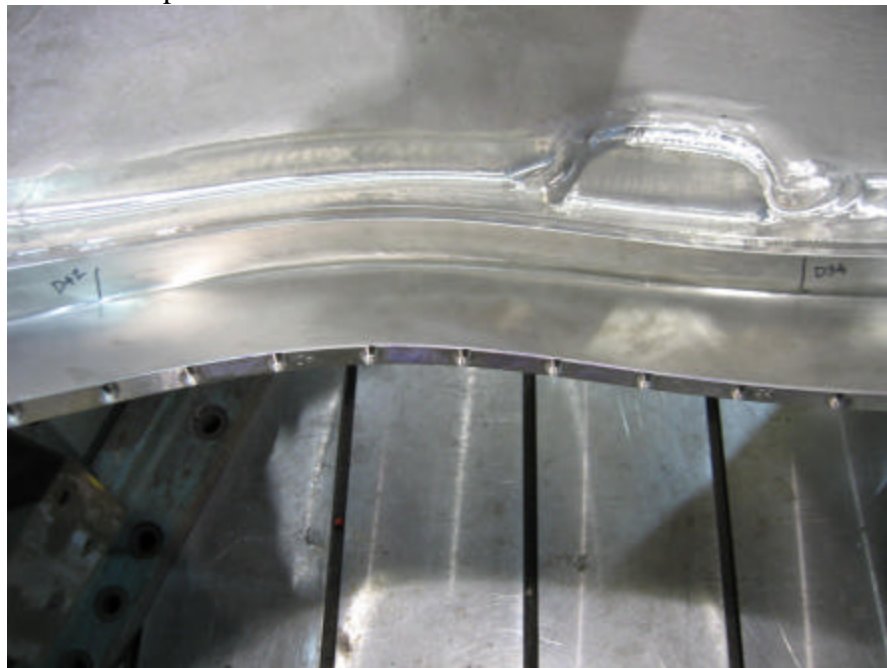
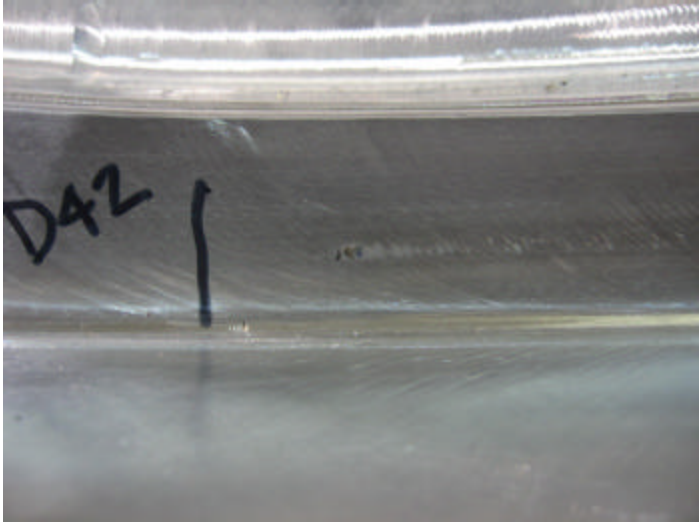
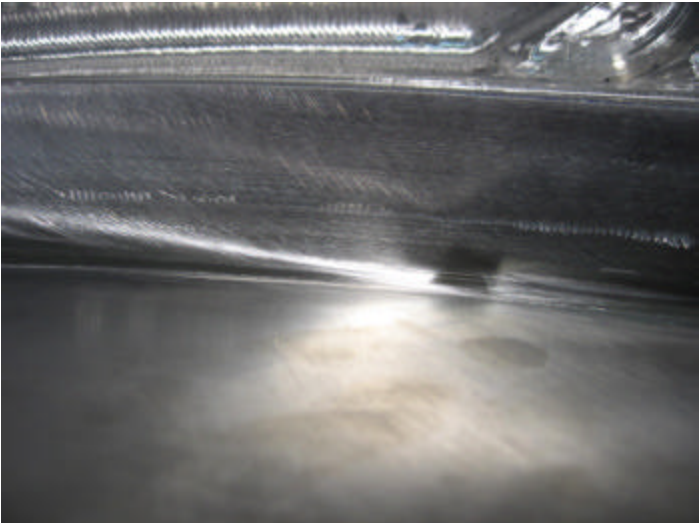
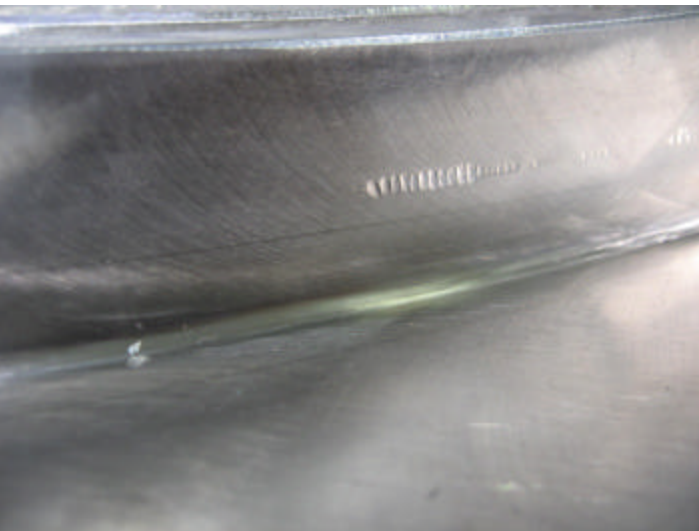
7. Various tool cutter marks on the D side short leg between holes 34 and 42. Cutter marks are no deeper than .010".

#7-Accept as is.

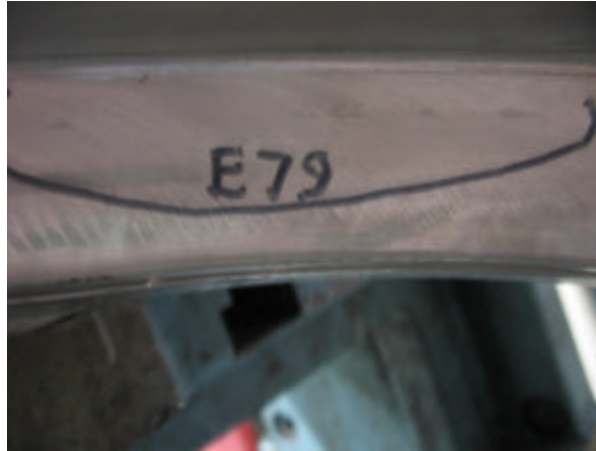
8. Various cutter marks on the E side of the T section. Cutter marks are no more than .010" deep.

Short leg of T near hole 79.

#8-Accept as is.

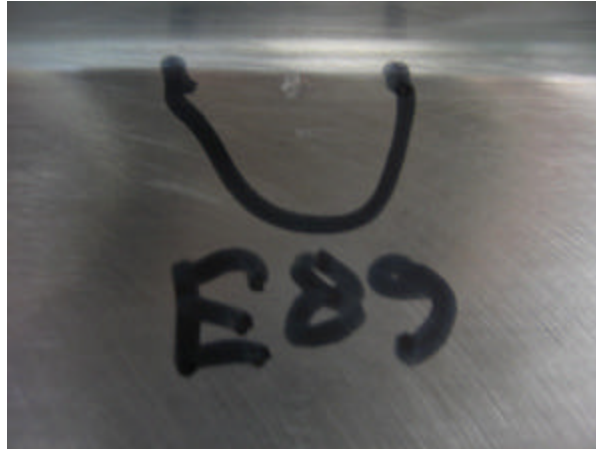
In radius between long and short legs near hole 89.

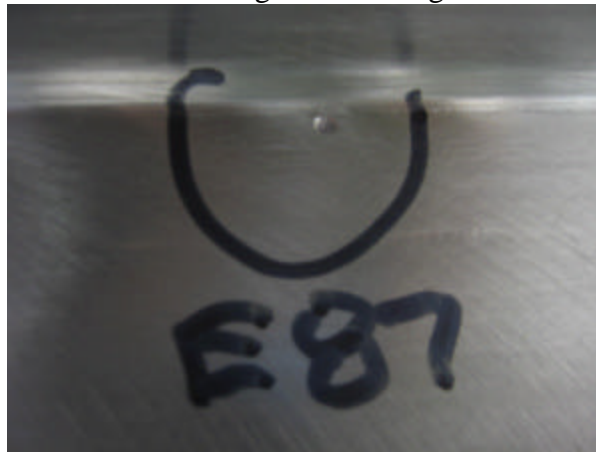
In radius between long and short legs near hole 87.

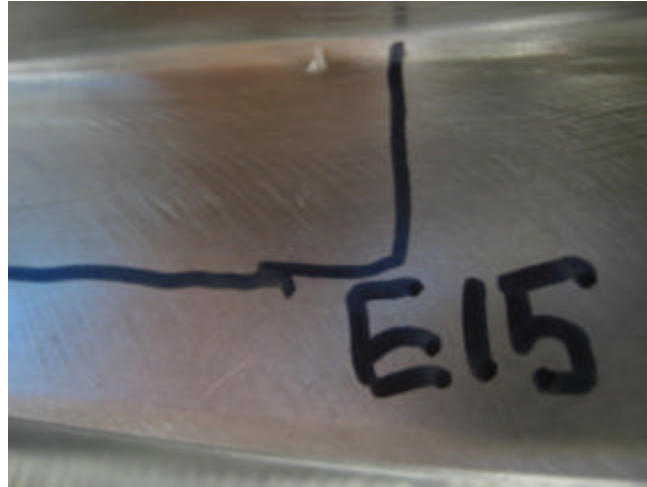
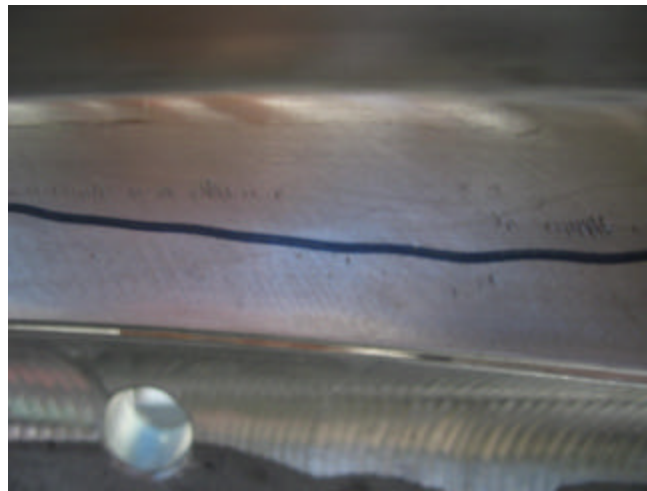
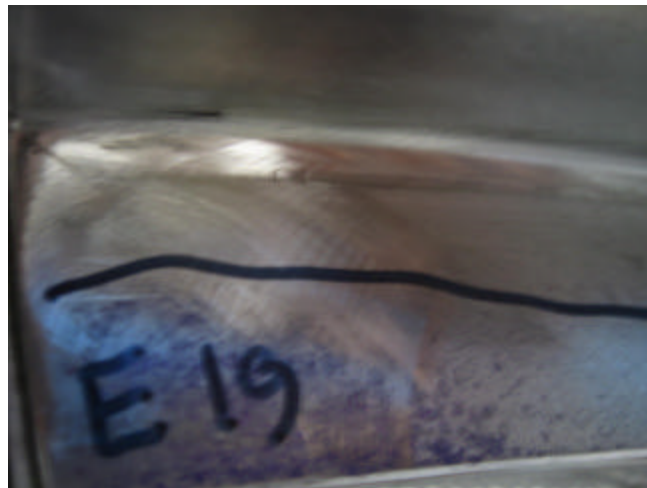
The following photos are of the short leg of T between holes 15 and 19.

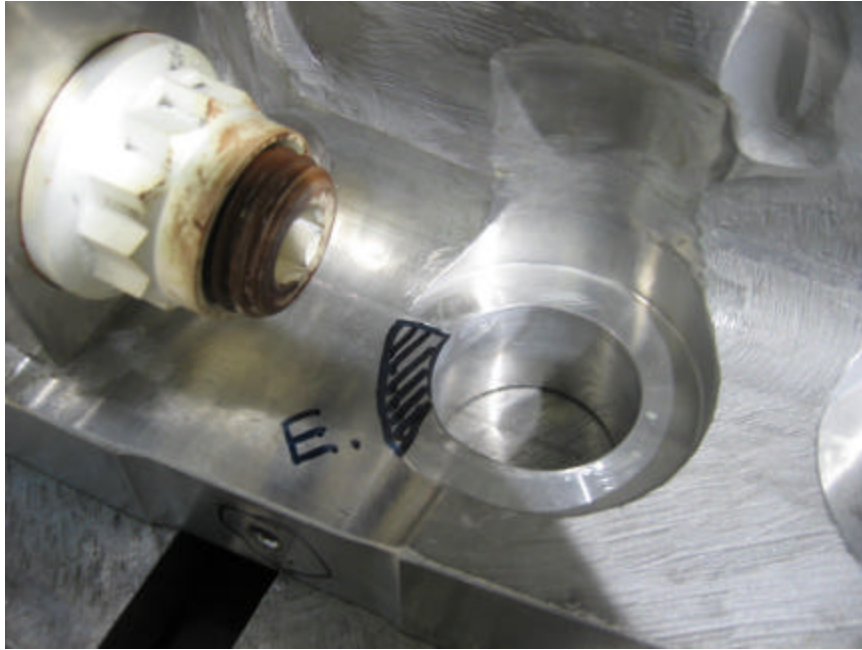
9. Approx. 20% of counterbore did not clean up to 100%. Hole is located on the datum E flange next to the poloidal break. (area shaded in photo below).

#9-Accept as is.

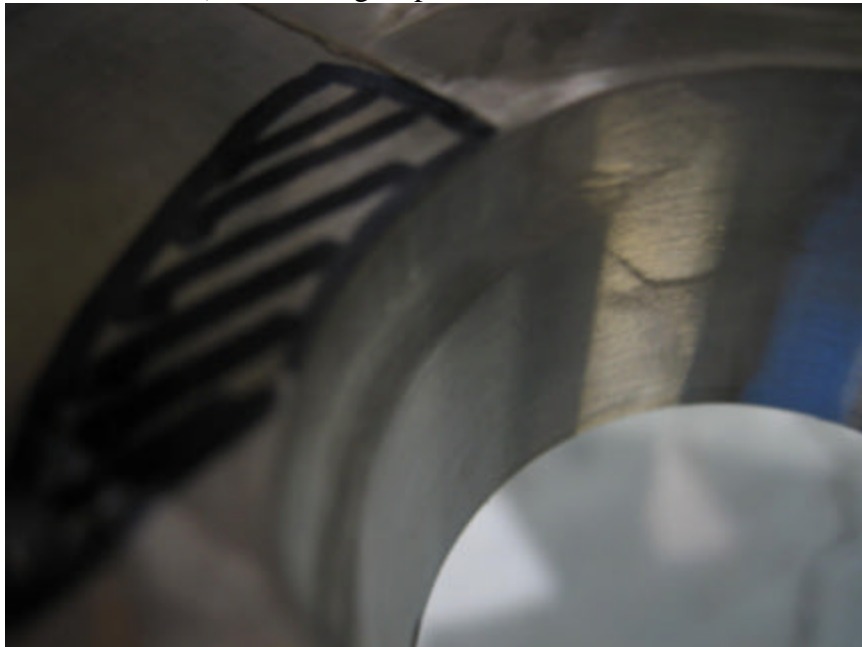
10. There is also an oversized area in this same 1.885 hole. The hole checks $\text{Ø}1.884''$ from the datum E face to a depth of .950". The oversized area extends approximately 1/3 around the diameter (the oversized area is offset to the centerline of the bore). At its largest point, the bore checks $\text{Ø}1.948''$.

#10-Accept as is.

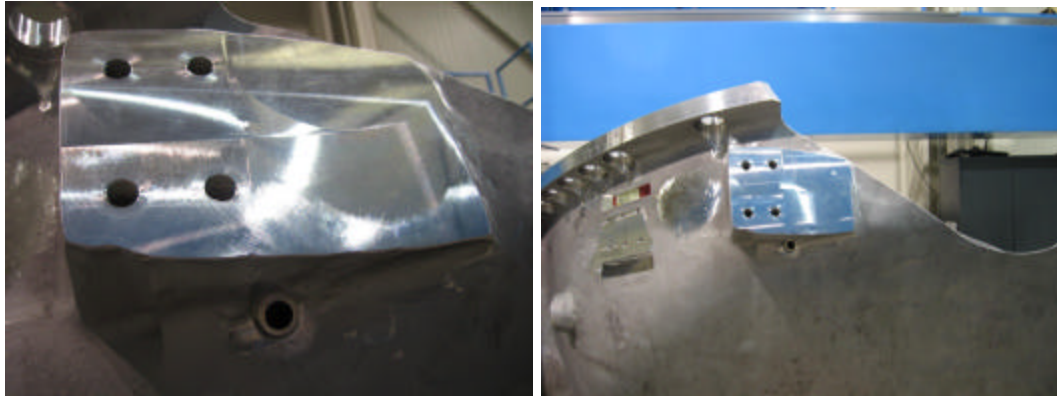
11. The pad shown below has excess casting stock which was machined flush with the pad face. See detail J in section F2 on sheet 7.

#11-Accept as is.

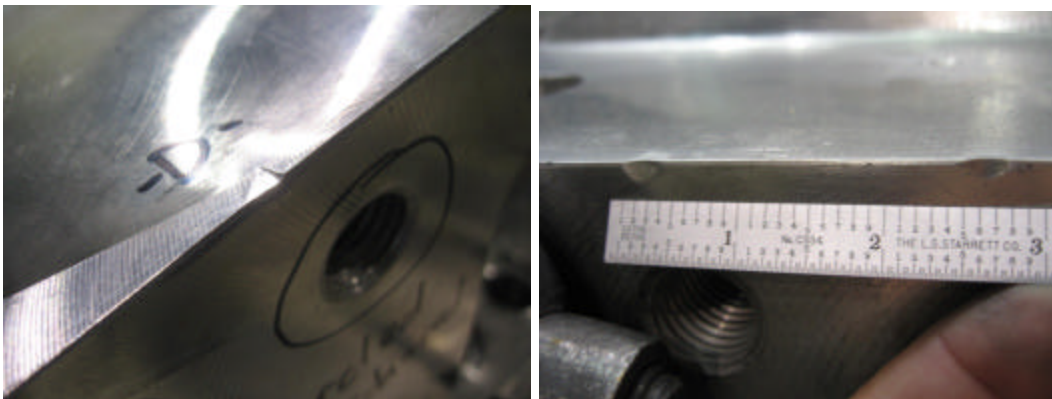
12. Various dings on the datum flange edges. Dings are being caused by swivel hoist rings when lifting the parts. Any raised metal around the areas have been polished flush to the surrounding surfaces.

#12-Accept as is.

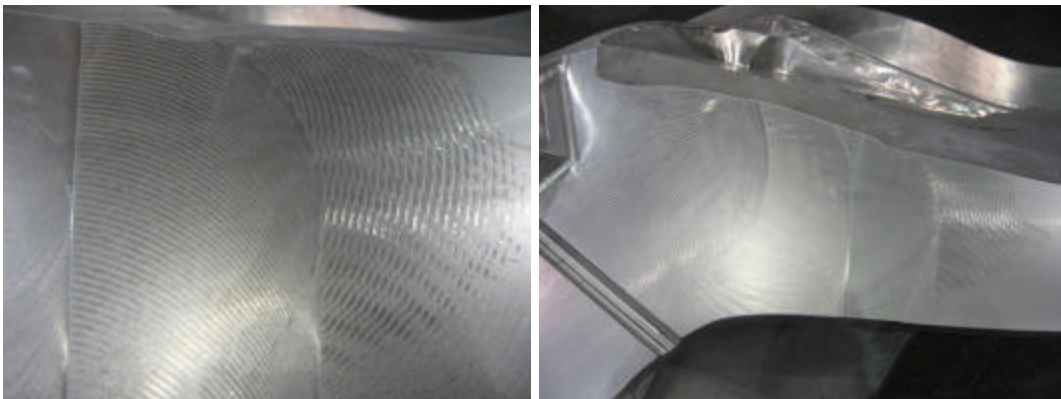
14. The area shown below on the datum E flange exceeds the v^{125} surface finish requirement. Area checks approximately v^{250} . This area is located on sheet 5, zone D5.

#14-Accept as is.
