NC20920 – B3 Visual Review

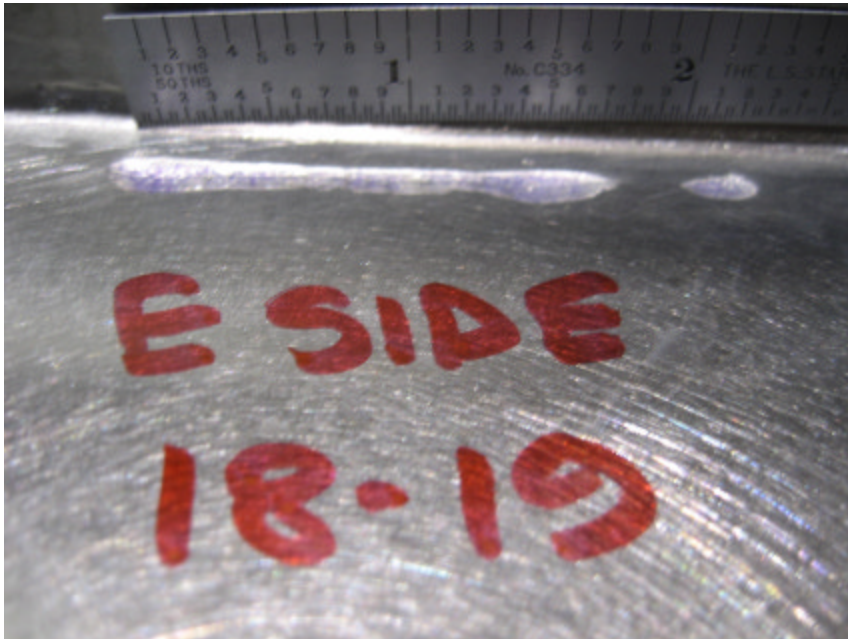
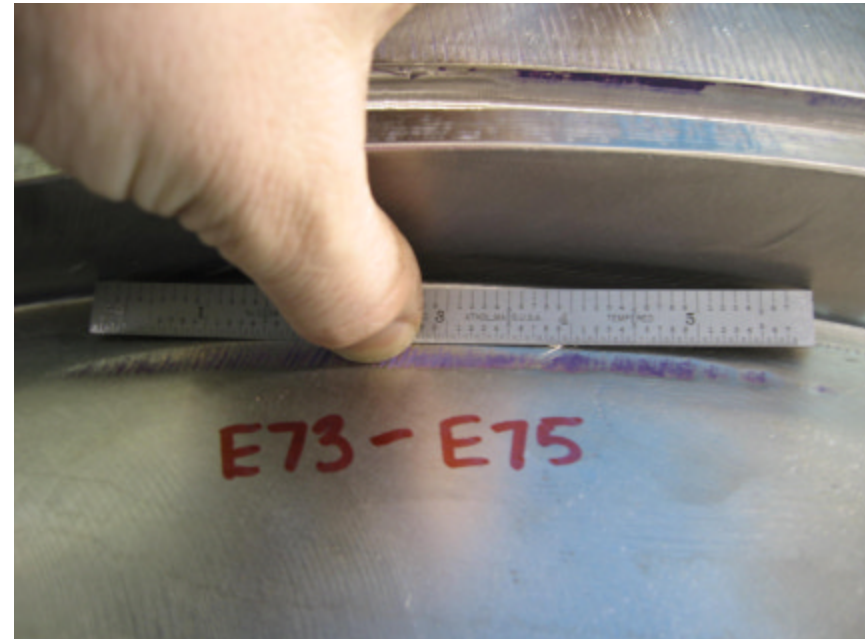
Tool Gouges on E side Long Leg near radius

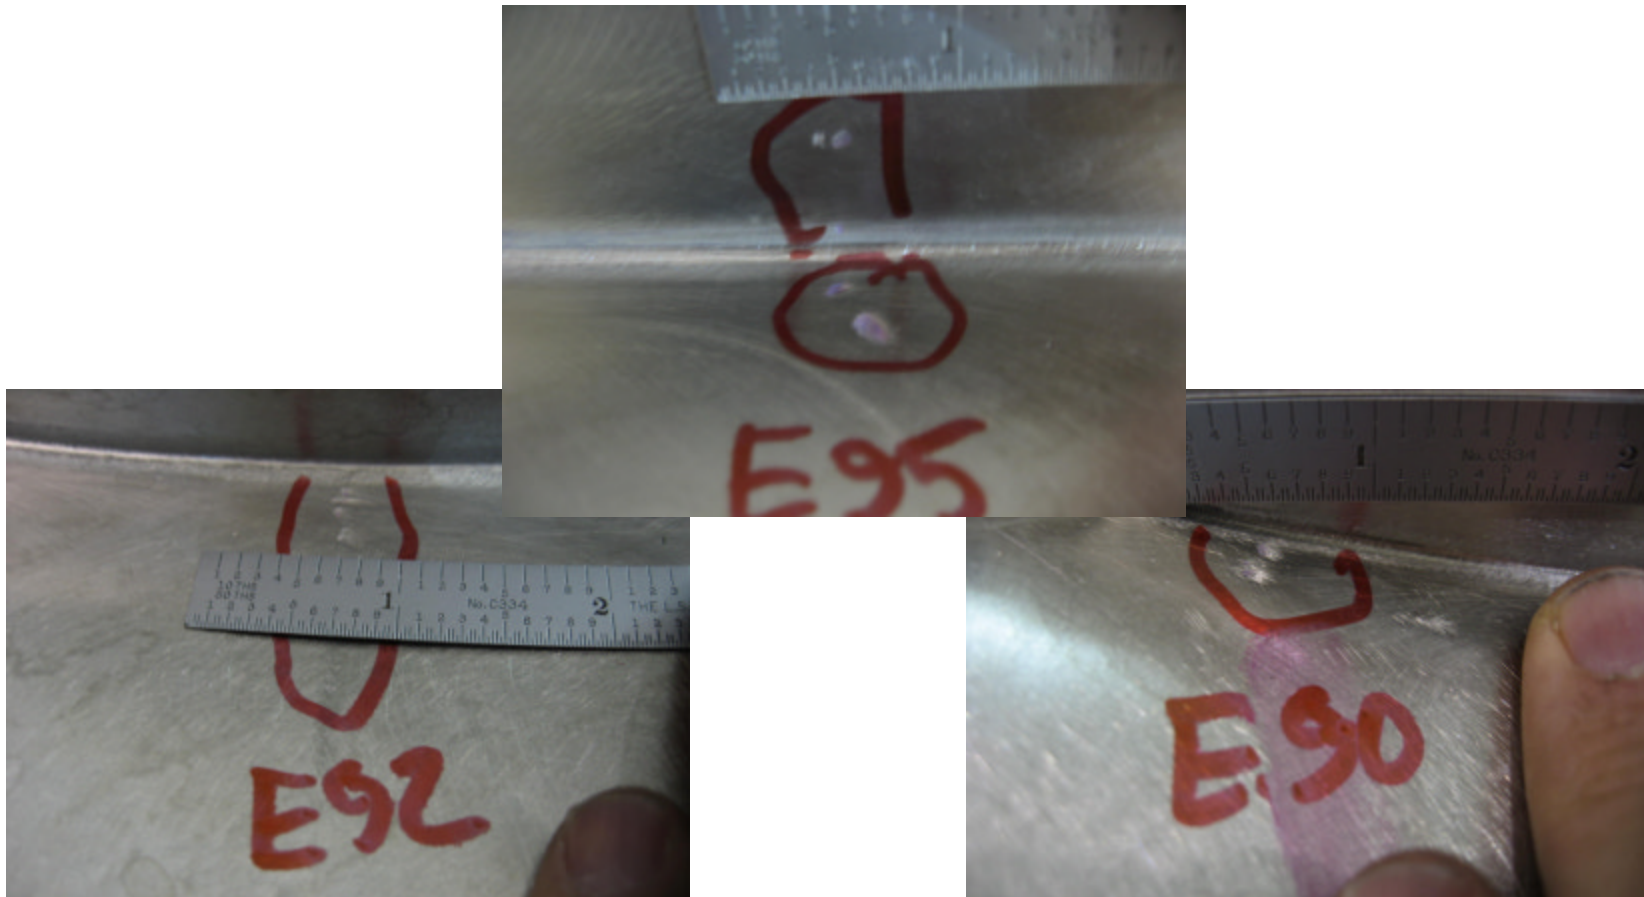
Tool Gouges on E side Long Leg near radius

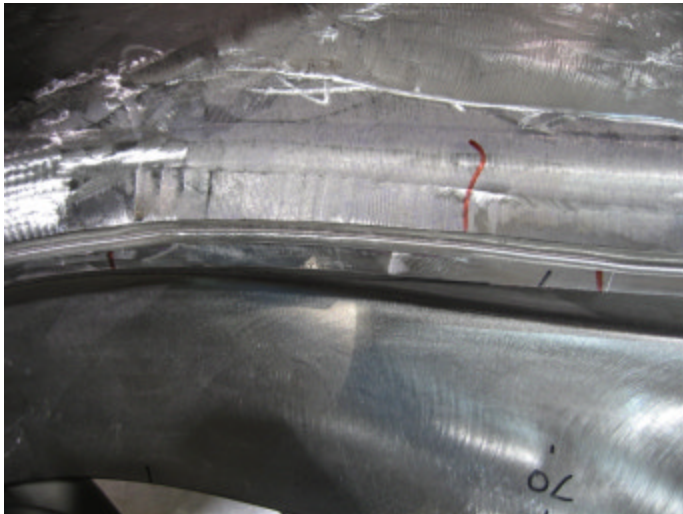
.400" distance from short leg to
VPI groove (sheet 2, zone G7)

There is an area on the Datum D side from T
hole 81 to 86 that checks as small as .300".
The transition has been blended smooth.

There is an area on the Datum D side from T
hole 70 to 73 that checks as large as .506".

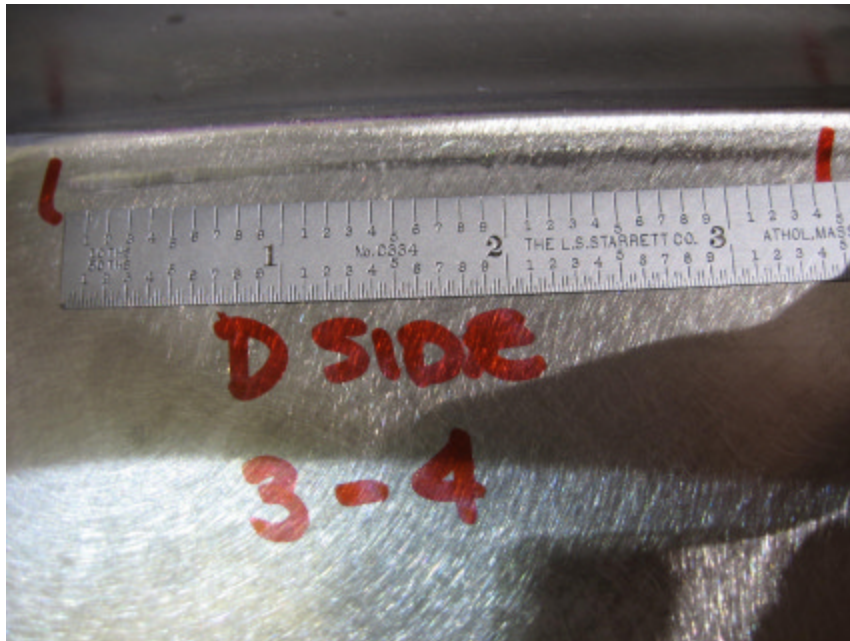
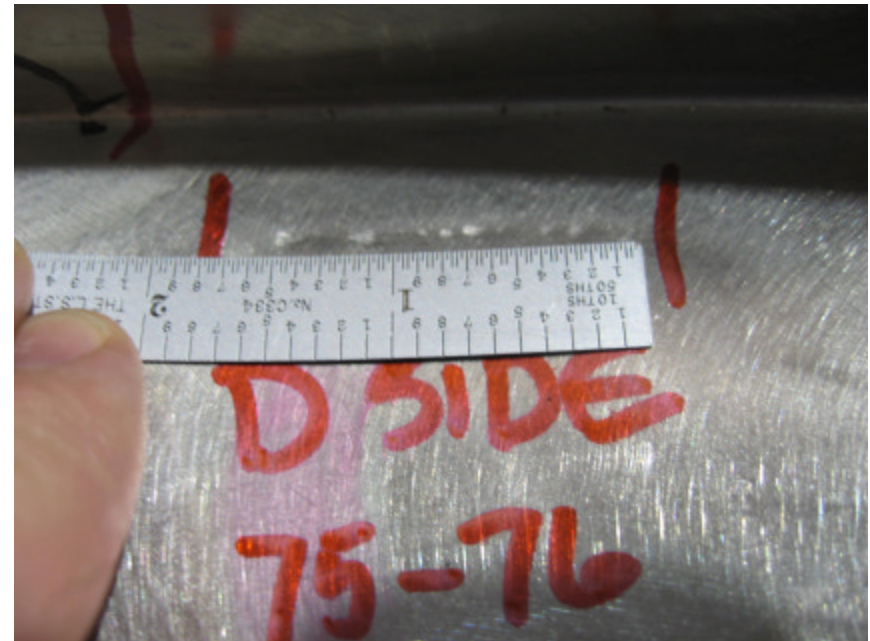
Tool Gouges on D side Long Leg near radius

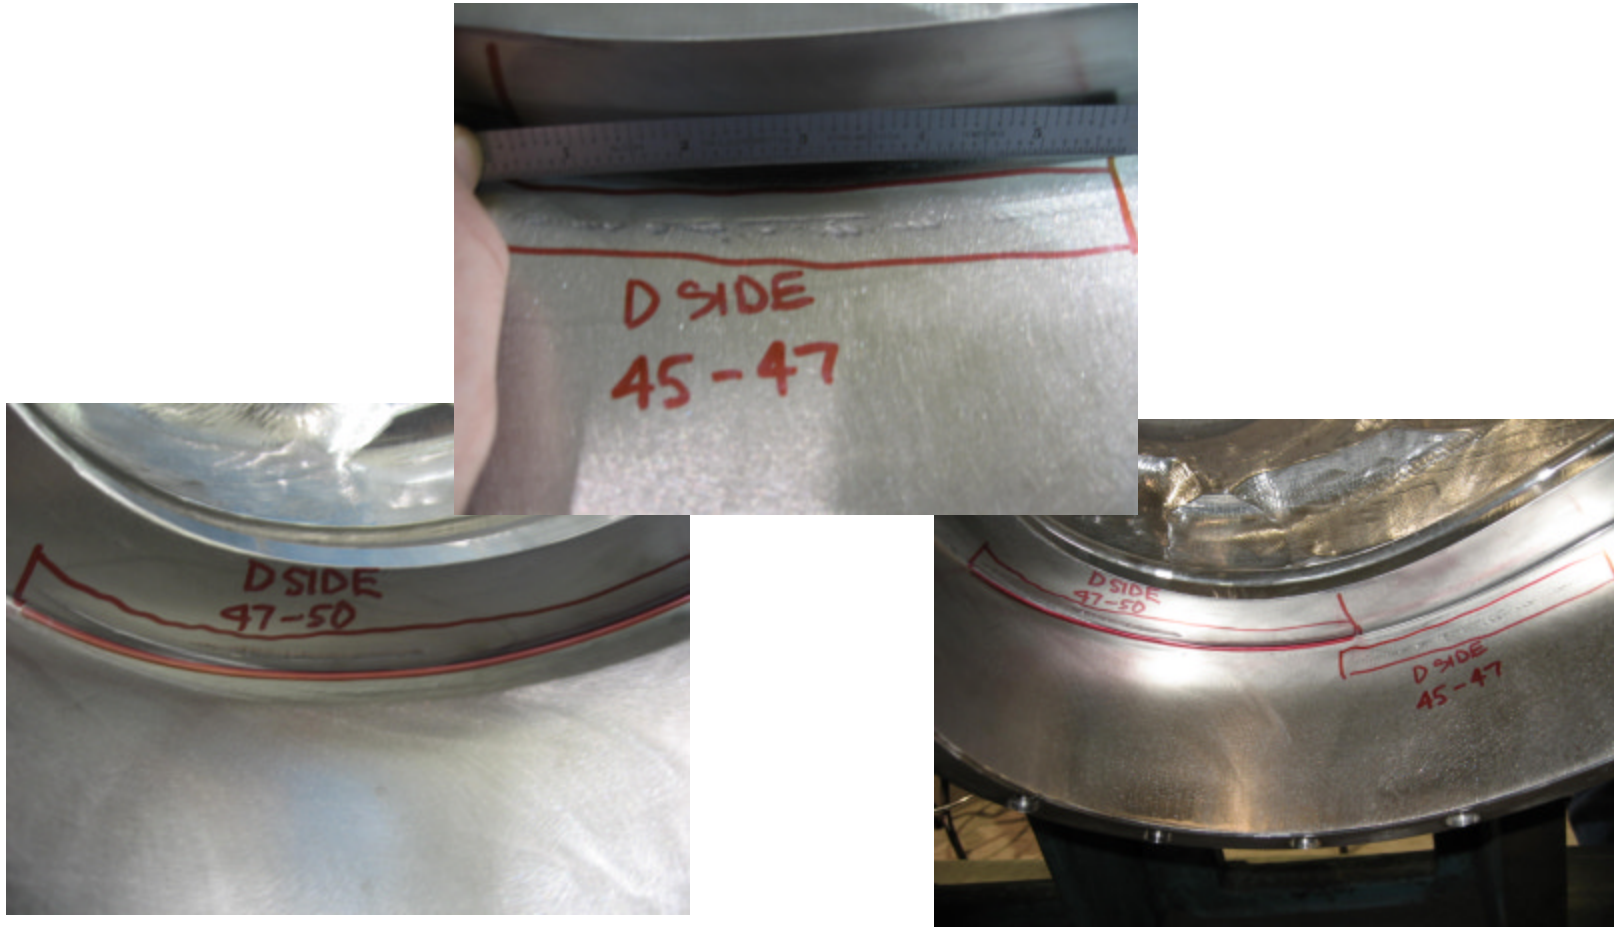
Tool Gouges on D side Long and Short Legs near radius

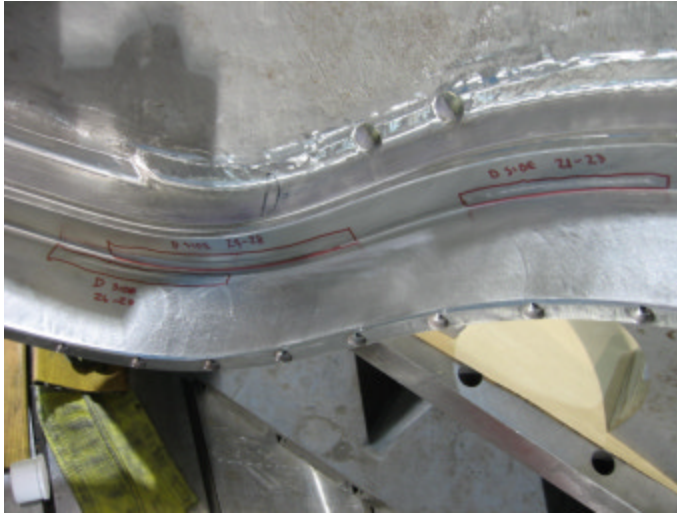
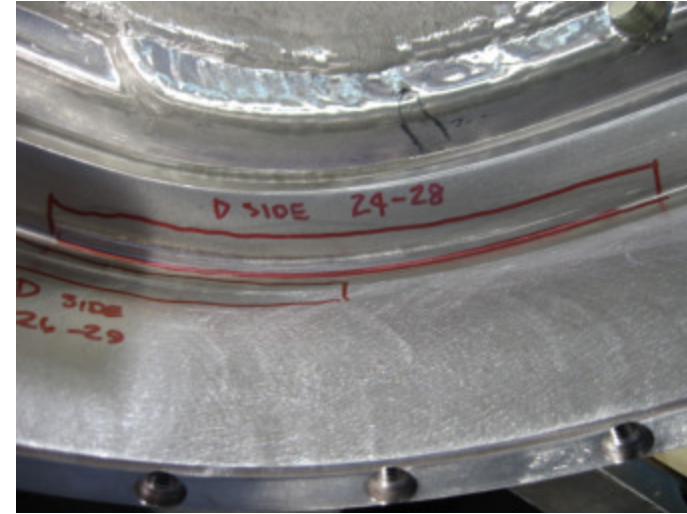
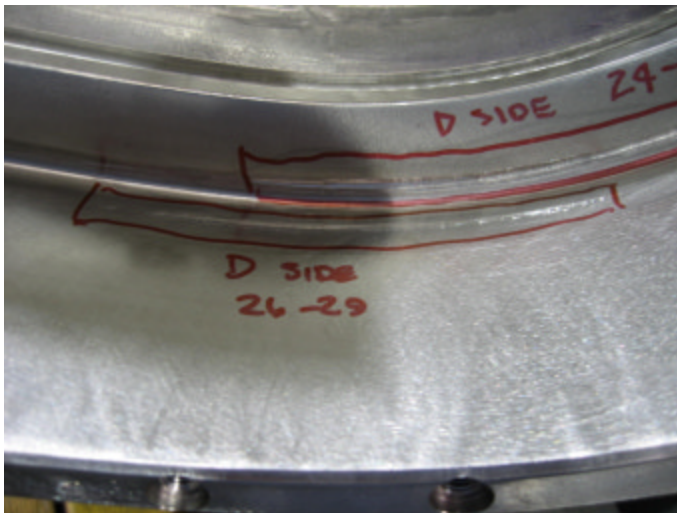
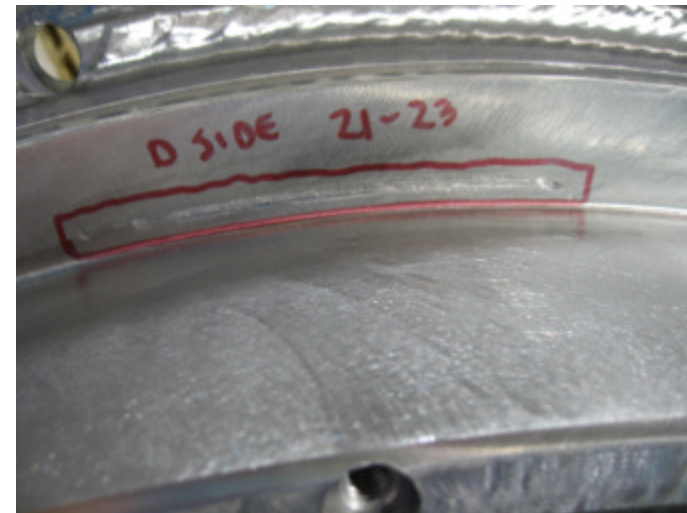
Tool Gouges on D side Long and Short Legs near radius

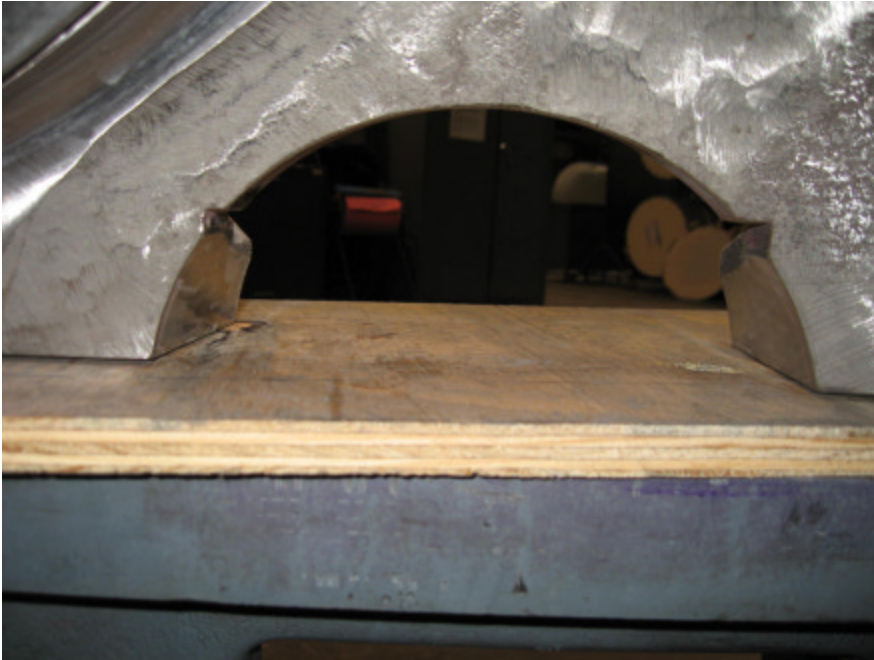
The picture to the left is of the port opening on the Datum D flange just beneath the Lead Block pad.

A programming error resulted in too much material being removed during the rough machining operation. An area on both sides of the port did not clean up.

One area measures approximately .25" x .25" and the other is .35" x .35". Both cutter marks extend through the opening the thickness of the casting wall.

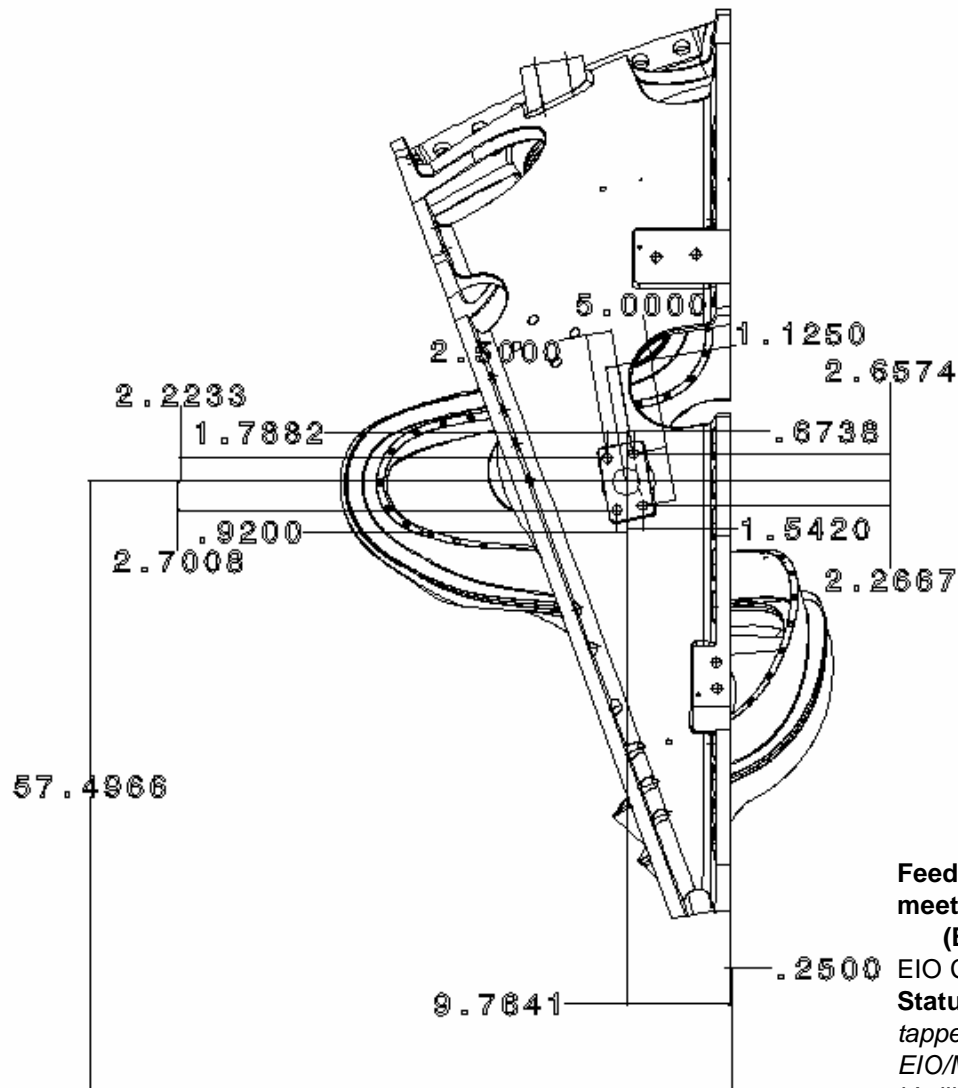
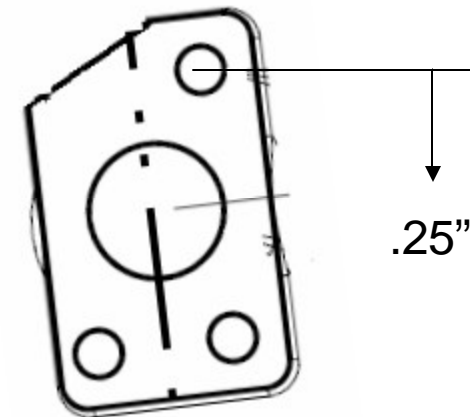
From the orientation shown, the 1-8" hole pattern was shifted .25" down. This hole pattern, per the model, was not centered about the 2.5" hole prior to this shift.

Status: (Open) MTM confirms that the center hole position is fixed but the tapped hole pattern is being shifted as needed (applies to all Type B castings). EIO/MTM will provide proposed shifted locations prior to drilling. On B3 & B6 it's likely that one hole cannot be drilled (corner missing). The CA will remain open until after B6 is completed.
