Part: SE141-115 / MODULAR COIL, TYPE B

Problem: SEVERAL ITEMS NOTED DURING VISUAL REVIEW OF CASTING. SEE ATTACHMENT.
Rev. 1 - added pages 9 & 10 to the attachment. (1-2-07)

NC20920 – B3 Visual Review

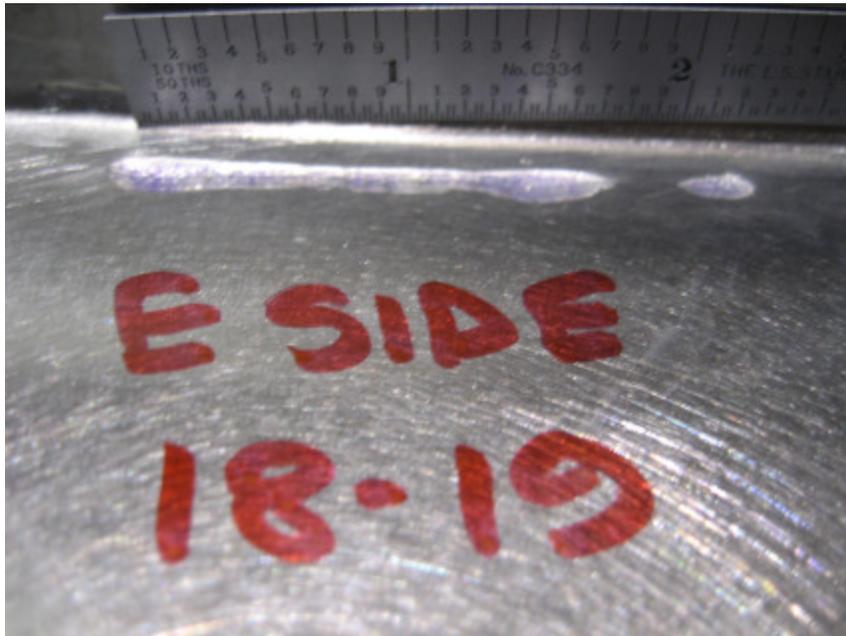
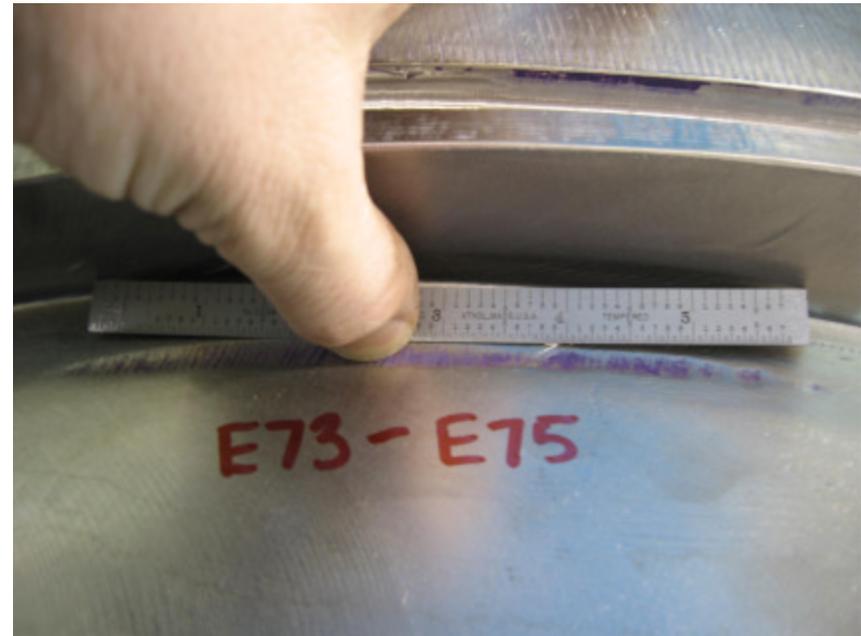
Tool Gouges on E side Long Leg near radius

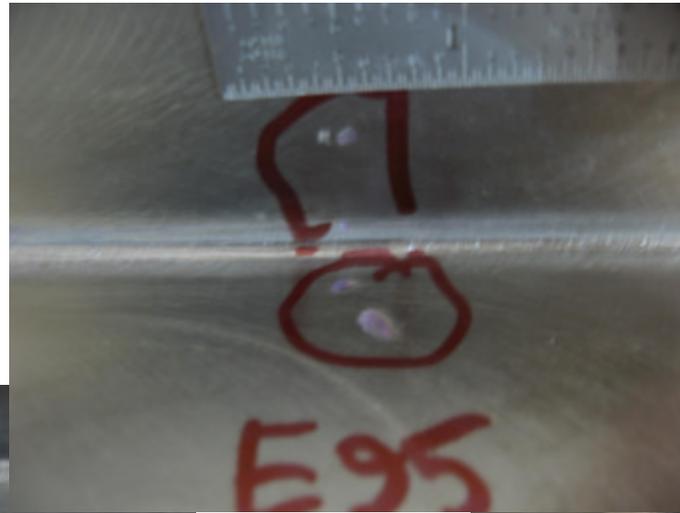
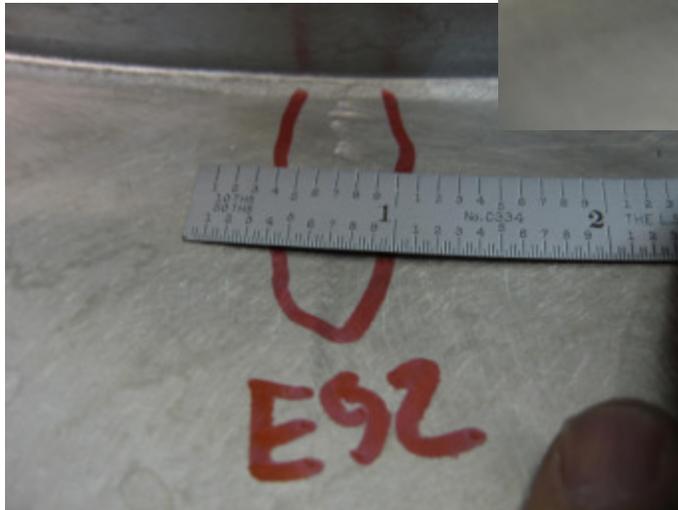
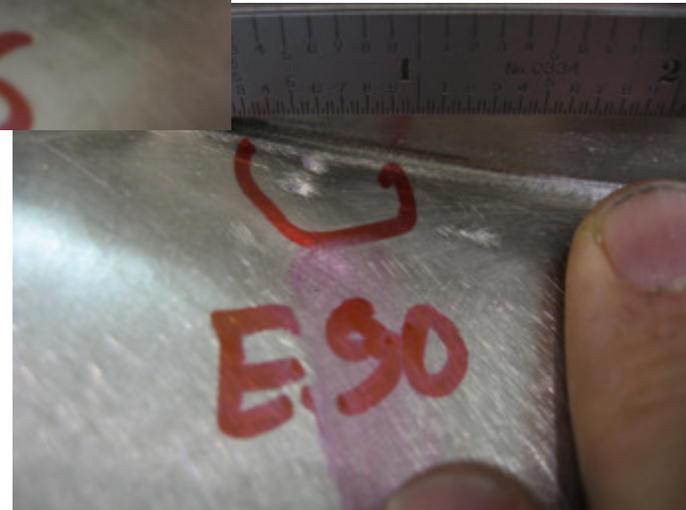
Tool Gouges on E side Long Leg near radius

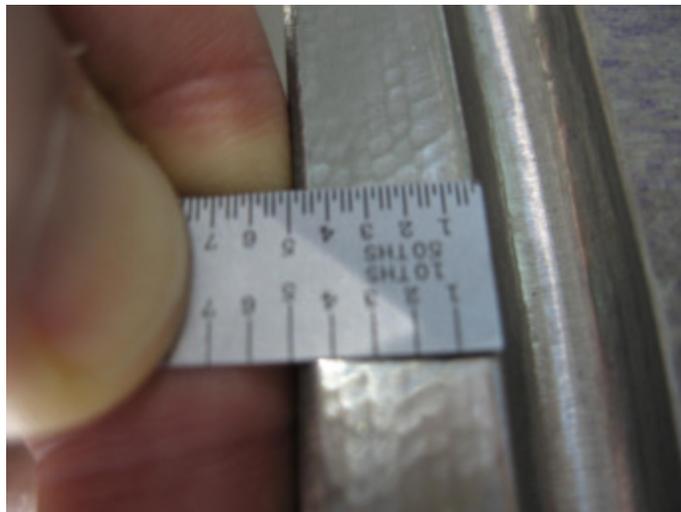
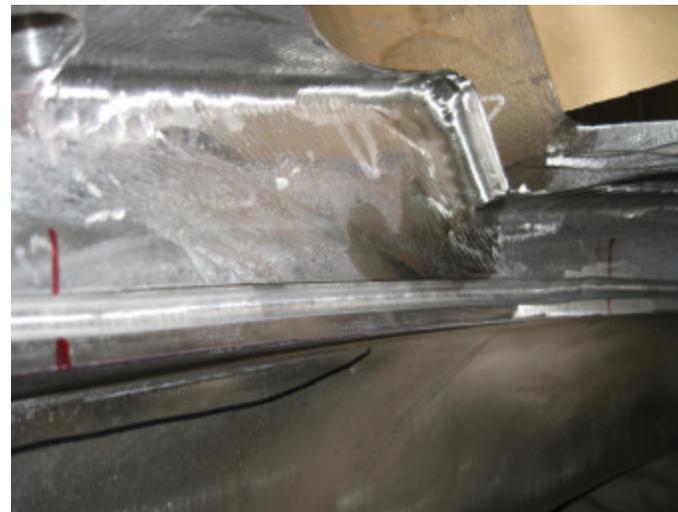
.400" distance from short leg to VPI groove (sheet 2, zone G7)

There is an area on the Datum D side from T hole 81 to 86 that checks as small as .300".
The transition has been blended smooth.

There is an area on the Datum D side from T hole 70 to 73 that checks as large as .506".

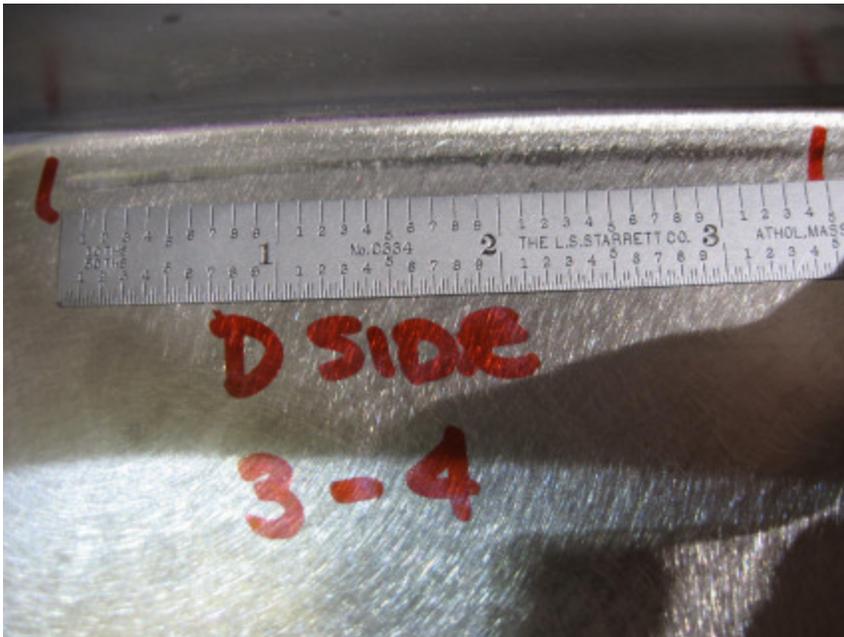
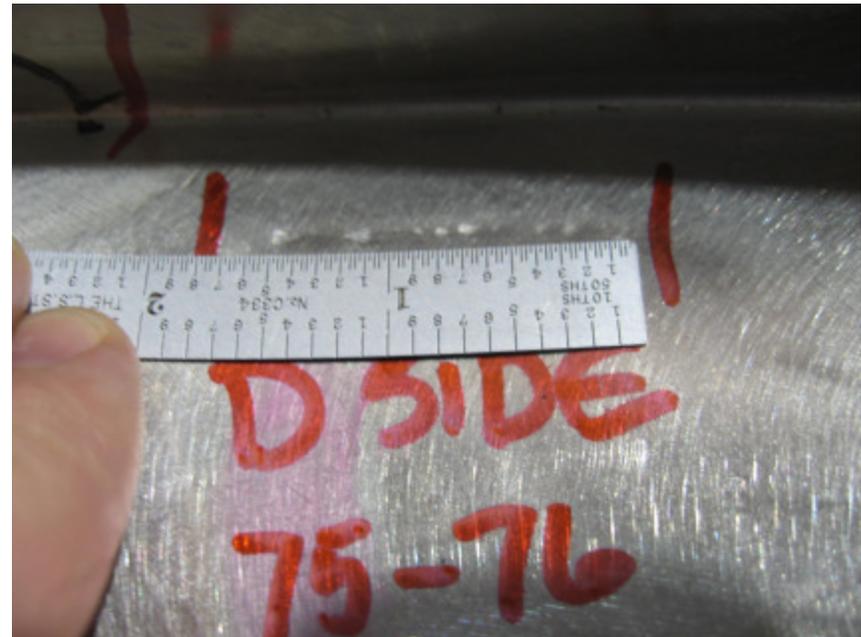
Tool Gouges on D side Long Leg near radius

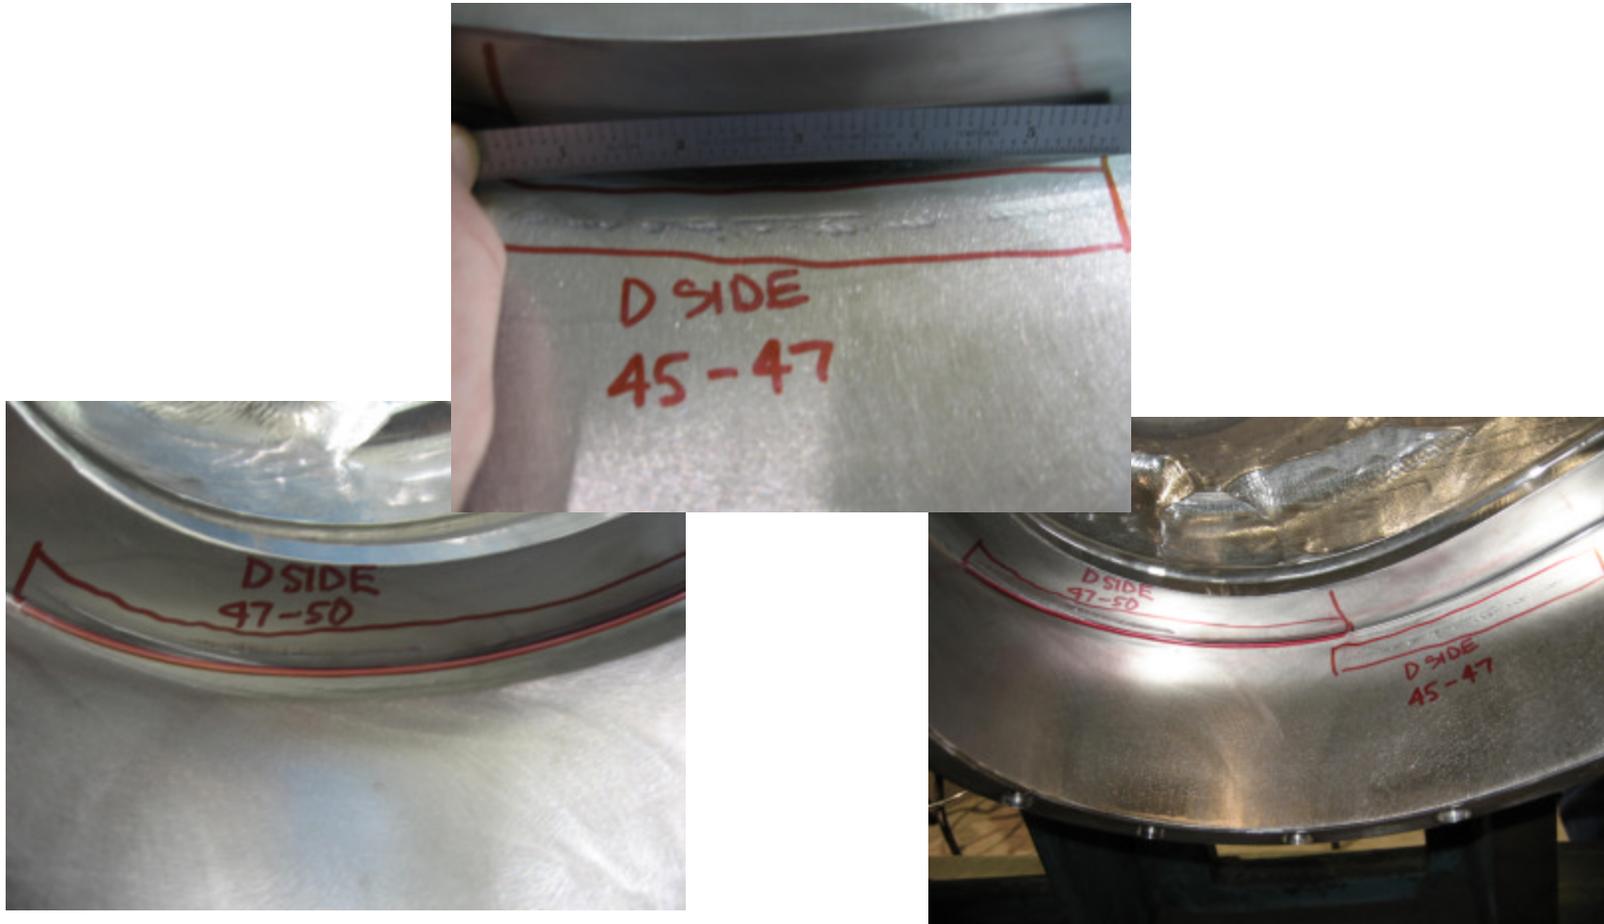
Tool Gouges on D side Long and Short Legs near radius

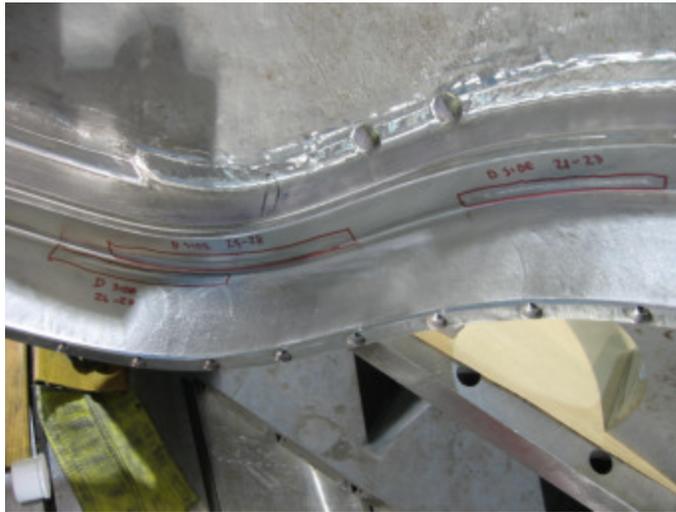
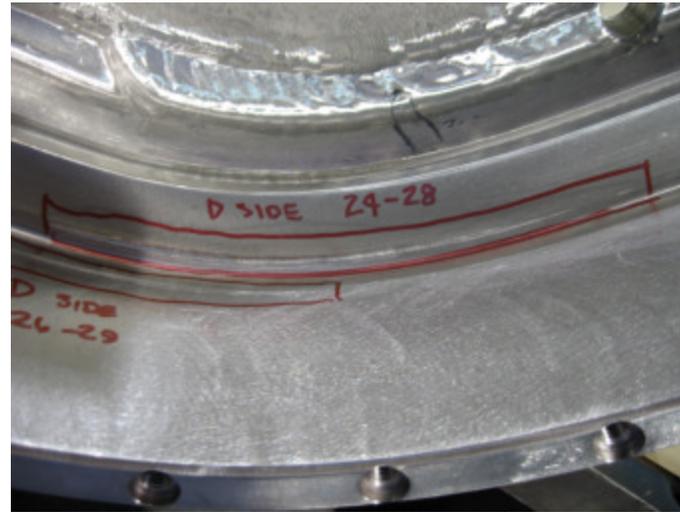
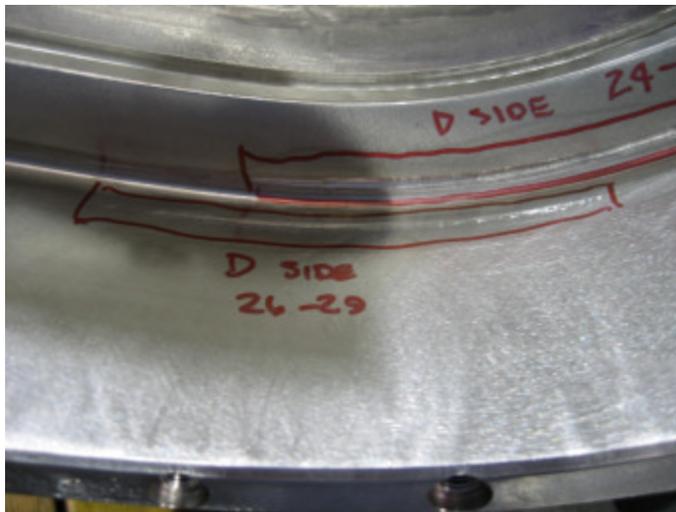
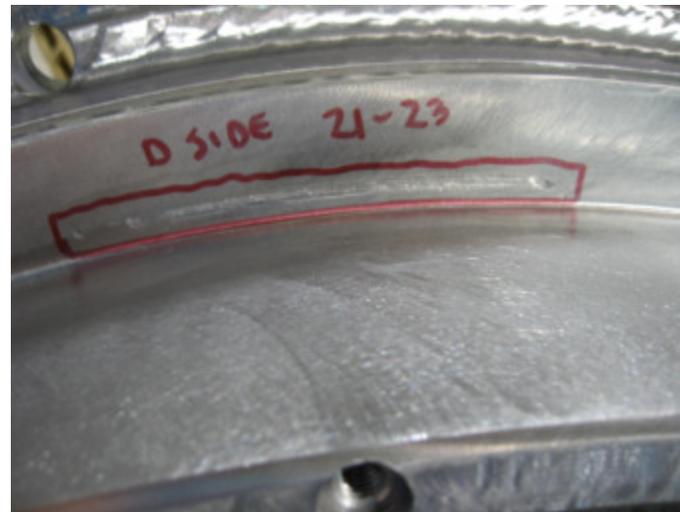
Tool Gouges on D side Long and Short Legs near radius

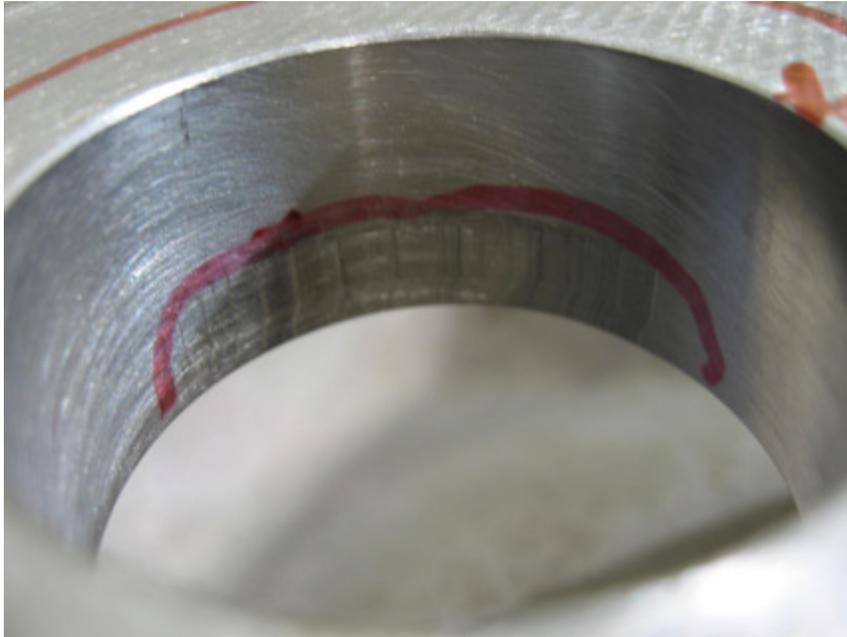
Oversize area in hole #27 in Datum E flange. (reported on NC20917 step 730)

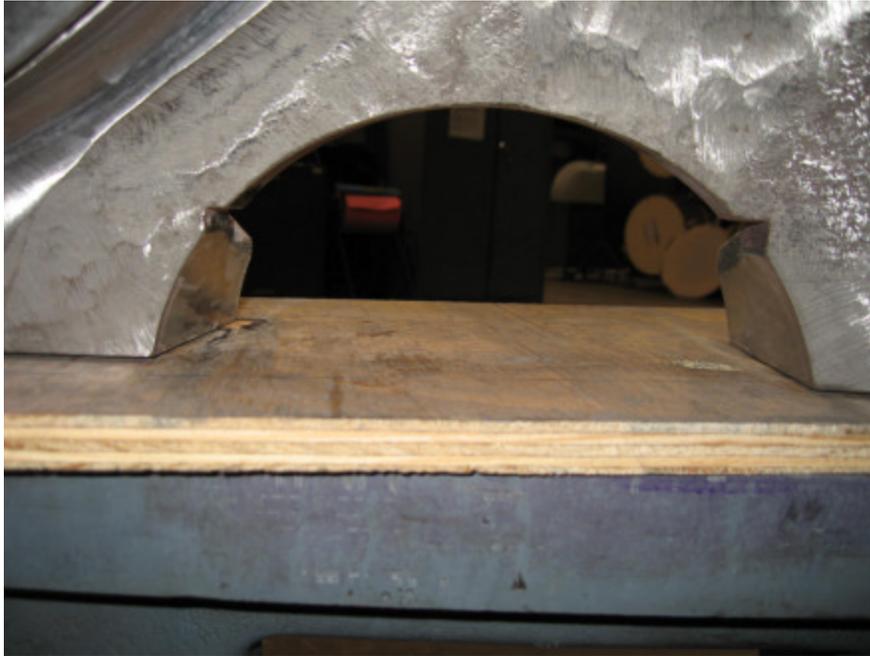
The picture to the left is of the port opening on the Datum D flange just beneath the Lead Block pad.

A programming error resulted in too much material being removed during the rough machining operation. An area on both sides of the port did not clean up.

One area measures approximately .25" x .25" and the other is .35" x .35". Both cutter marks extend through the opening the thickness of the casting wall.

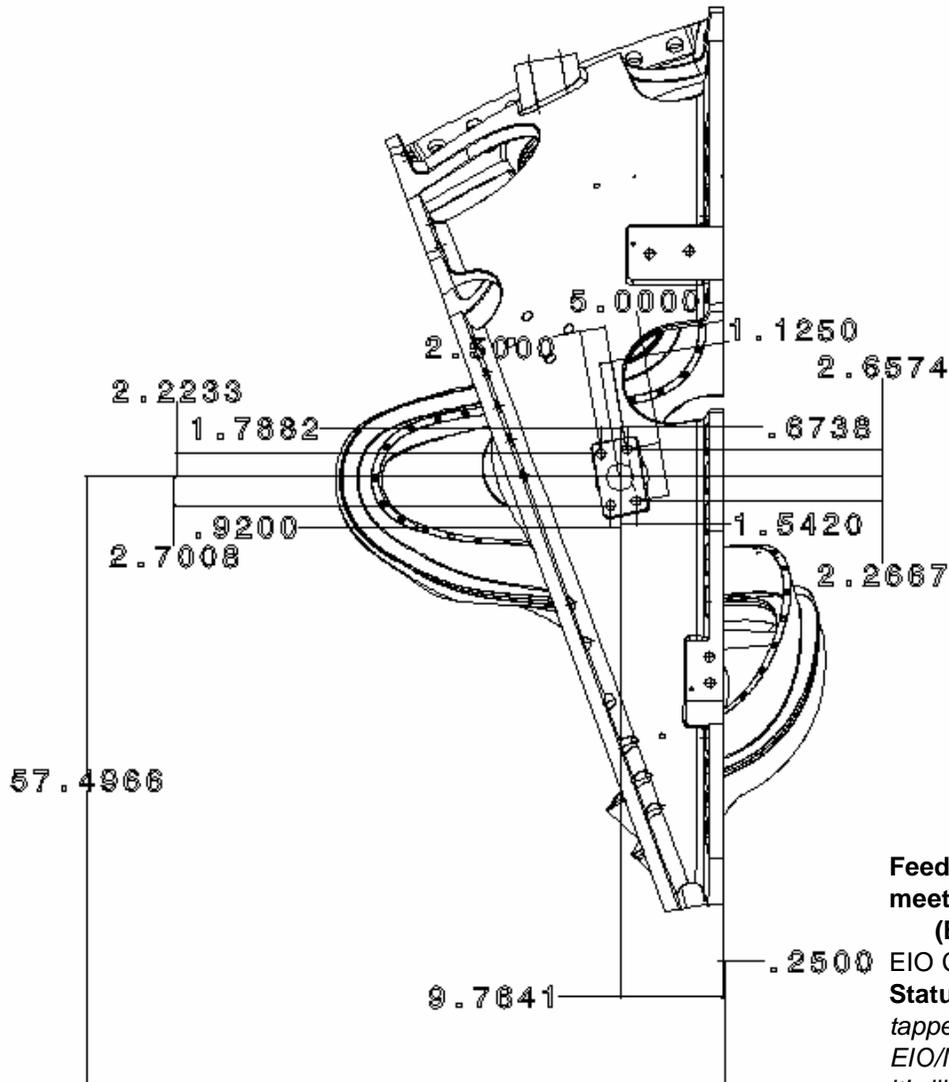
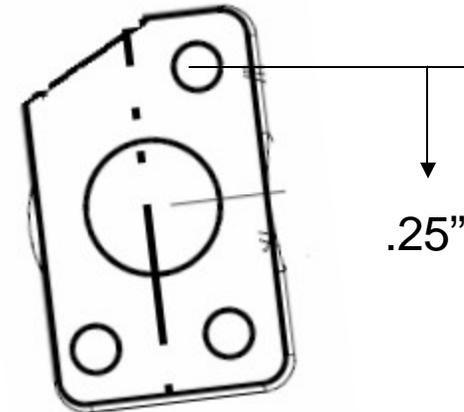
From the orientation shown, the 1-8" hole pattern was shifted .25" down. This hole pattern, per the model, was not centered about the 2.5" hole prior to this shift.

(EIO, MTM) Provide documentation of completion of corrective action for EIO CA 090606(NCR) for B-3 & B-6 Vacuum Vessel support pads deviations.
Status: (Open) MTM confirms that the center hole position is fixed but the tapped hole pattern is being shifted as needed (applies to all Type B castings). EIO/MTM will provide proposed shifted locations prior to drilling. On B3 & B6 it's likely that one hole cannot be drilled (corner missing). The CA will remain open until after B6 is completed.
