Part: SE141-115 / MODULAR COIL, TYPE B

Drawing ID: SE141-102 Revision: 3
W/O Links: 1-Type:W: 65708/6.0 Sub: 0

Problem: Various defects identified during the visual review of the casting. See attached report for details.

NC21871 – B6 Visual Review

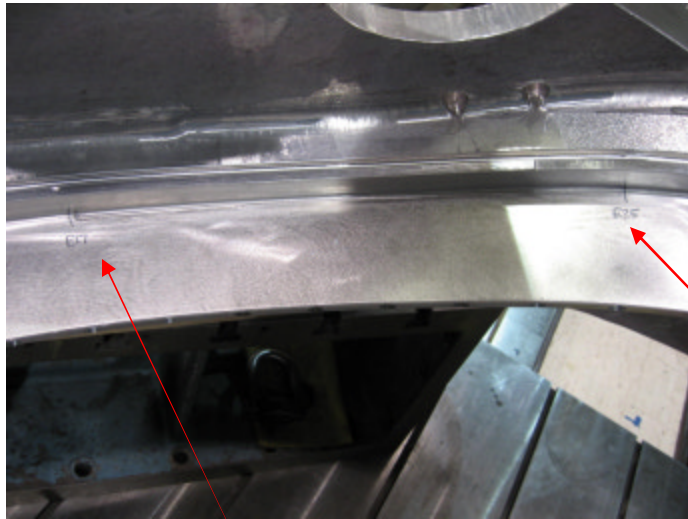
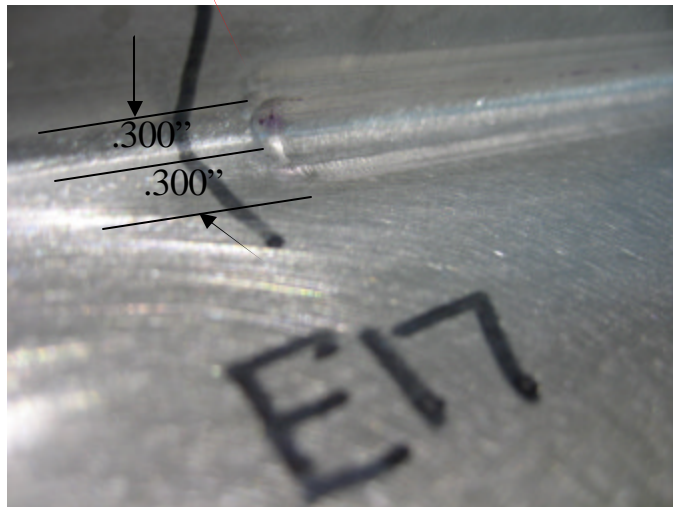
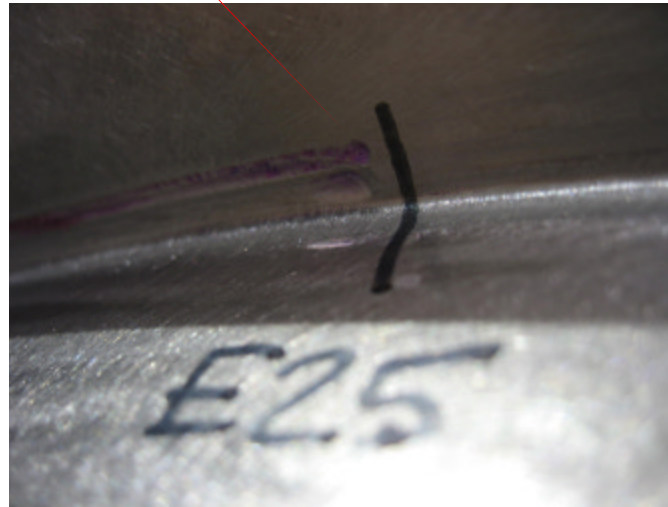
There is an undercut in the area of the 1/8" radius on both the long and short legs of E side between holes 17 and 25. The undercut extends outward in each direction approximately .300" from each wall. The undercut is deepest near E17 (approximately .040") and gradually tapers until E25.

The attached inspection report was examined by Jim Chrzanowski on 5/23/07. All of the deviations are accepted as is, since they will not cause any problems during coil manufacture.

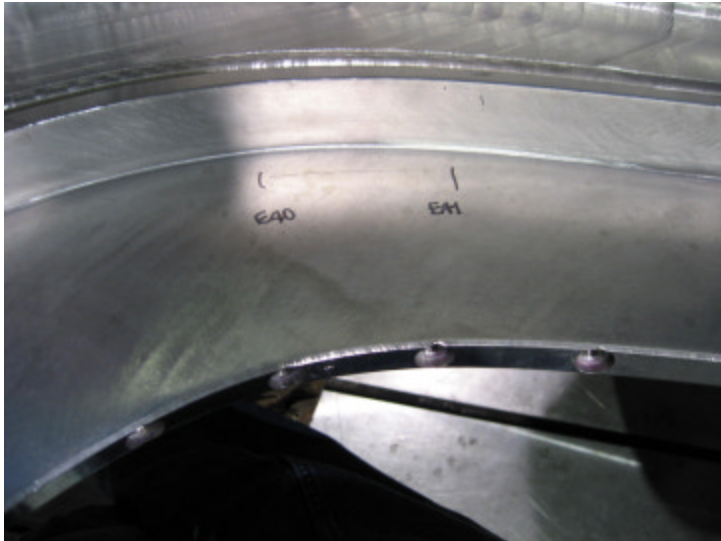
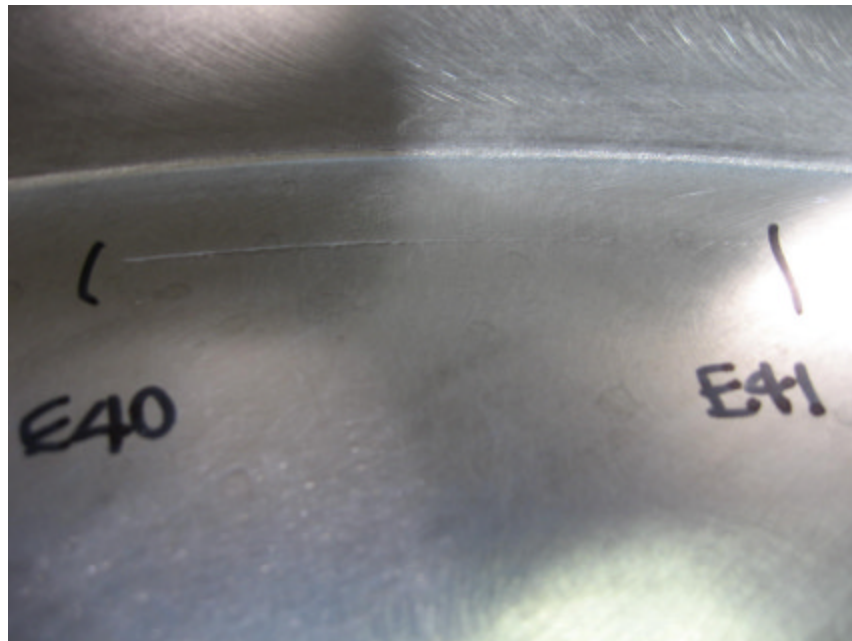
Tool gouge on E side long leg
between T holes 40 and 41. This
tool gouge is less than .005" deep.

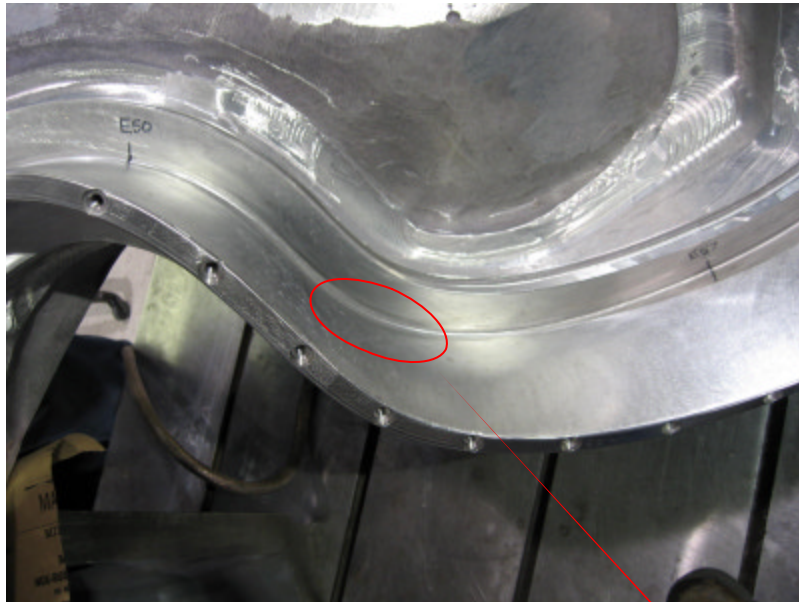
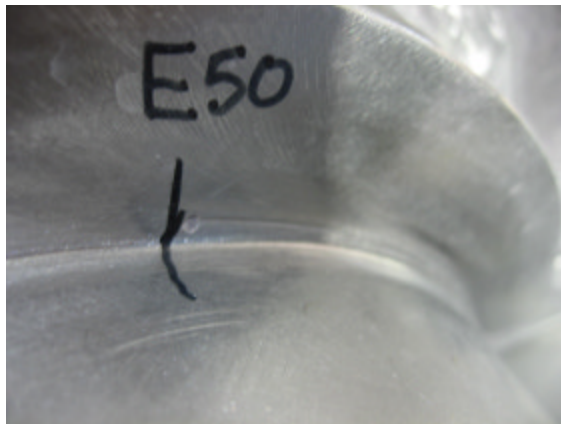
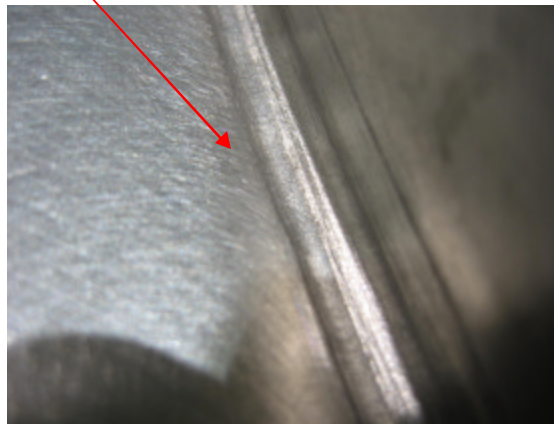
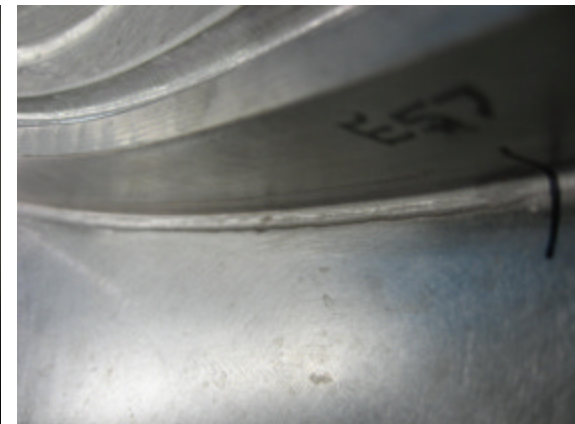
There is an undercut in the area of the 1/8" radius on both the long and short legs of E side between holes 50 and 57. The undercut extends outward in each direction approximately .200" from each wall. The undercut is deepest along the long leg between 54 and 55 (approximately .043" deep). The undercut along the short leg is less than .010" in depth.

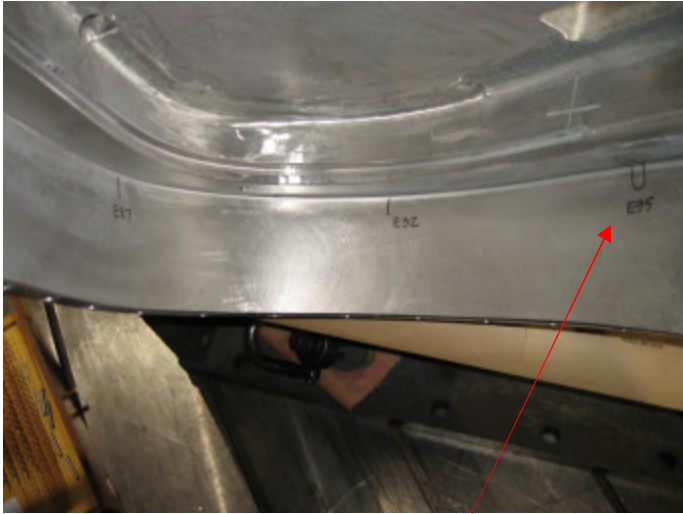
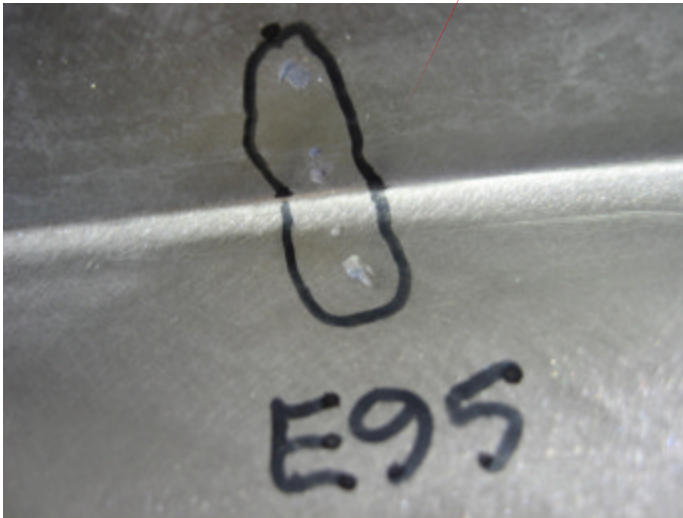
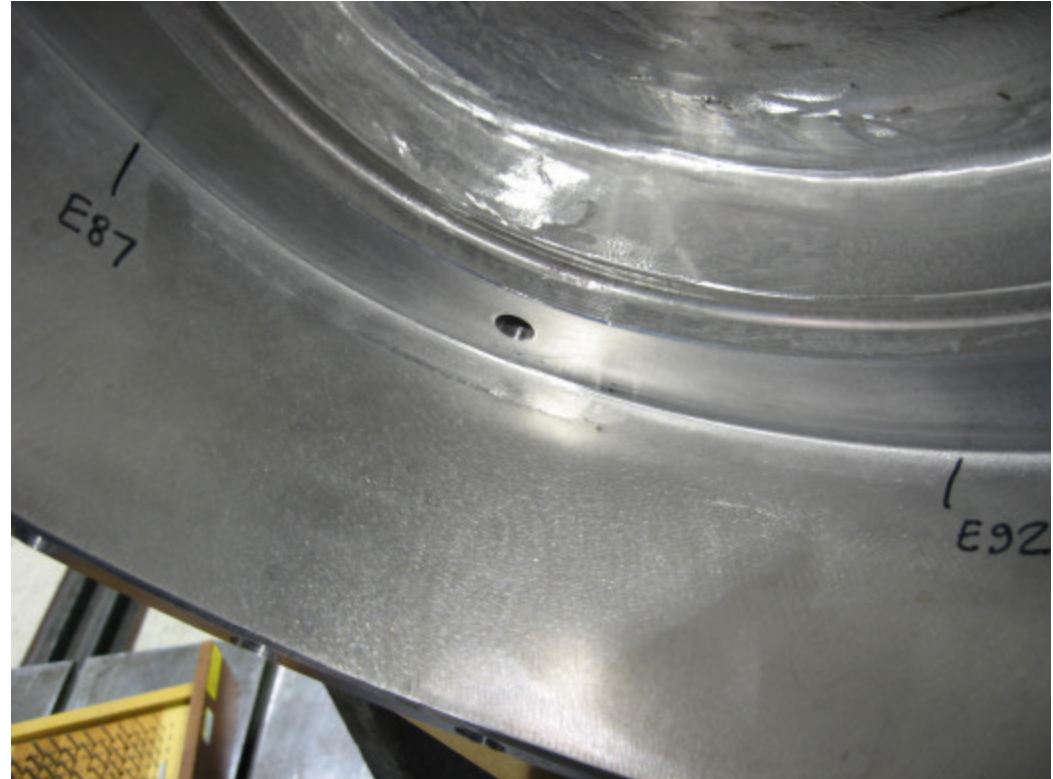
Tool gouge between holes 87 and 92 along long leg of datum E side. Depth of gouge is between .005” and .008”.

Tool marks near hole 95 are less than .005” in depth.

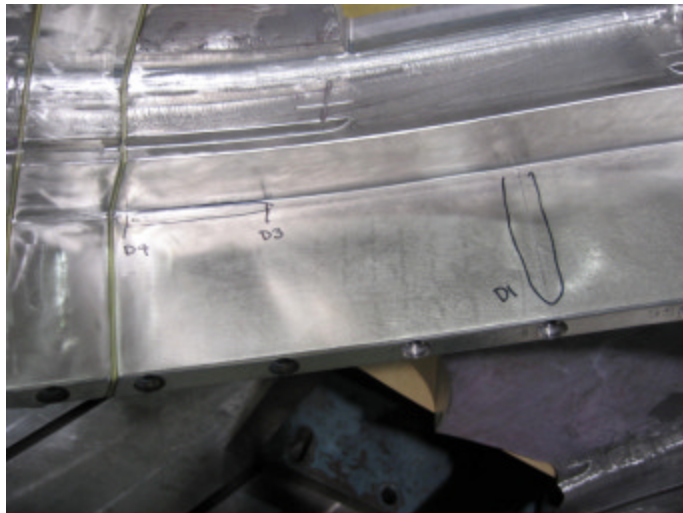
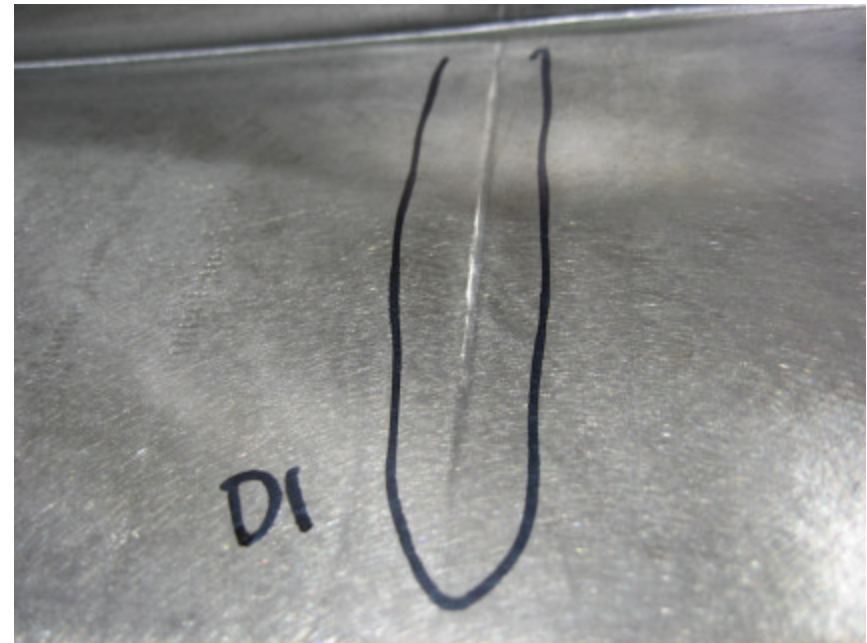
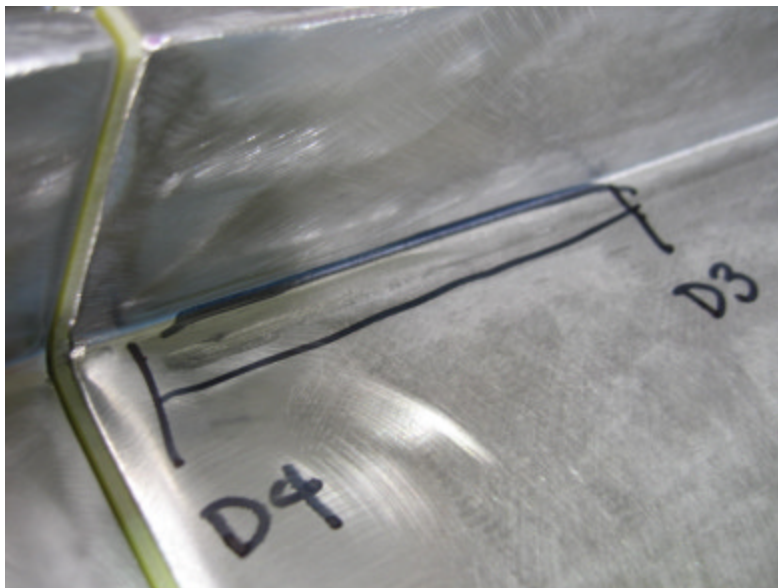
These pictures show tooling gouges on the long leg of the T on the datum D side near hole 1 and between holes 3 and 4. Gouge at D1 is $<.005''$ in depth and between D3 and D4 are $<.010''$ in depth.

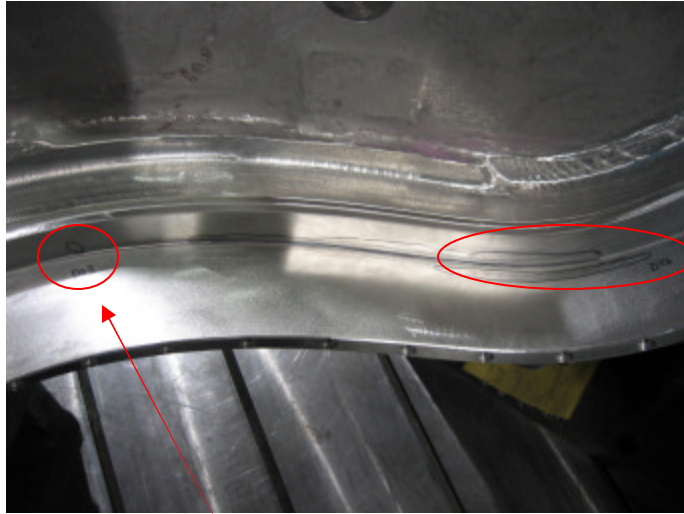
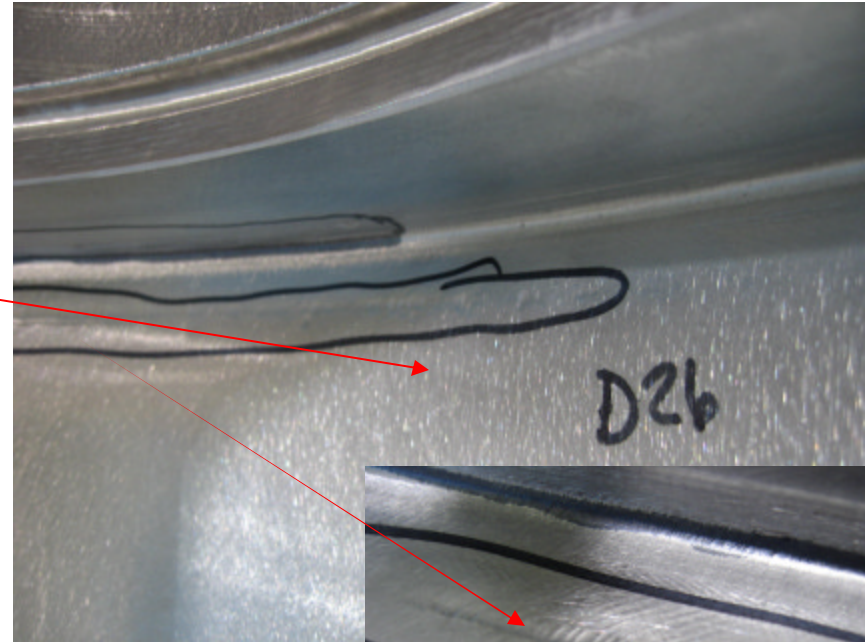
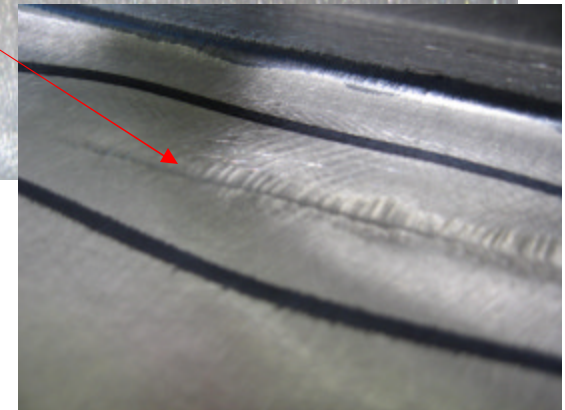
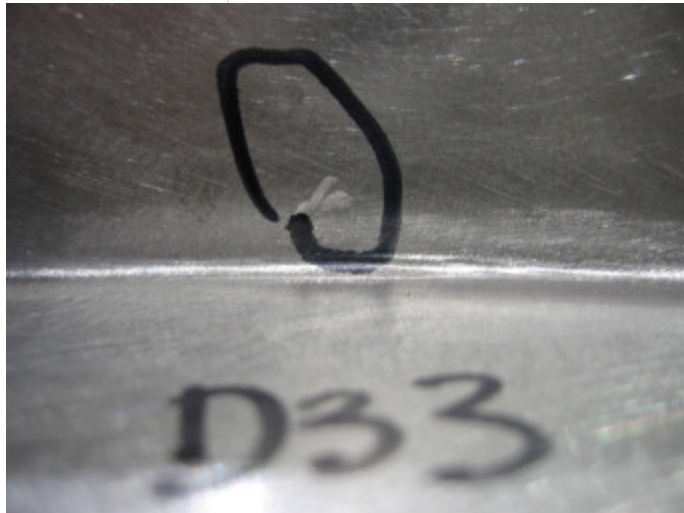
Tool gouges on D side long and short leg
between T holes 26 and 33. All gouges are
<.010" in depth.

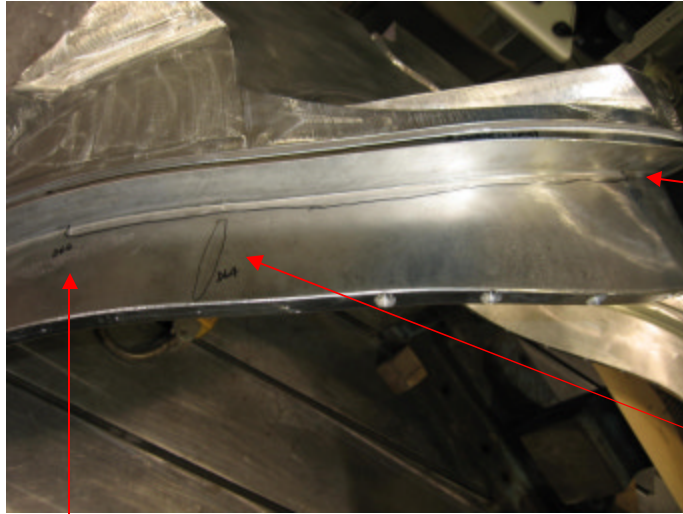
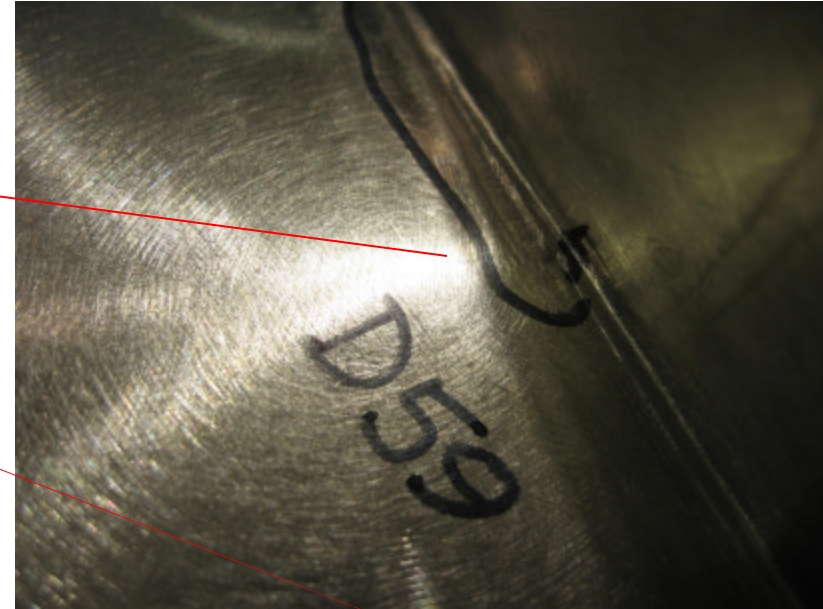
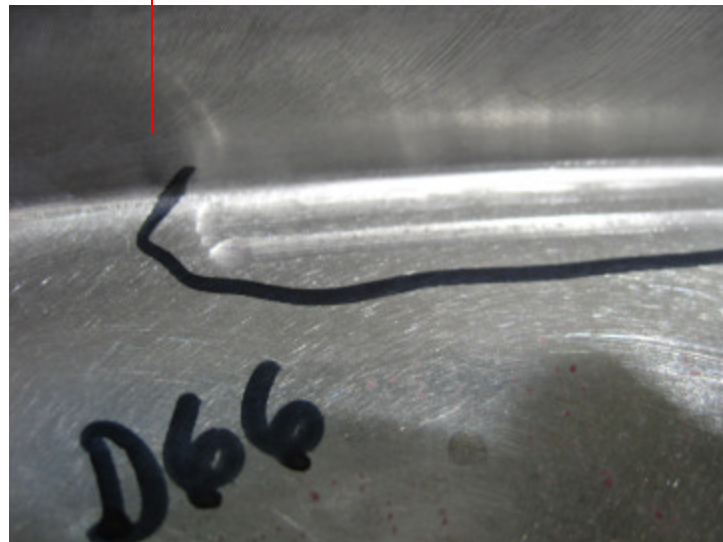
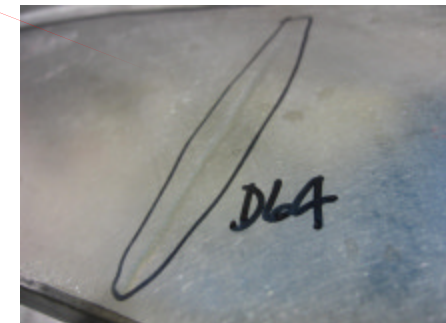
Tool gouges on D side long leg between T holes 59 and 66. Gouge near radius between D59 and D66 is $<.010''$ in depth. Gouge at D64 is $<.005''$ in depth.

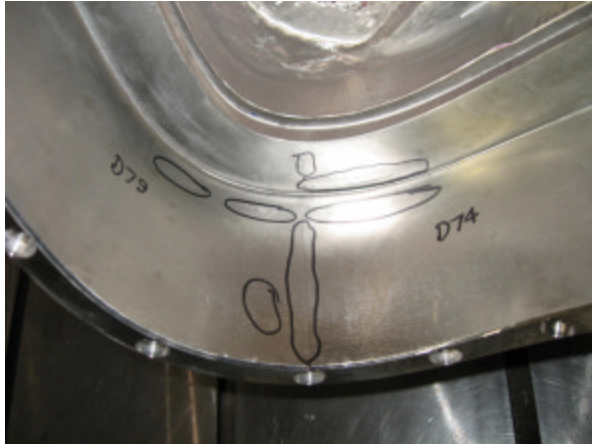
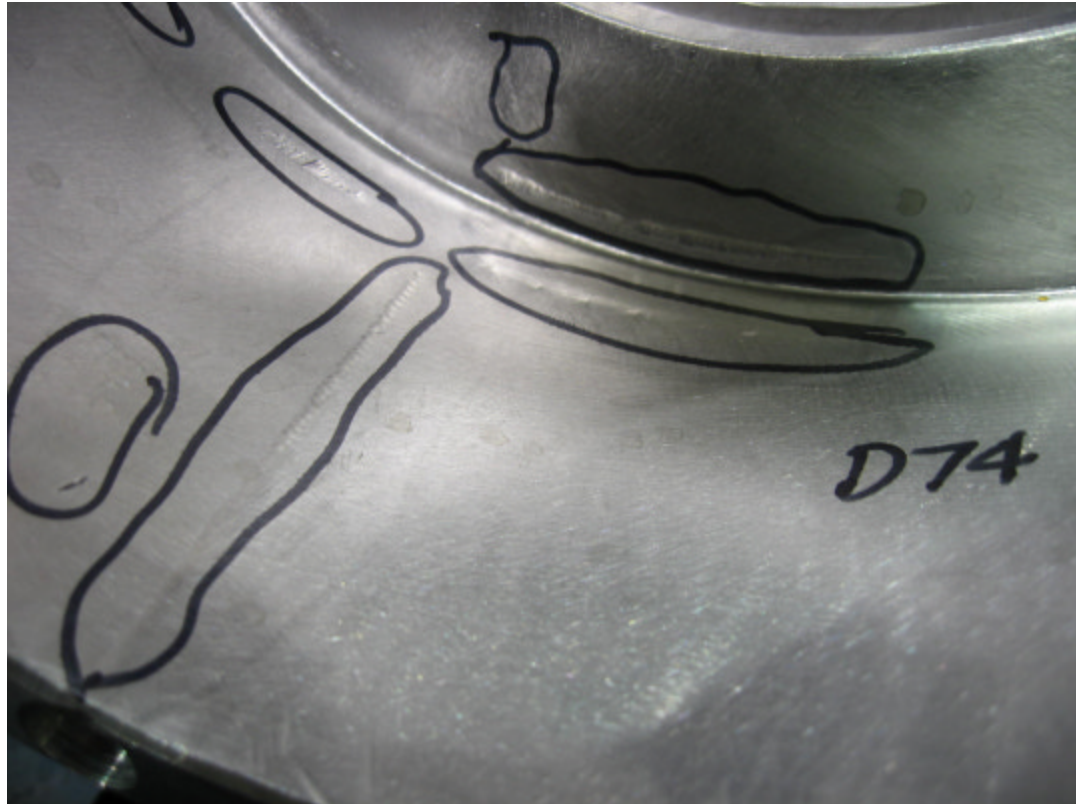
Several tool gouges on the datum D side long and short leg between T holes 74 and 79. None of these areas are greater than .010" in depth.

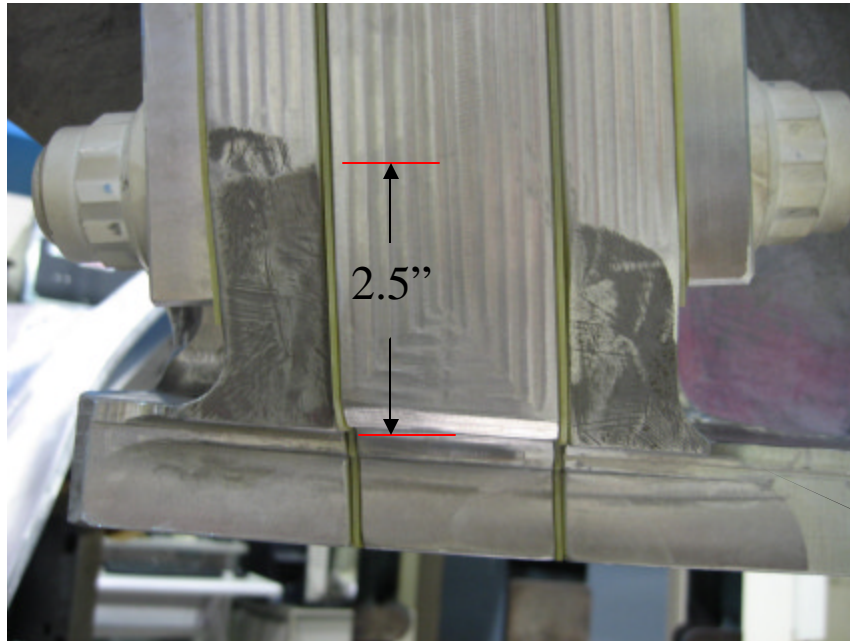
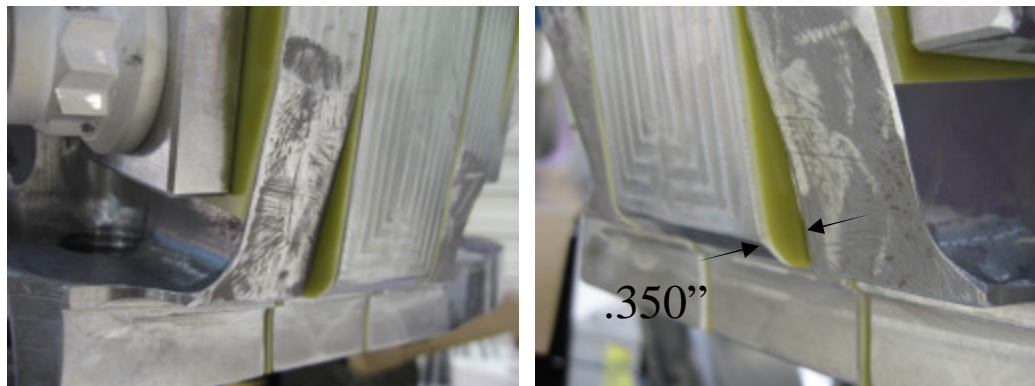
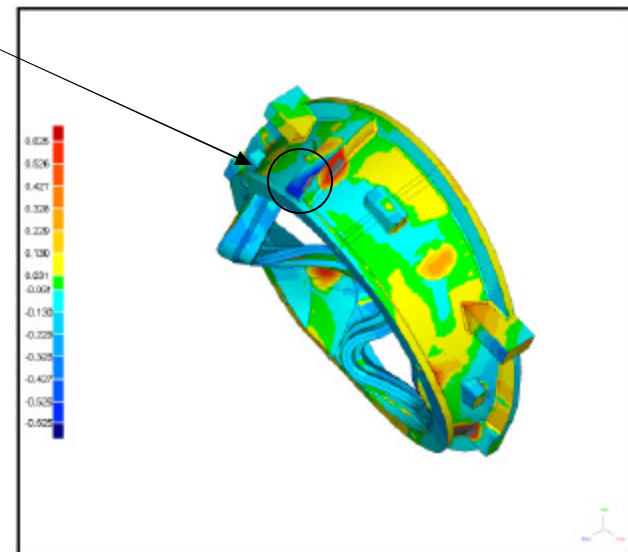
Non-cleanup of perimeter of poloidal break flange faces near datum E. The longest area of non-cleanup is 2.5" and both sides are approximately .350" at the widest point. MetalTek scan shows this area as minus stock.

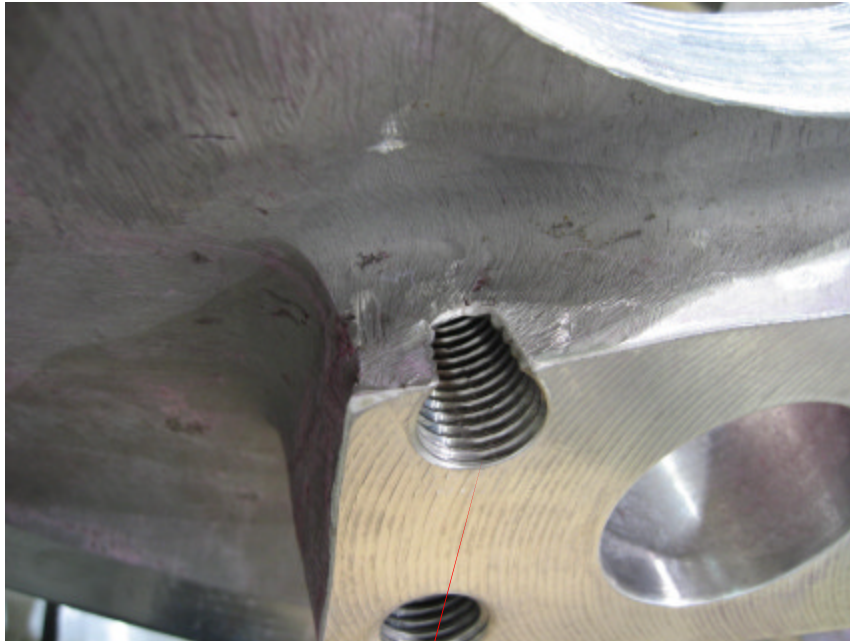
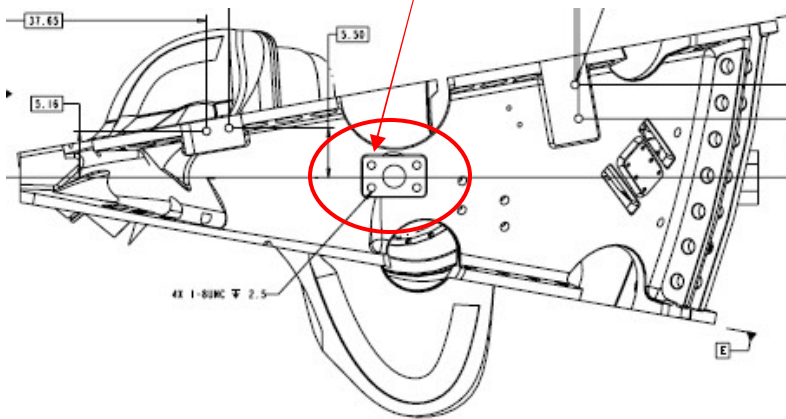
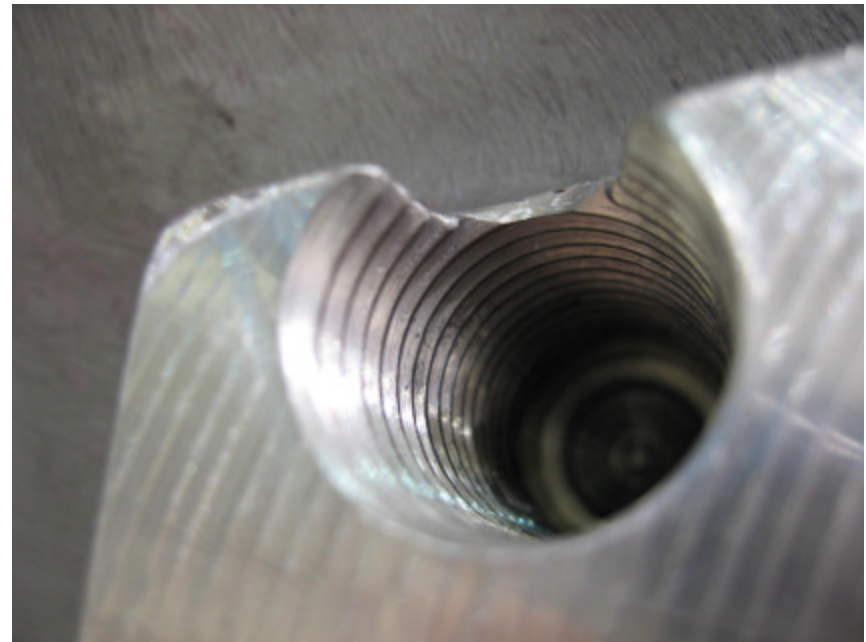
Vacuum support pad located on drawing sheet 3 zone C6 has one of the 1-8” tapped holes breaking out the side of the pad. There are approximately 5 threads breaking out the side which leaves 15 functional threads remaining.
