Status	2 - Disposition Needed		Trend	01-Deviation From Doc/Proc	
Department	NCSX		Division	WBS 141	
Source/Org	FABRICATION, OPERATIONS & MAINTENANCE				
Item Dwg/Part#	SE142C-270 Rev. 0	Procurement #		Cost Center	
RAP#	3234	Job Doc #	D-NCSX-MCF-004	Vendor	VARIOUS
RAP Title Modular Coil Fabrication - Post VPI Activities

NCR 3634, Attachment, R3 (p. 1 of 2)

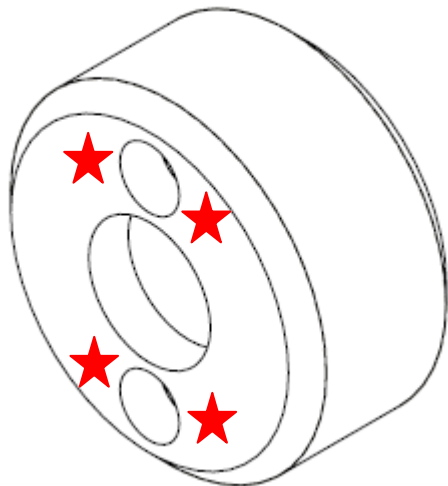
REV 3: 10/4/07 – Upon further discussion and investigation with NCSX Engineering an additional sample of remaining “keeper screws” (pt. #6) was conducted with the intention of better defining specifically which areas of these parts are exhibiting high magnetic permeability. See details of sampling and drawing below.

The worst case possible from the data above appears to be the entire top surface of the part at just under 1.06 Mu. Only the outer surfaces of the part was able to be measured due to the configuration of the gauge and part, none of the threads exhibited any permeability and most of the pieces sampled only had a few spots on the top surface around the spanner wrench holes, see drawing below.
