<b>Status</b>	2 - Disposition Needed		<b>Trend</b>	01-Deviation From Doc/Proc	
<b>Department</b>	NCSX		<b>Division</b>	WBS 141	
<b>Source/Org</b>	FABRICATION, OPERATIONS & MAINTENANCE				
<b>Item Dwg/Part#</b>	SE142C-270 Rev. 0	<b>Procurement #</b>			<b>Cost Center</b>
<b>RAP#</b>	3234	<b>Job Doc #</b>	D-NCSX-MCF-004	<b>Vendor</b>	VARIOUS
<b>RAP Title</b> Modular Coil Fabrication - Post VPI Activities

**NCR 3639 ATTACHMENT, R3 (p. 1 of 2)**

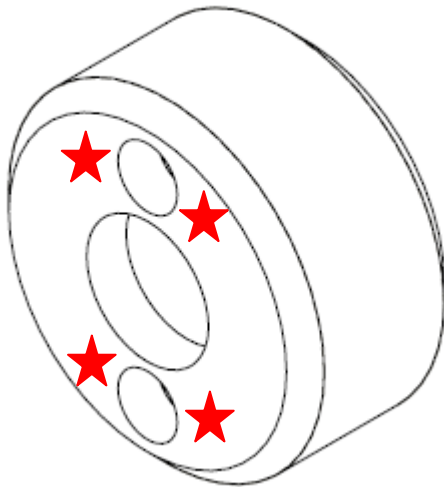
REV 3: 10/4/07 – Upon further discussion and investigation with NCSX Engineering an additional sample of remaining “keeper screws” (pt. #6) was conducted with the intention of better defining specifically which areas of these parts are exhibiting high magnetic permeability. See details of sampling and drawing below.

<u>Sample #</u>	<u>Number of spots &gt;1.02 Mu</u>	<u>Permeability of spots</u>
1	2	Both spots >1.02, <1.03 Mu
2	Entire top face	Entire top surface >1.02, <1.03 Mu
3	2	1 spot >1.02, <1.03 Mu; 1 spot >1.03, <1.04 Mu
4	2	Both spots >1.02, <1.03 Mu
5	3	All spots >1.02, <1.03 Mu
6	0	Entire part <1.02 Mu
7	4	3 spots >1.02, <1.03 Mu; 1 spot >1.04, <1.05 Mu
8	3	All spots >1.02, <1.03 Mu
9	3	2 spots >1.02, <1.03 Mu; 1 spot >1.03, <1.04 Mu

10	5	4 spots >1.02, <1.03 Mu; 1 spot >1.03 , <1.04 Mu
11	6	5 spots >1.02, <1.03 Mu; 1 spot >1.03, <1.04 Mu
12	6	4 spots >1.02, <1.03 Mu; 1 spot >1.03, <1.04 Mu; 1 spot >1.04, <1.06

The worst case possible from the data above appears to be the entire top surface of the part at just under 1.06 Mu. Only the outer surfaces of the part was able to be measured due to the configuration of the gauge and part, none of the threads exhibited any permeability and most of the pieces sampled only had a few spots on the top surface around the spanner wrench holes, see drawing below.
