Status 2 - Disposition Needed 9 - Closed **Trend** 01-Deviation From Doc/Proc
Department NCSX **Division** WBS 141
Source/Org FABRICATION, OPERATIONS & MAINTENANCE
Item Dwg/Part# SE142C-270 Rev. 0 **Procurement #** _____ **Cost Center** _____
RAP# 3234 **Job Doc #** D-NCSX-MCF-004 **Vendor** VARIOUS
RAP Title Modular Coil Fabrication - Post VPI Activities

NCR 3639 ATTACHMENT, R3 (p. 1 of 2)

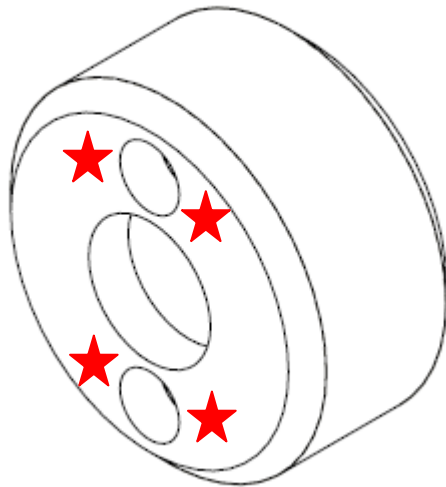
REV 3: 10/4/07 – Upon further discussion and investigation with NCSX Engineering an additional sample of remaining “keeper screws” (pt. #6) was conducted with the intention of better defining specifically which areas of these parts are exhibiting high magnetic permeability. See details of sampling and drawing below.

10	5	4 spots >1.02, <1.03 Mu; 1 spot >1.03 , <1.04 Mu
11	6	5 spots >1.02, <1.03 Mu; 1 spot >1.03, <1.04 Mu
12	6	4 spots >1.02, <1.03 Mu; 1 spot >1.03, <1.04 Mu; 1 spot >1.04, <1.06

The worst case possible from the data above appears to be the entire top surface of the part at just under 1.06 Mu. Only the outer surfaces of the part was able to be measured due to the configuration of the gauge and part, none of the threads exhibited any permeability and most of the pieces sampled only had a few spots on the top surface around the spanner wrench holes, see drawing below.
