Part: SE141-115 / MODULAR COIL, TYPE B Revision: 8

Problem: Sheet 5, zone D4.

SE141-115 Type B2 Flange Hole Rework Proposal

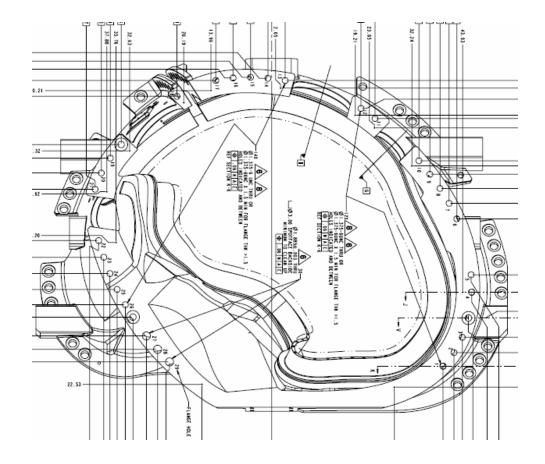
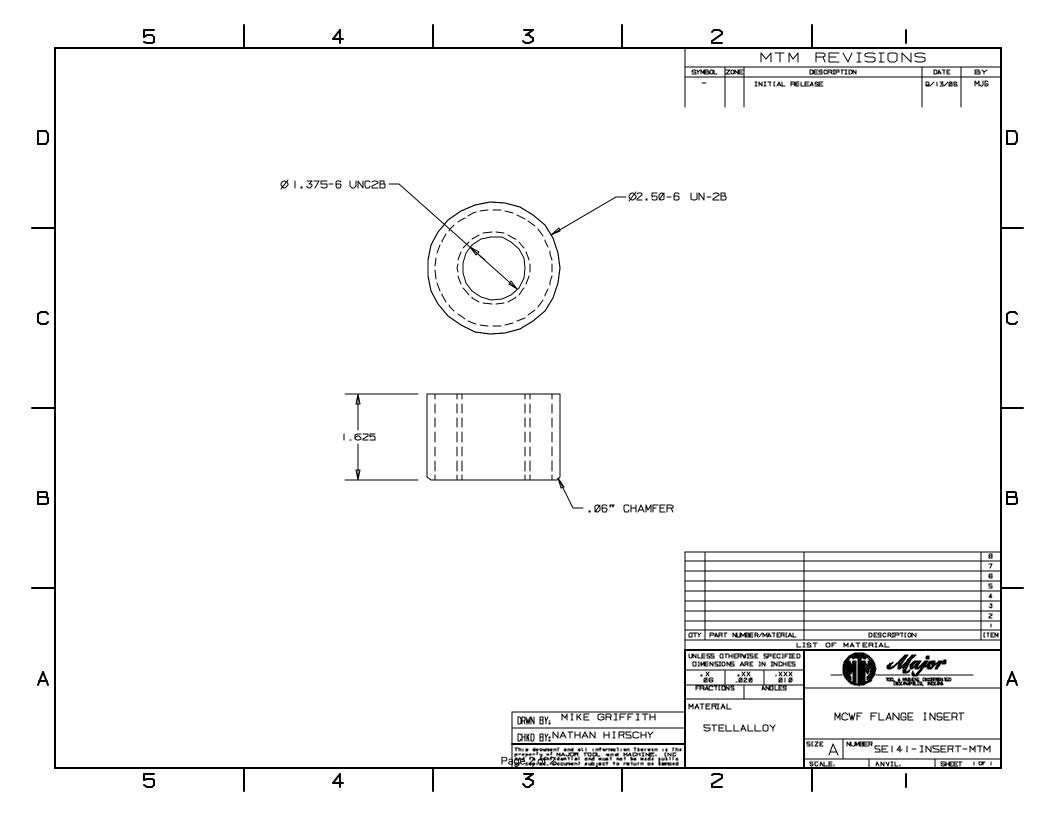
8 of the 1.375 threaded holes on datum -E- are out of position by a 1/2 inch (holes 19 thru 26).

Rework Proposal for Holes 19 thru 26:

•Oversize holes for a Ø2.50-6 UN insert.

•Inserts will be manufactured complete with the \emptyset 1.375-6 ID thread.

•For 5 Blind Holes: bottom out insert in hole (approx. 1.6' deep) and tack weld in 4 places on flange.

•For 3 Thru Holes: install insert and tack weld in 4 places on flange face and 4 places on back side of flange.

•All inserts will be faced off flush with Datum -E- flange.
