Part: SE141-115 / MODULAR COIL, TYPE B

Problem: SEVERAL ITEMS NOTED DURING VISUAL REVIEW OF CASTING. SEE ATTACHMENT.
Rev. 1 - added pages 9 & 10 to the attachment. (1-2-07)

NC20920 – B3 Visual Review

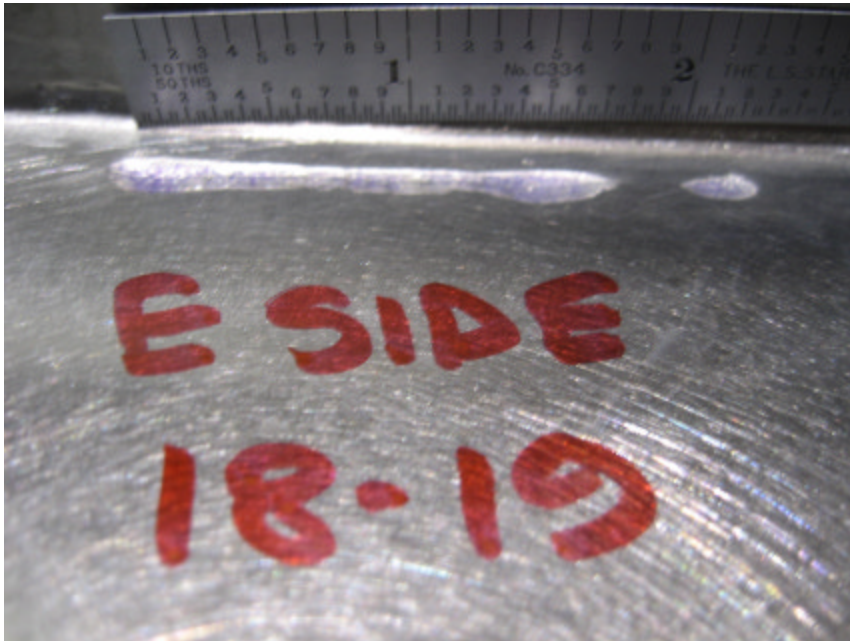
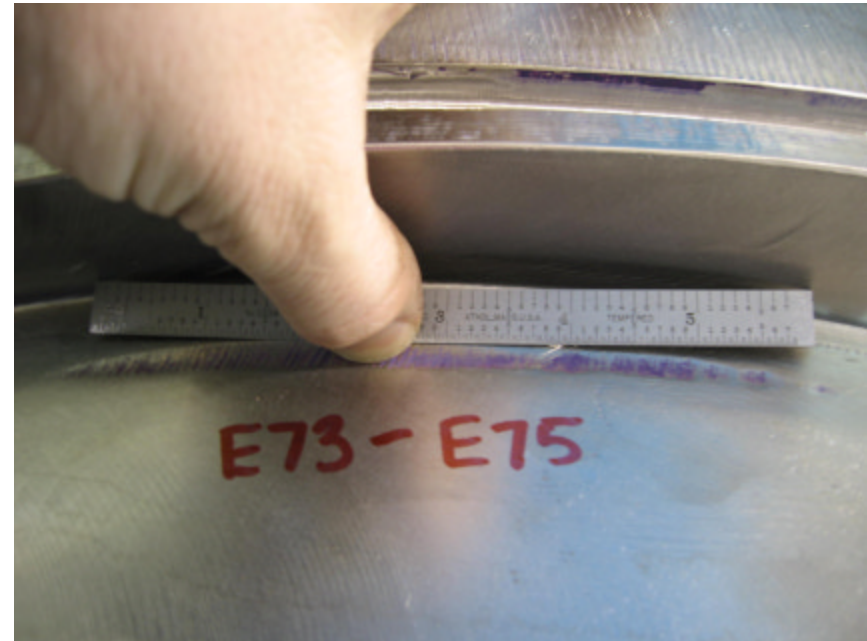
Tool Gouges on E side Long Leg near radius

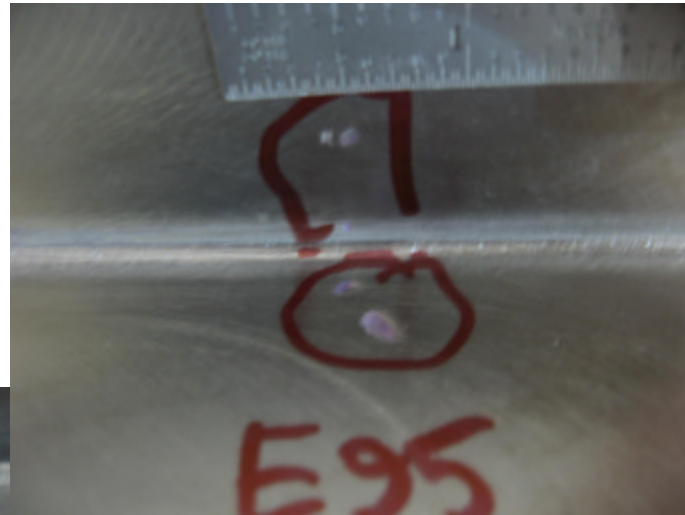
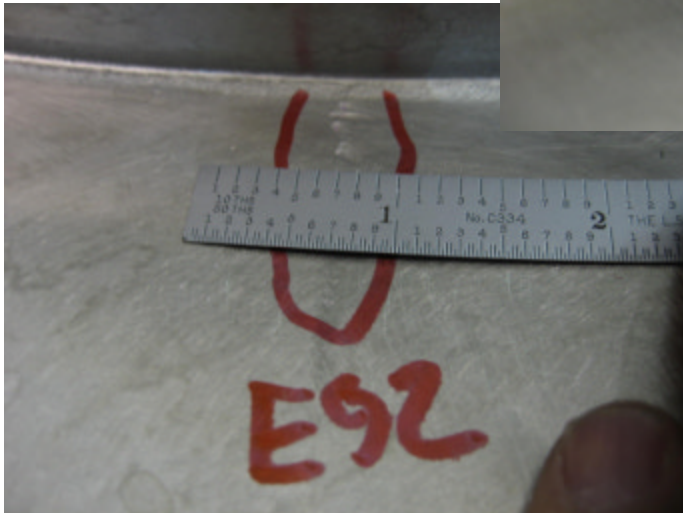
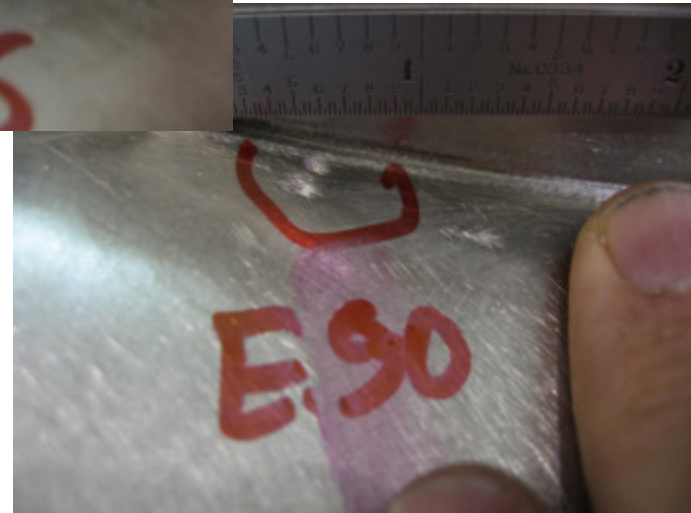
Tool Gouges on E side Long Leg near radius

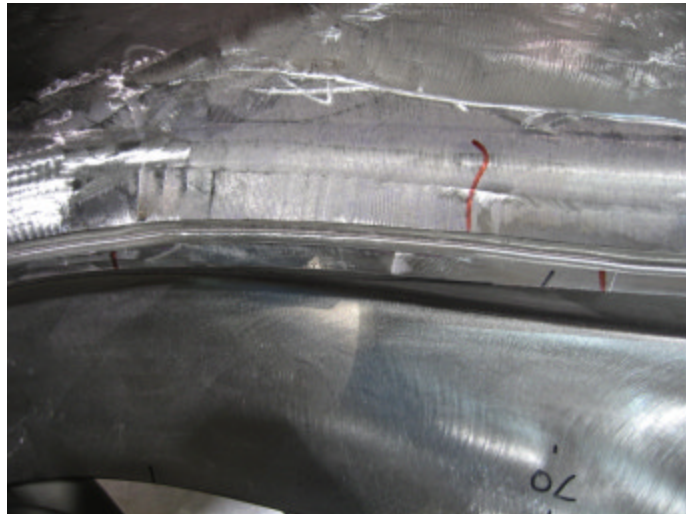
.400" distance from short leg to VPI groove (sheet 2, zone G7)

There is an area on the Datum D side from T hole 81 to 86 that checks as small as .300". The transition has been blended smooth.

There is an area on the Datum D side from T hole 70 to 73 that checks as large as .506".

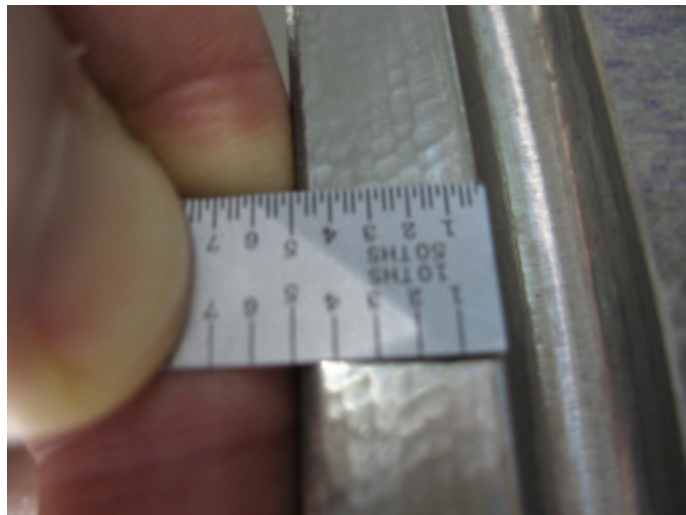
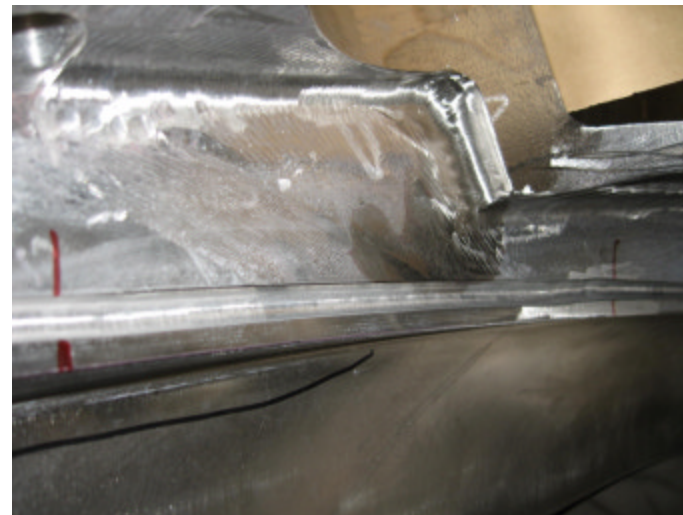
Tool Gouges on D side Long Leg near radius

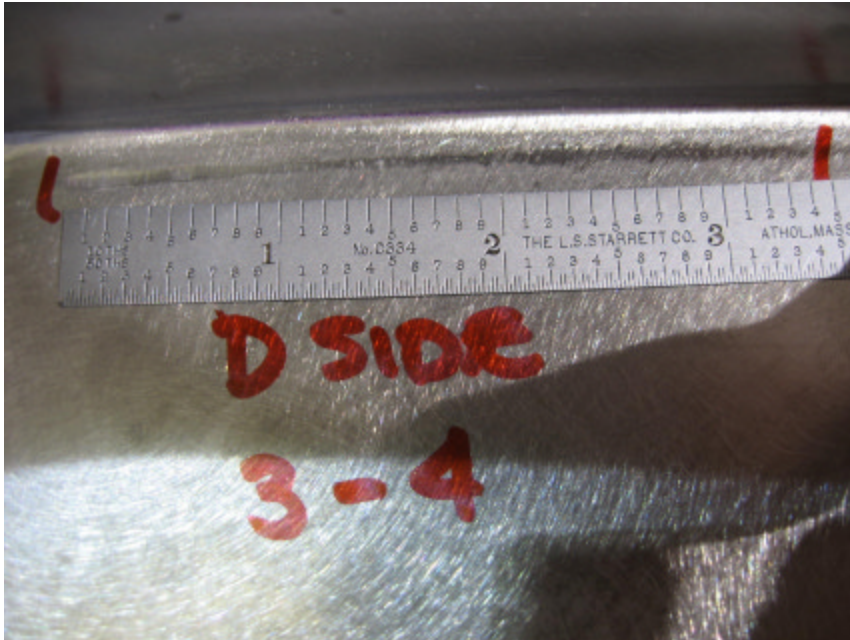
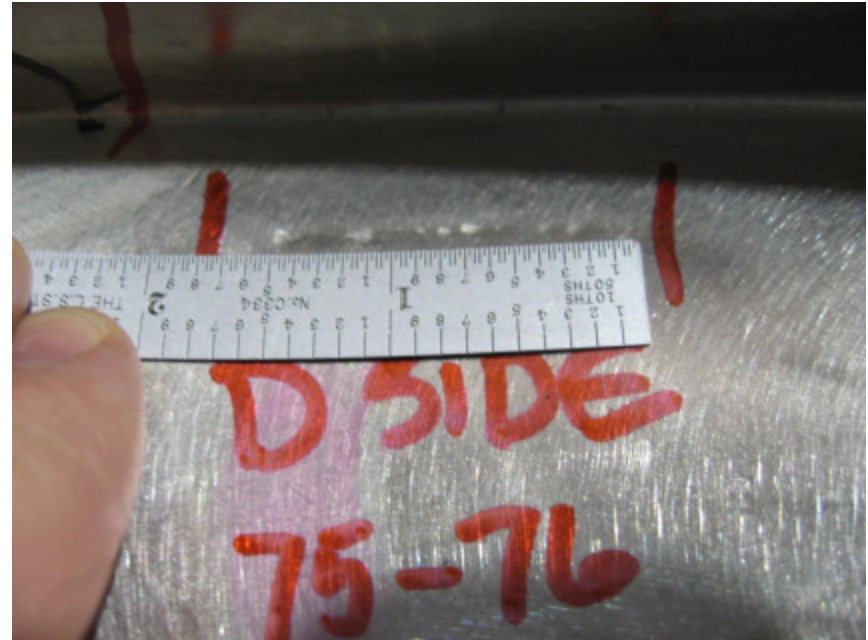
Tool Gouges on D side Long and Short Legs near radius

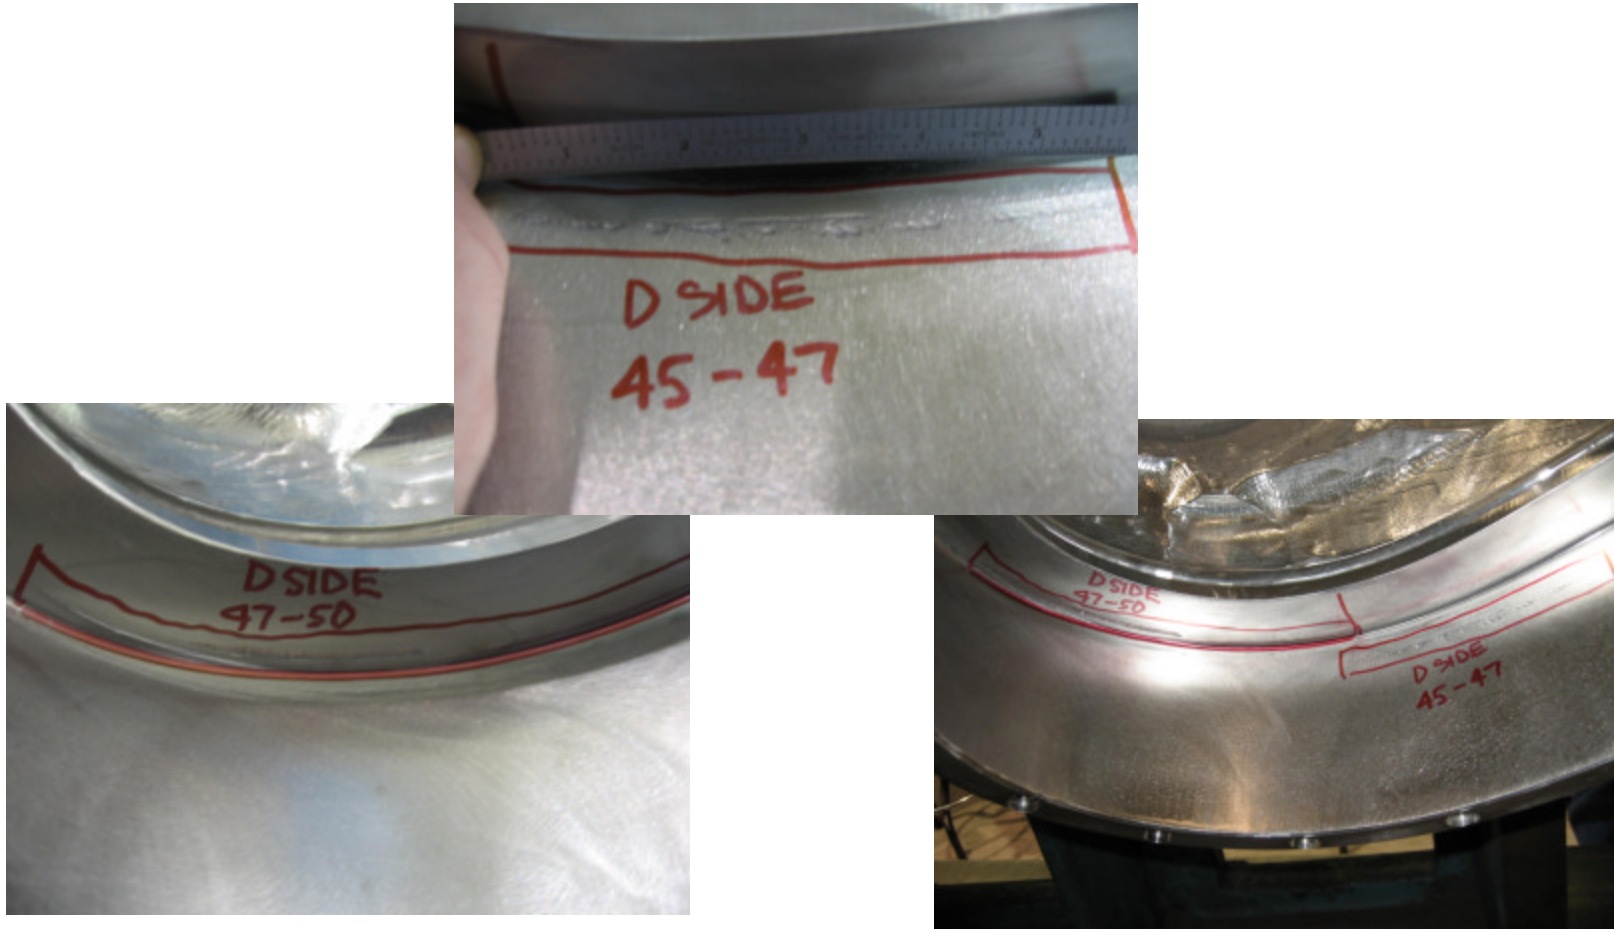
Tool Gouges on D side Long and Short Legs near radius

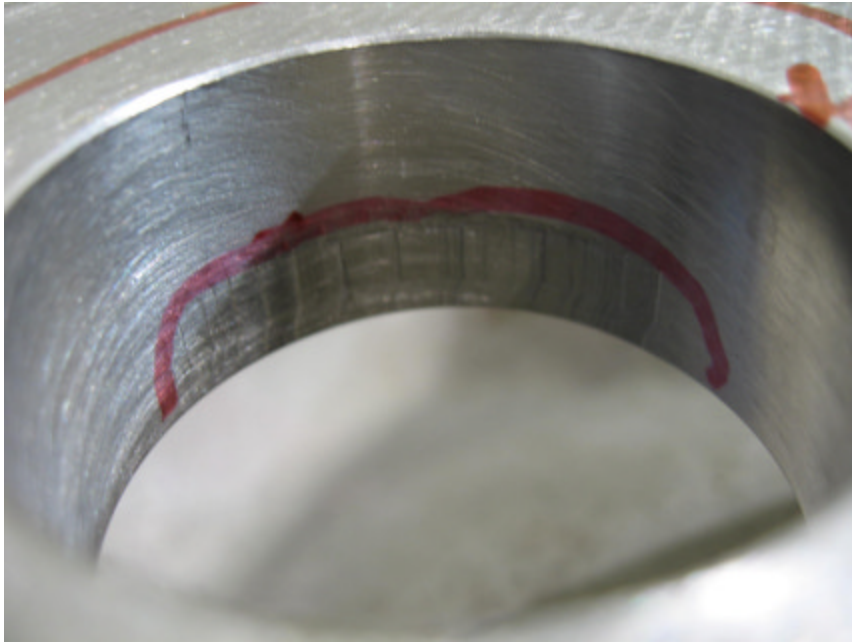
Oversize area in hole #27 in Datum E flange. (reported on NC20917 step 730)

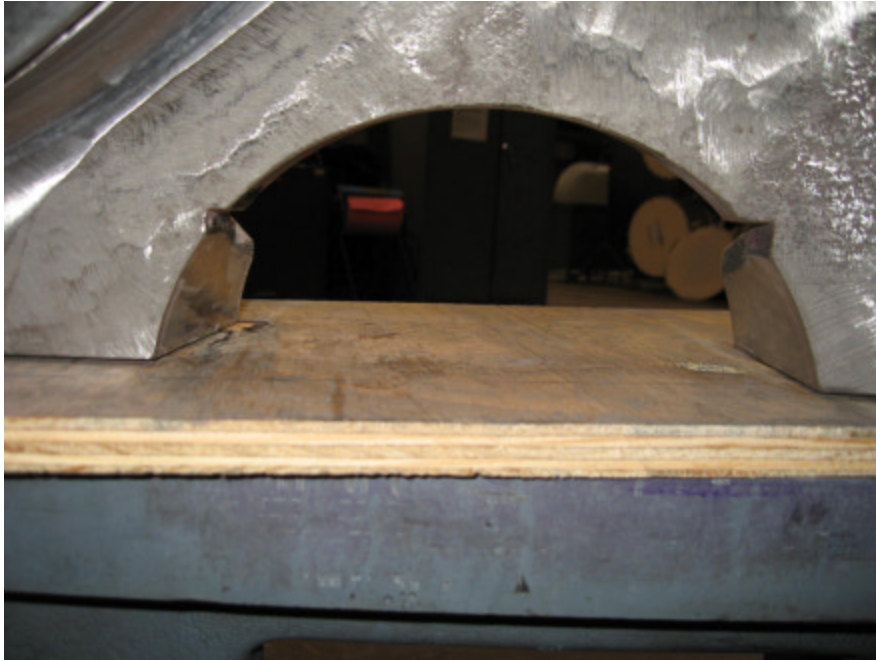
The picture to the left is of the port opening on the Datum D flange just beneath the Lead Block pad.

A programming error resulted in too much material being removed during the rough machining operation. An area on both sides of the port did not clean up.

One area measures approximately .25" x .25" and the other is .35" x .35". Both cutter marks extend through the opening the thickness of the casting wall.

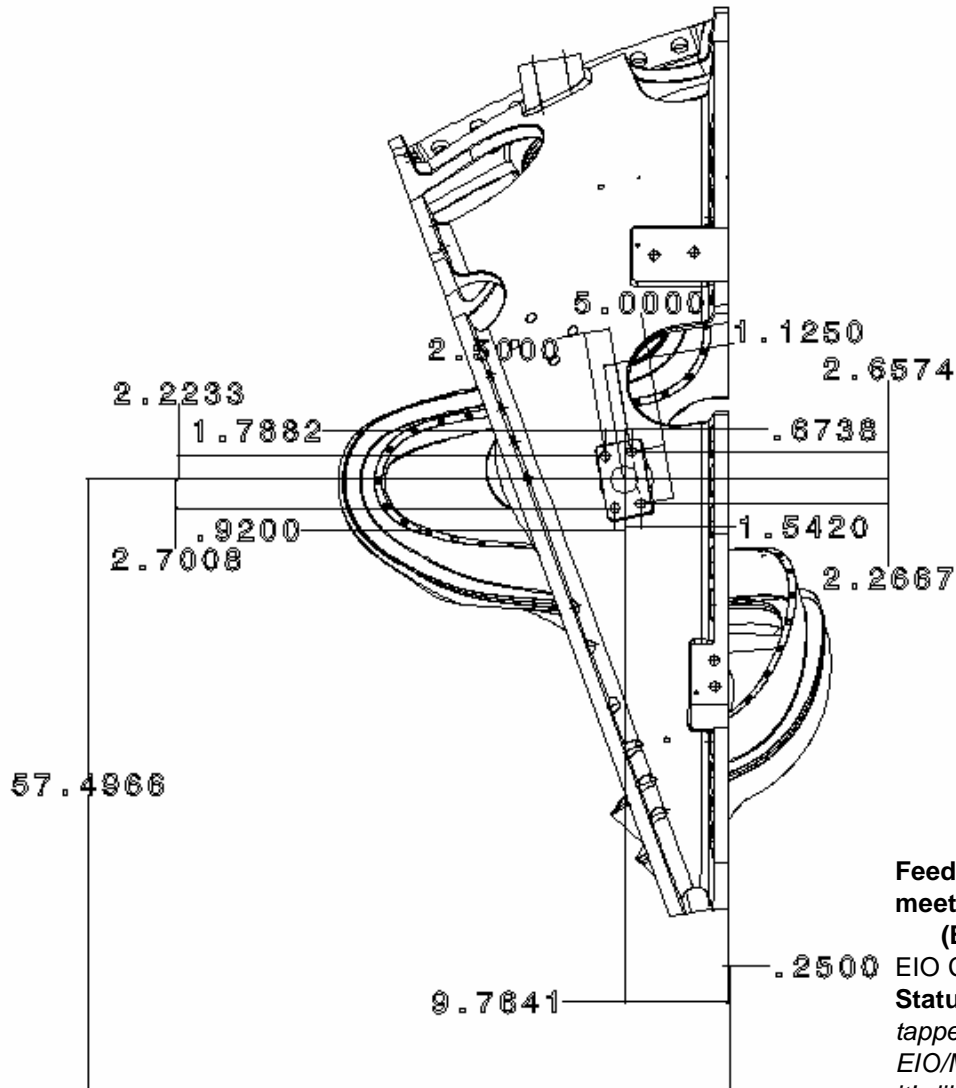
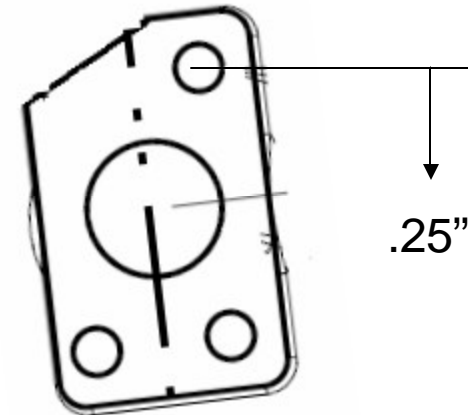
From the orientation shown, the 1-8" hole pattern was shifted .25" down. This hole pattern, per the model, was not centered about the 2.5" hole prior to this shift.

(EIO, MTM) Provide documentation of completion of corrective action for EIO CA 090606(NCR) for B-3 & B-6 Vacuum Vessel support pads deviations.
Status: (Open) MTM confirms that the center hole position is fixed but the tapped hole pattern is being shifted as needed (applies to all Type B castings). EIO/MTM will provide proposed shifted locations prior to drilling. On B3 & B6 it's likely that one hole cannot be drilled (corner missing). The CA will remain open until after B6 is completed.
