Major Tool & Machine, Inc.  
1458 East 19th Street  
Indianapolis, IN 46218-4289

MTM N/C: 17746

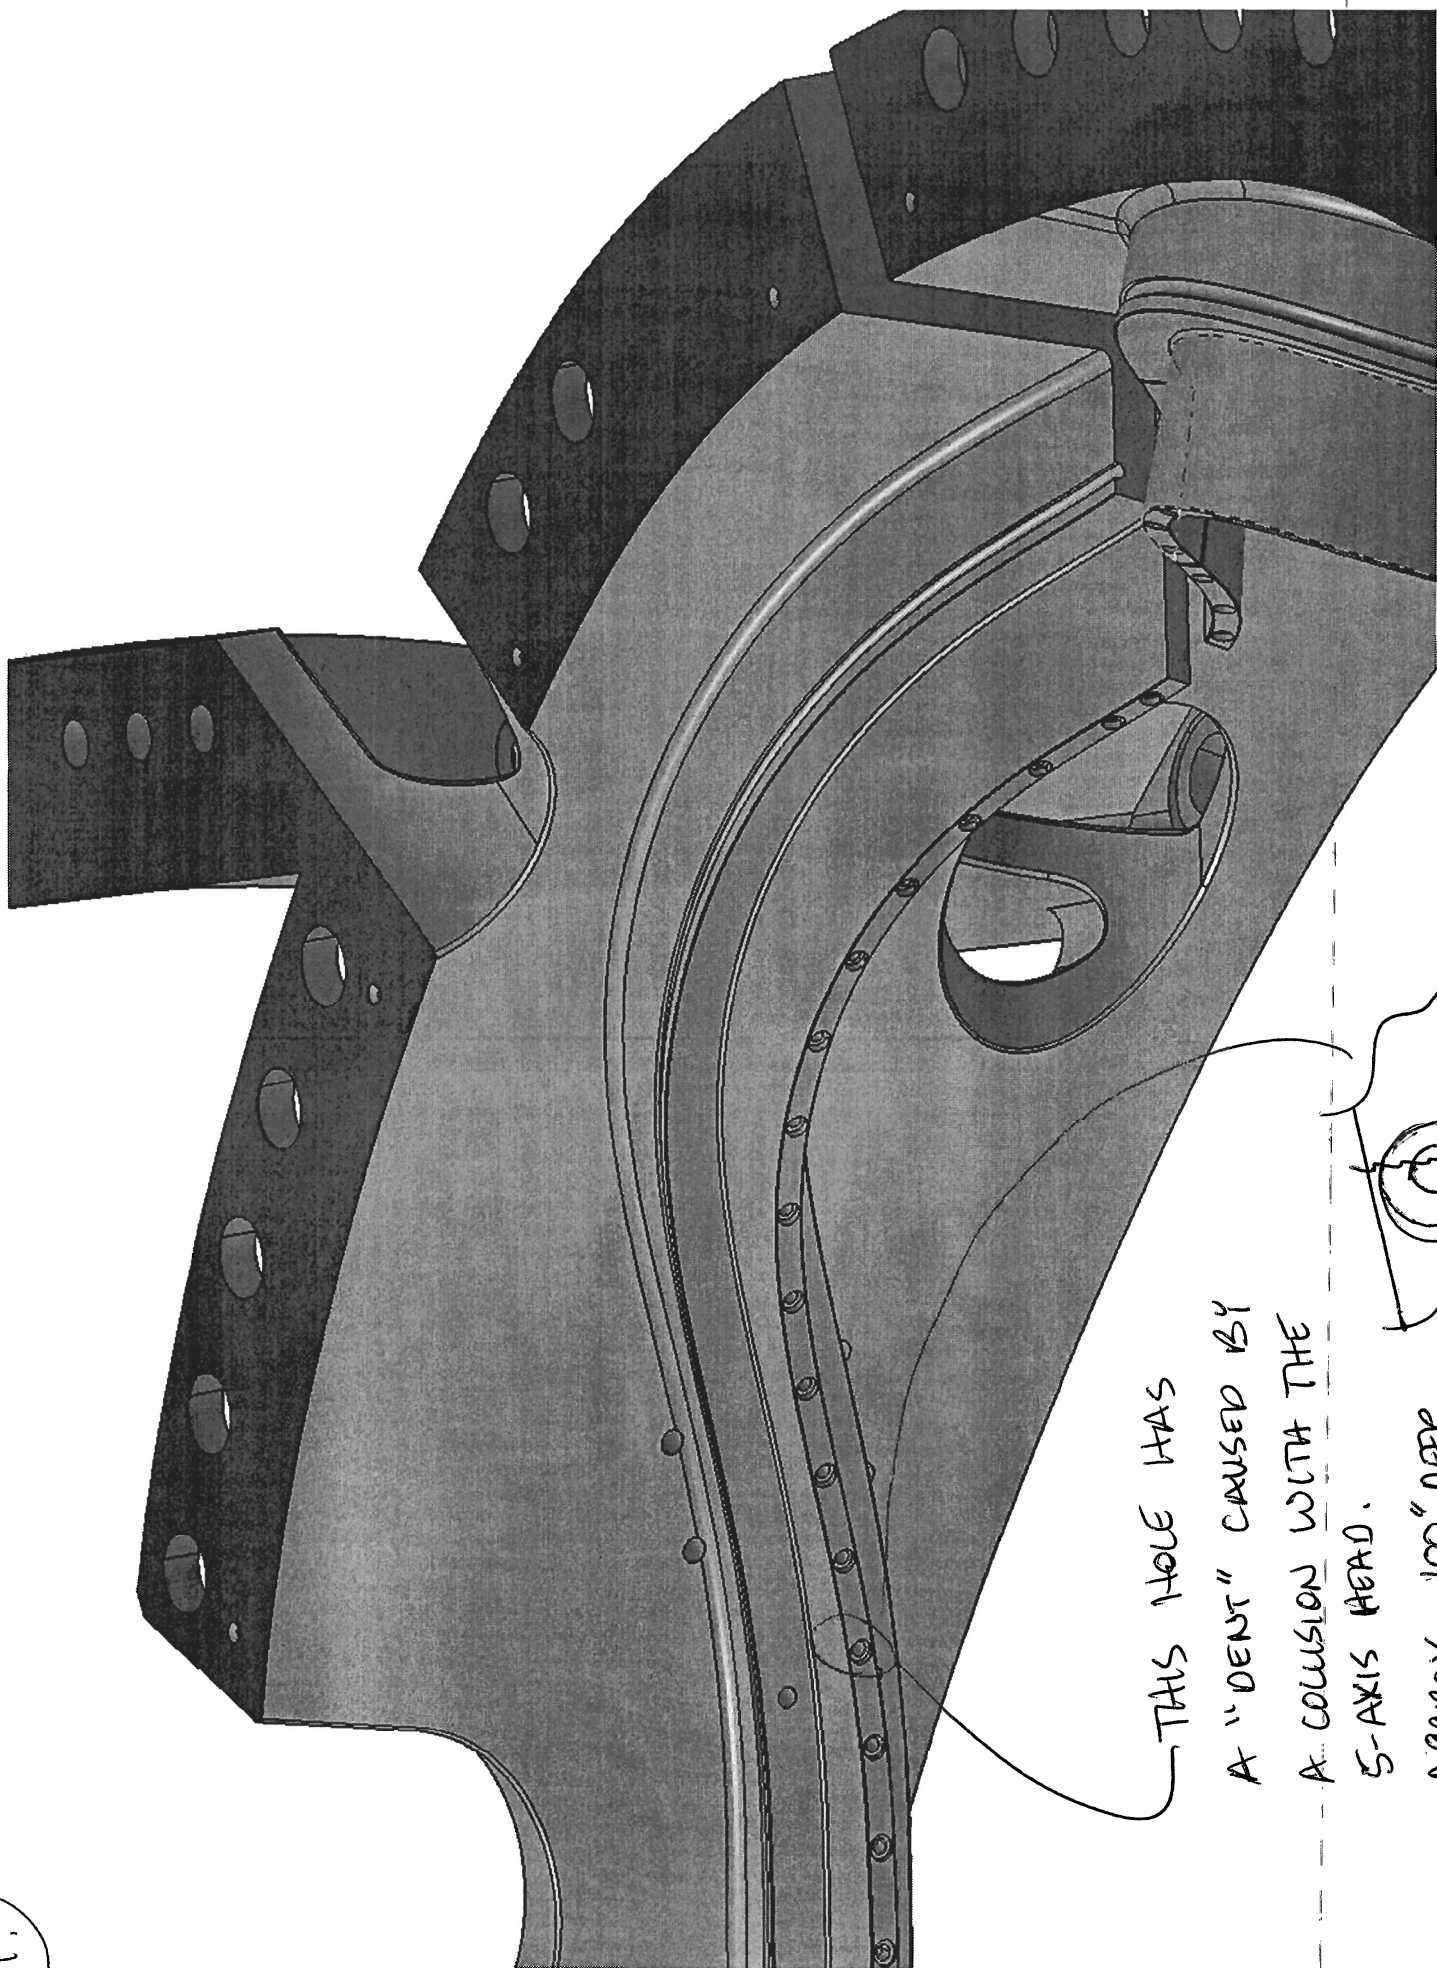
THIS HOLE HAS  
A "DENT" CAUSED BY  
A COLLISION WITH THE  
5-AXIS HEAD.  
APPROX. 100" DEEP

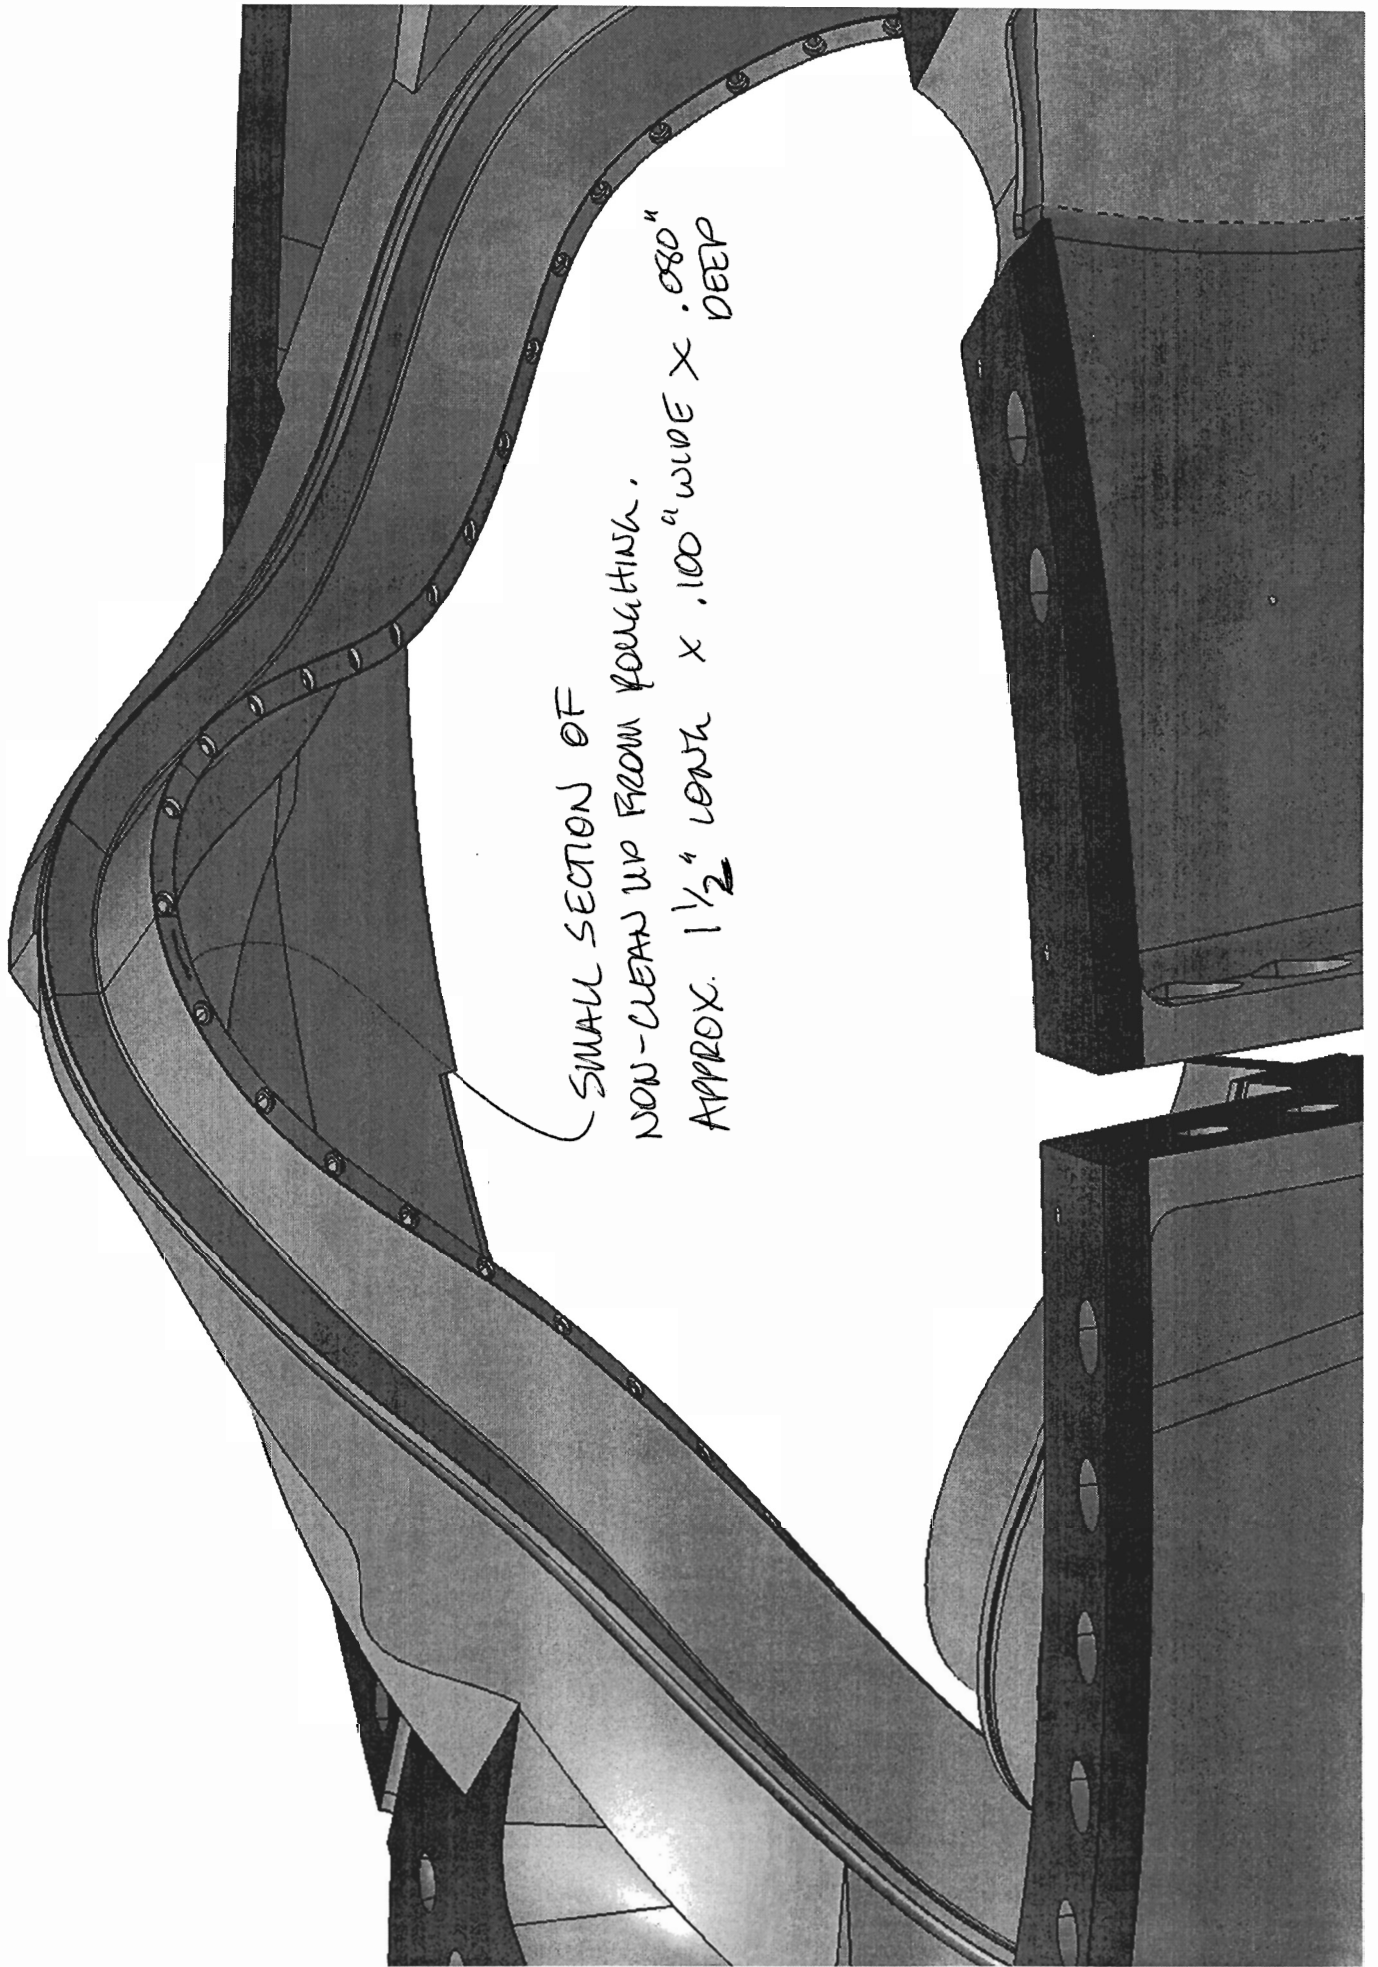
SMALL SECTION OF  
NON-CLEAN UP FROM FOUNDRY.  
APPROX. 1 1/2" LENGTH X .100" WIDE X .080" DEEP

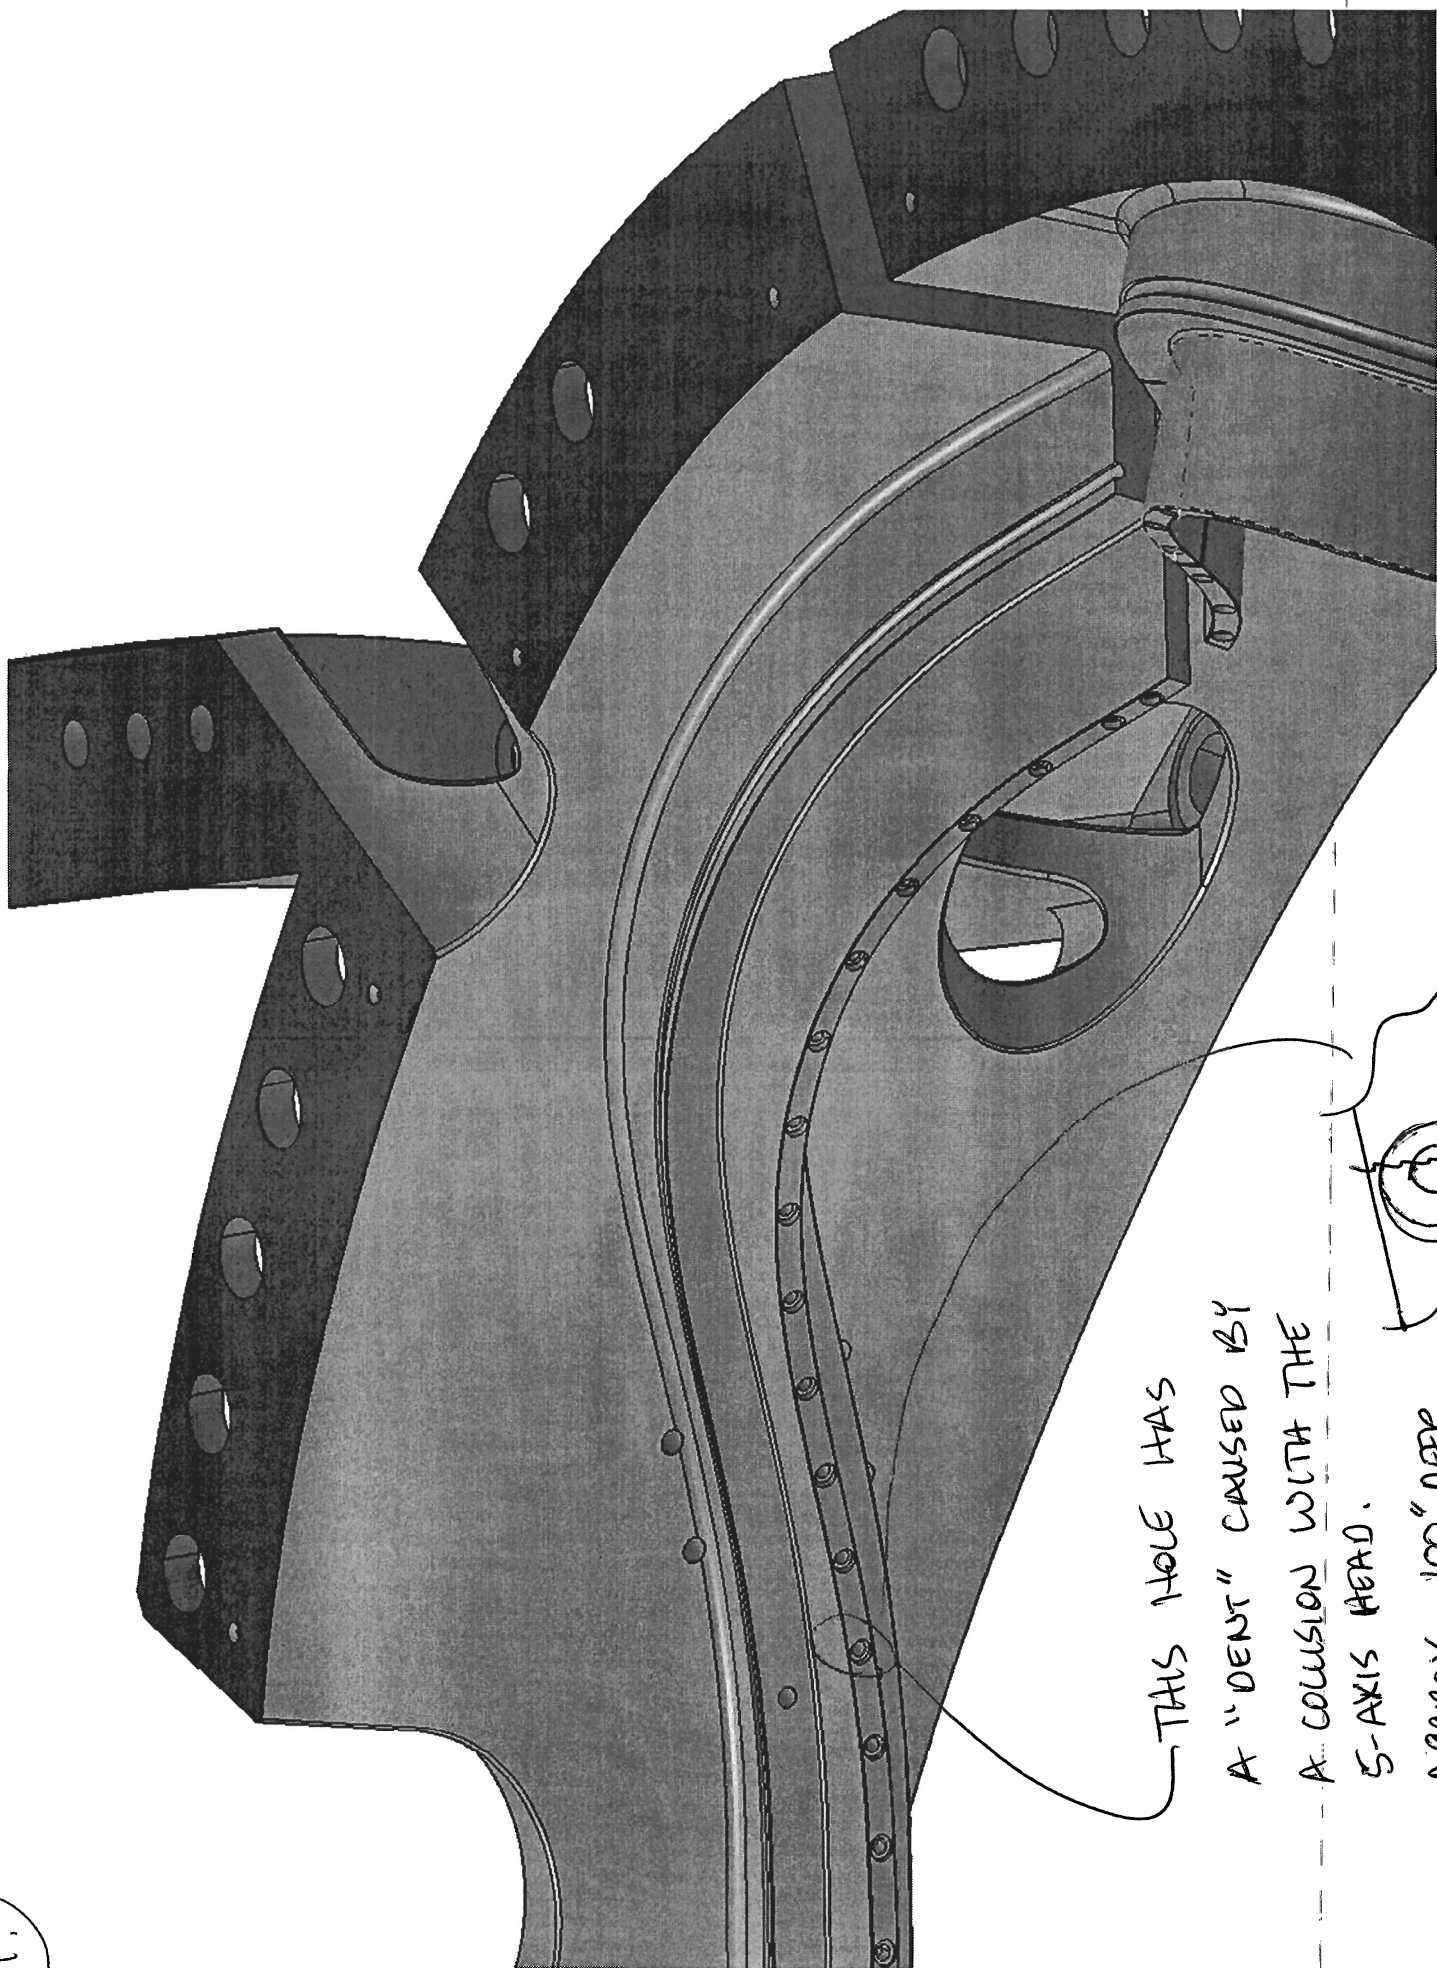
THIS HOLE HAS  
A "DENT" CAUSED BY  
A COLLISION WITH THE  
5-AXIS HEAD.  
APPROX. 100" DEEP
