PPPL NONCONFORMANCE REPORT NO: 3735    Open Date 11/15/07    Rev #: 1 , 12/20/2007

Status	1 - Eng Dept Head Concur Required	Trend	05-Design Interference
Department	NCSX	Division	WBS 142
Source/Org	Fabrication, Operations & Maintenance		
Item Dwg/Part#	b1_mtm_data_check.asm	Procurement #	WPF-1224
Cost Center	WBS/Other	00/00/00	
RAP#	3304	Job Doc #	WPF-1224
		Vendor	
RAP Title	Coil to Coil Assembly Trials

Review of “B1” to “C1” interface  
Response to NCR 3735  
and  
Deviation Request to Address  
Remaining B-C Coil Interfaces

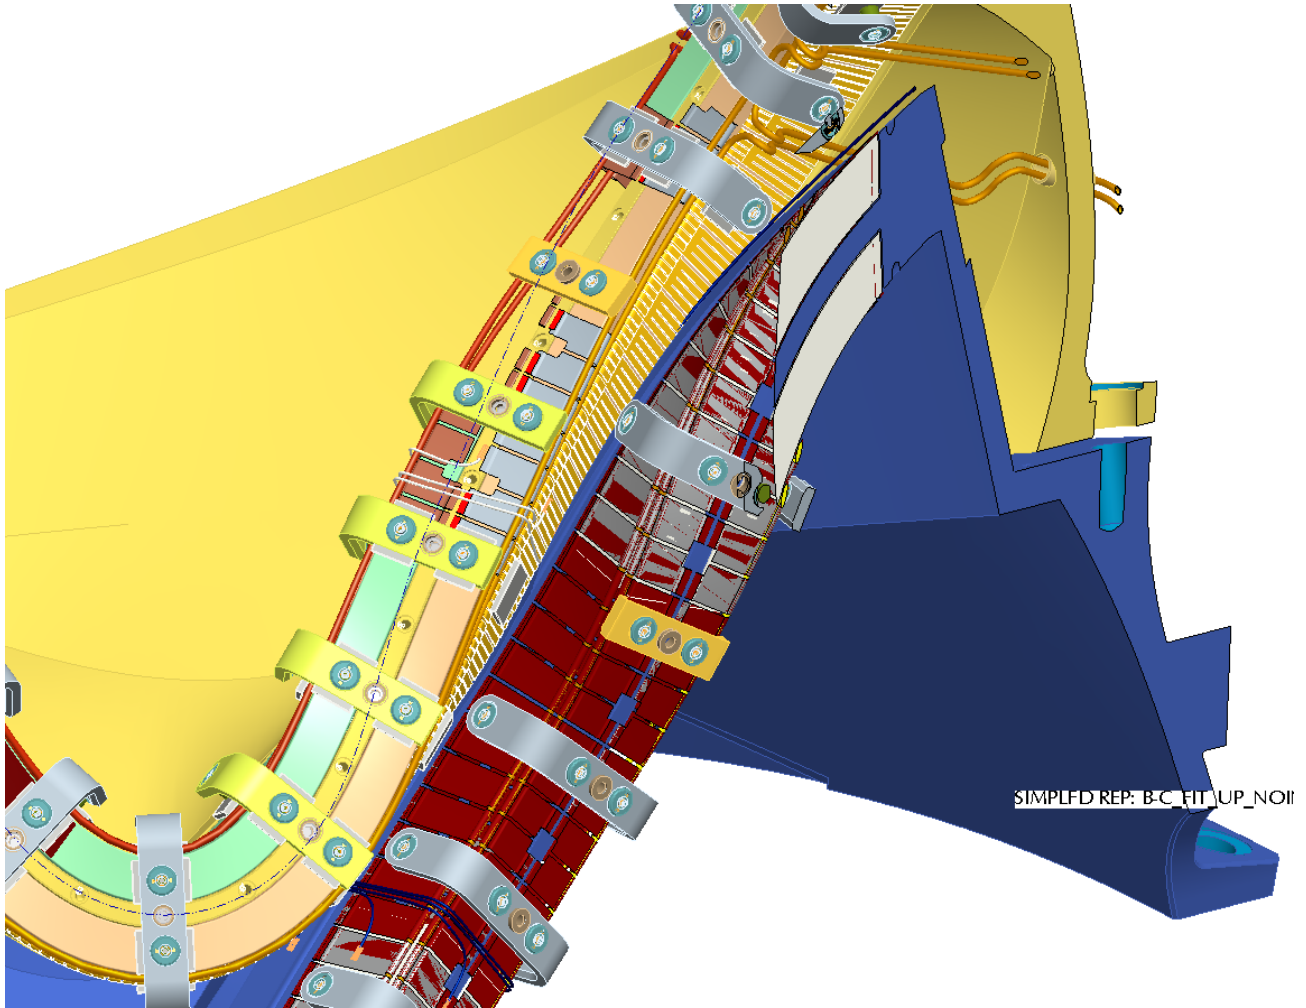
MCWF B1 & C1; During the trial fit-up of the B1 and C1 NCSX modular coils an interference was discovered in the vicinity of winding clamp #67. The interference is between the copper chill plates of each coil just above the VPI groove where the vertical chill plates are attached to the horizontal or base cladding, see attachment 1 for details.

Portion of master machine model identified as "b1\_mtm\_data\_check.asm" which brings together the top level MC assemblies, sel41-102 and -103 which include the MC Type-B and Type-C details.

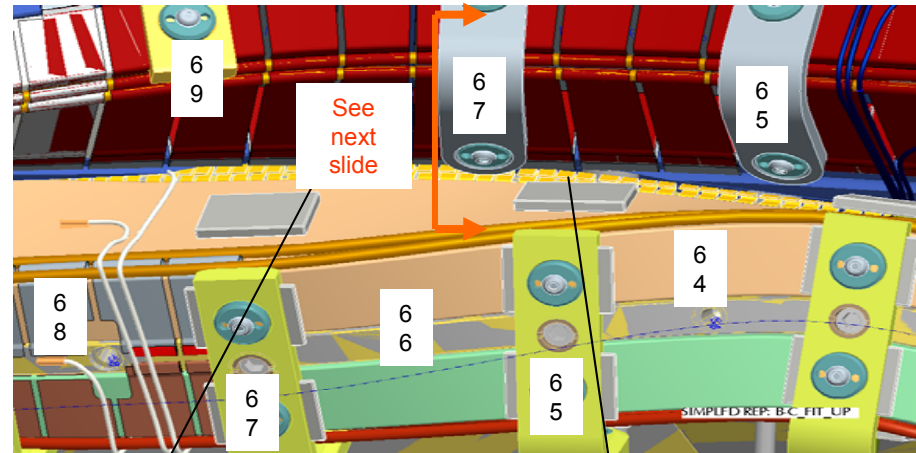
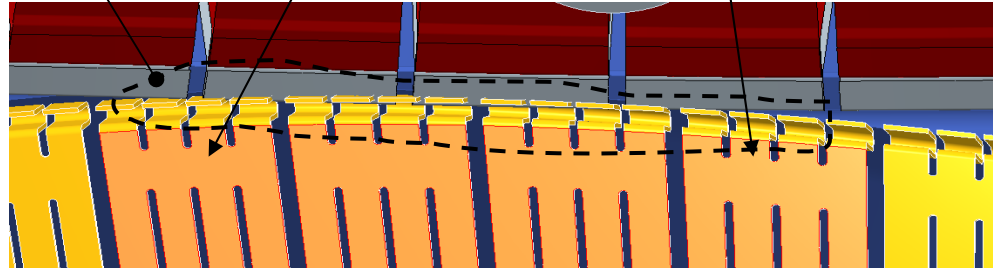
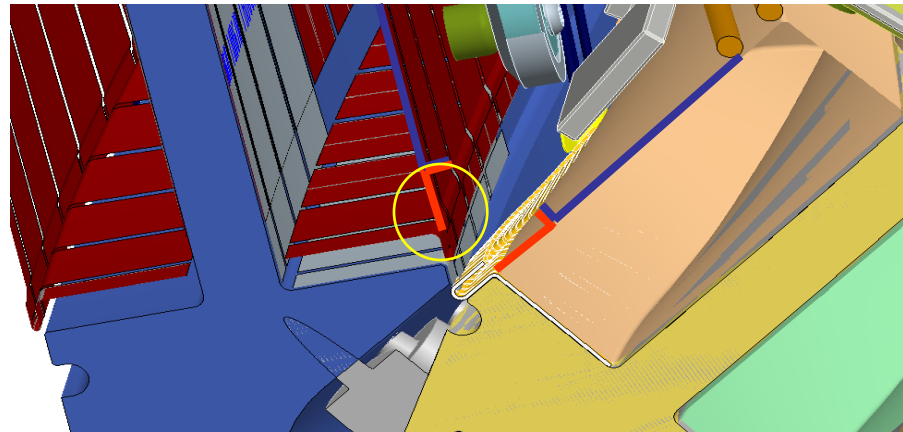
The "B" and/or "C" cladding needs to be modified as shown below in red in this area

On B coil, between clamp holes 65 & 69: and on C coil, between clamp holes 64 & 68:

- Unbend copper crimps & straighten copper.
- Form the copper as shown in the yellow circle. Bent out leg should be ~1/8".
- Form the upper copper to meet the bent out leg and form a crimp U section over the lower piece.
- Crimp the copper U.
- Epoxy the copper to the coil and overlay the repaired region with glass - epoxy.

*Every attempt should be made to avoid copper breakage. However IF the copper breaks during the unbending operation, abandon that piece. Analyses (see slide 14) indicates that breakage of every other finger has a negligible effect on dT; **if more than two adjacent fingers break, work shall be stopped and a NCR shall be written and dispositioned before proceeding.***

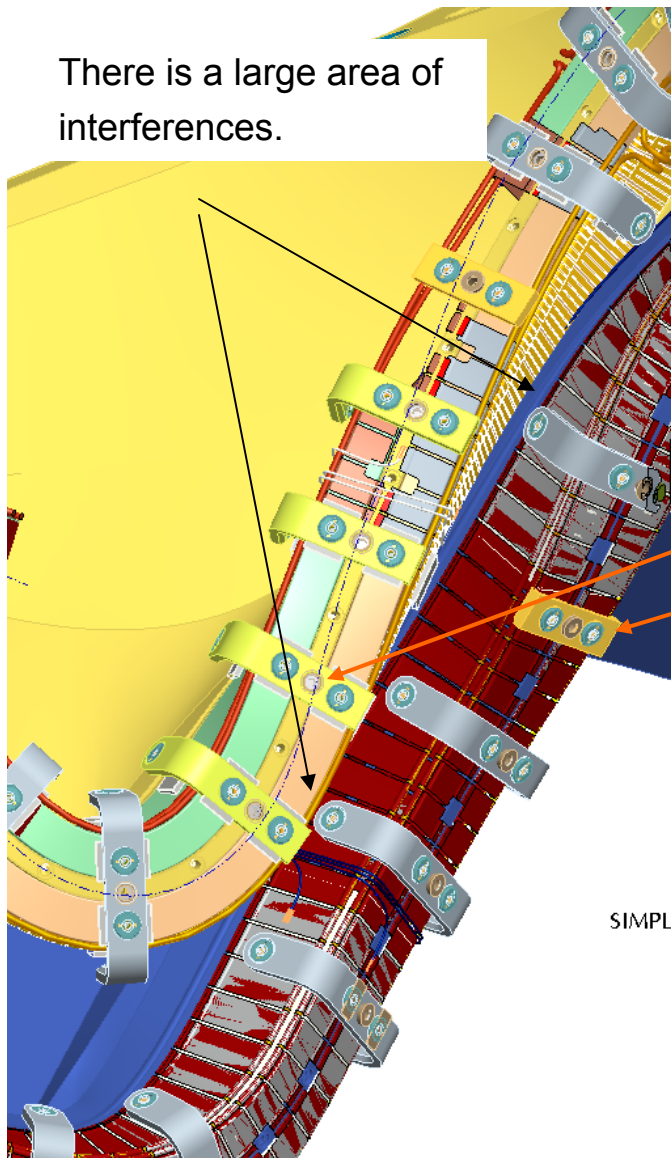
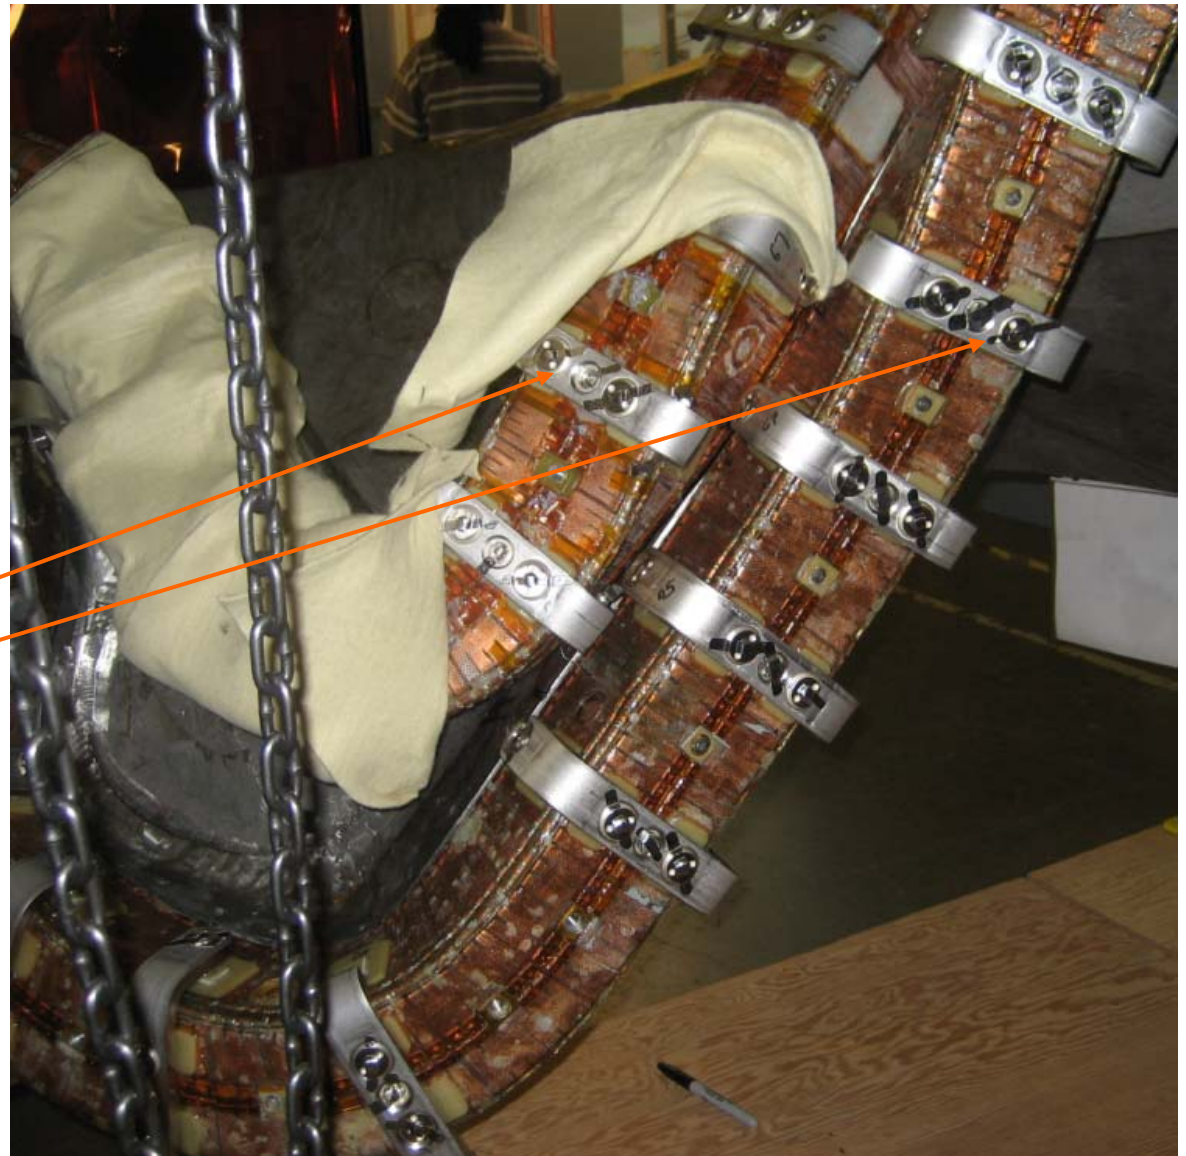
There is a large area of interferences.

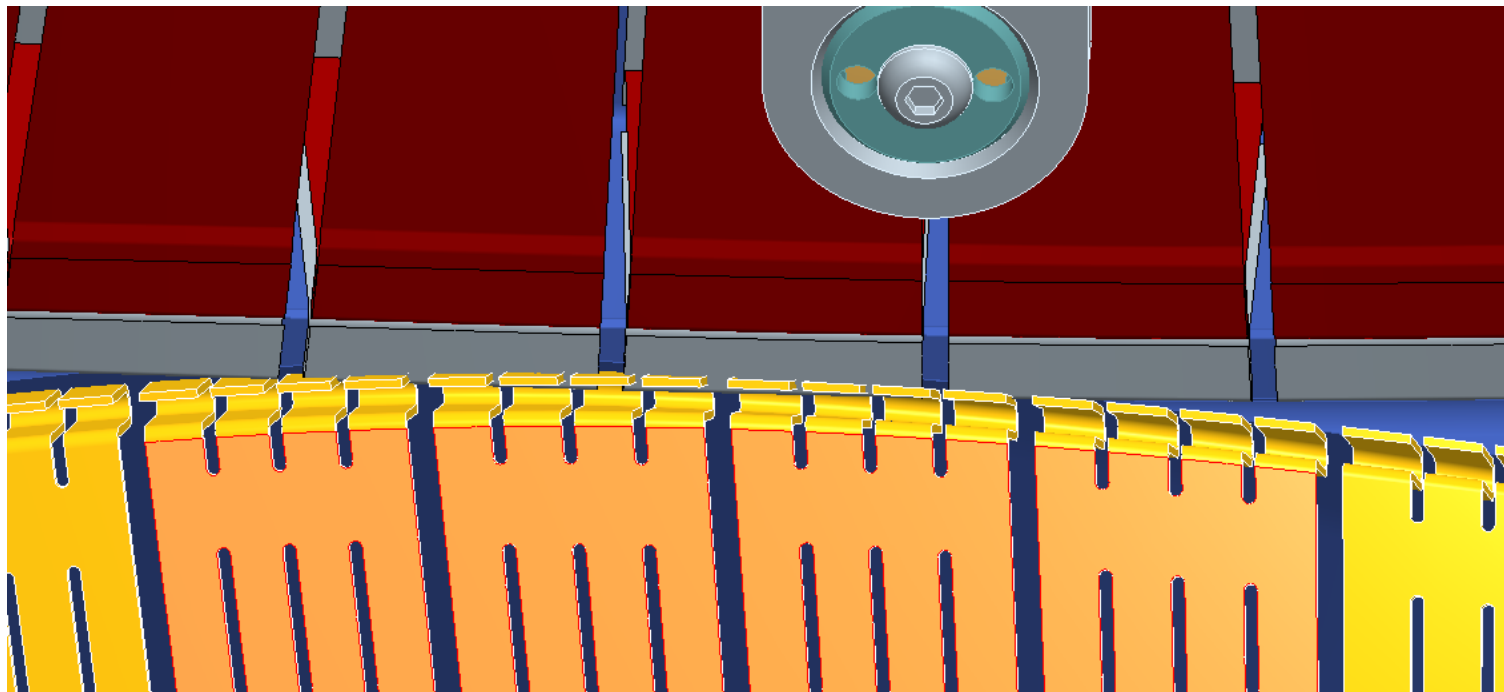
The “B” and/or  
“C” cladding in  
this area needs  
to be cut back.

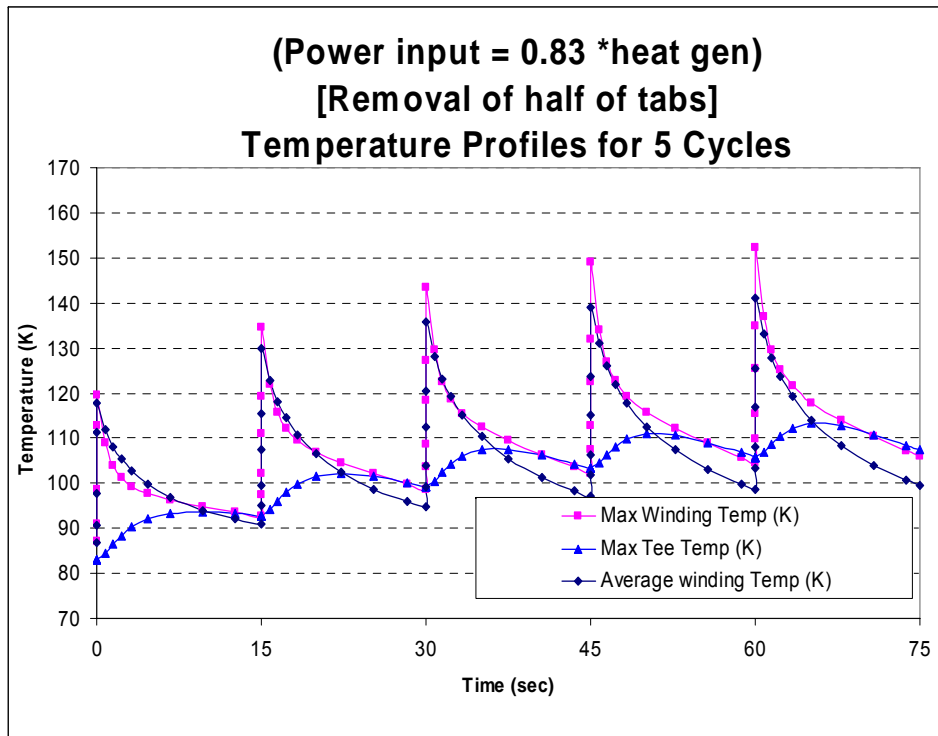
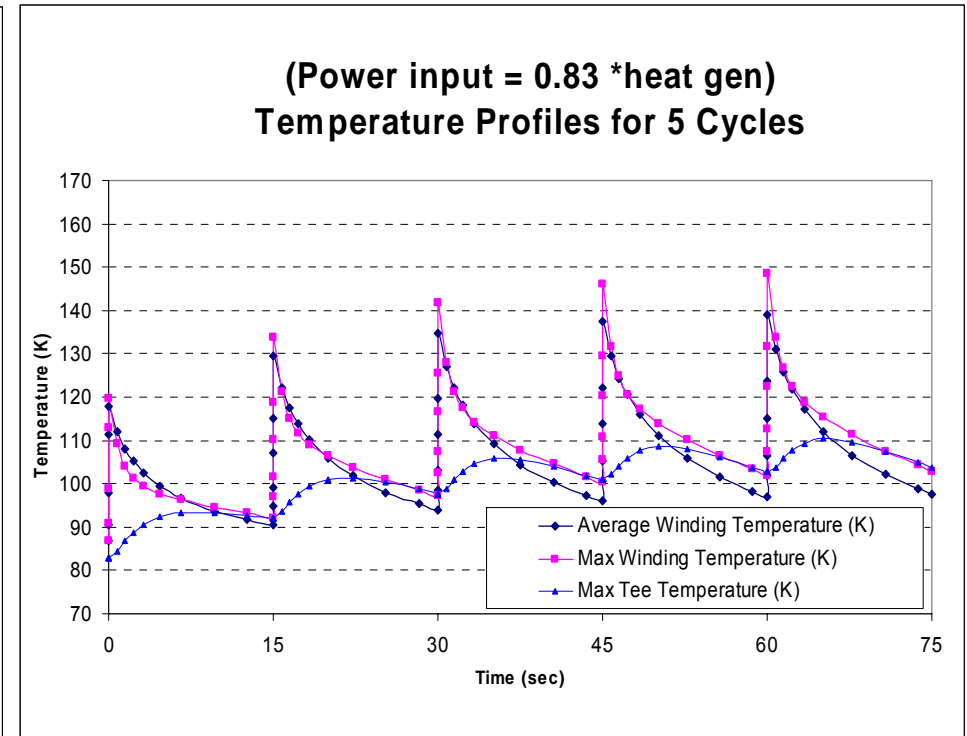
# Plot comparisons (1/2 tabs connected) (K.

Very little change (2 degrees max)

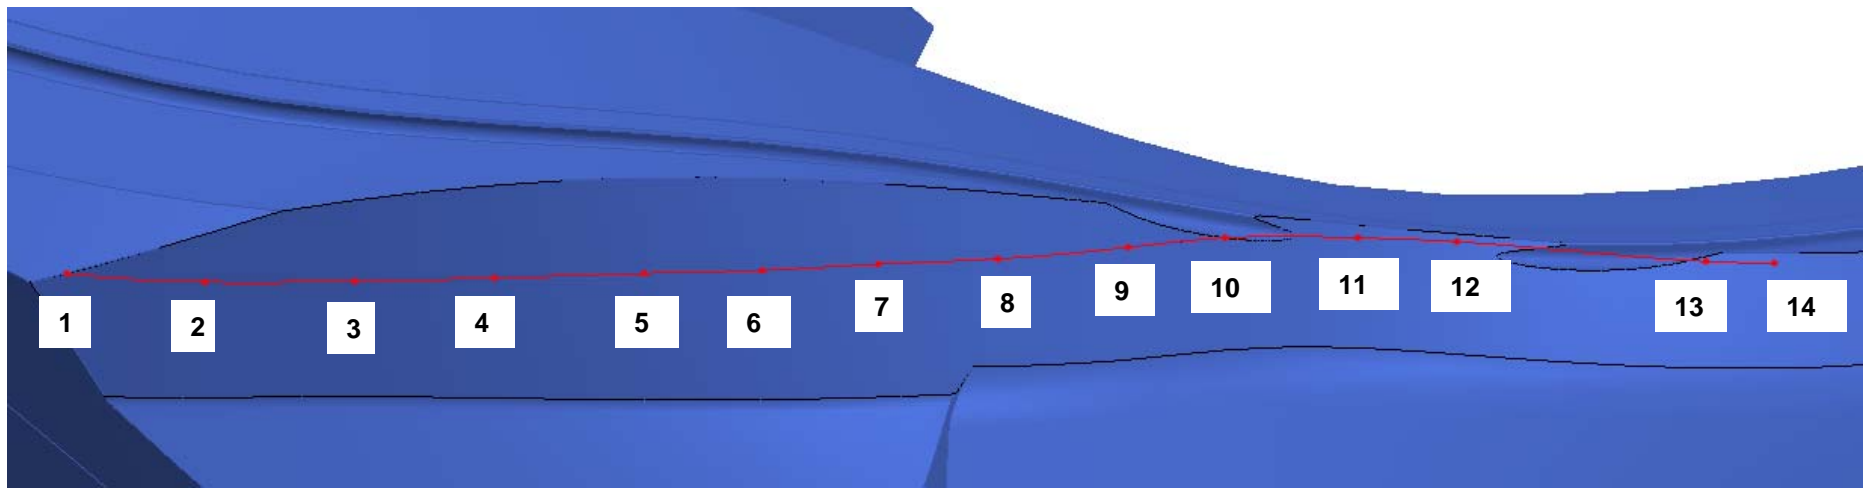
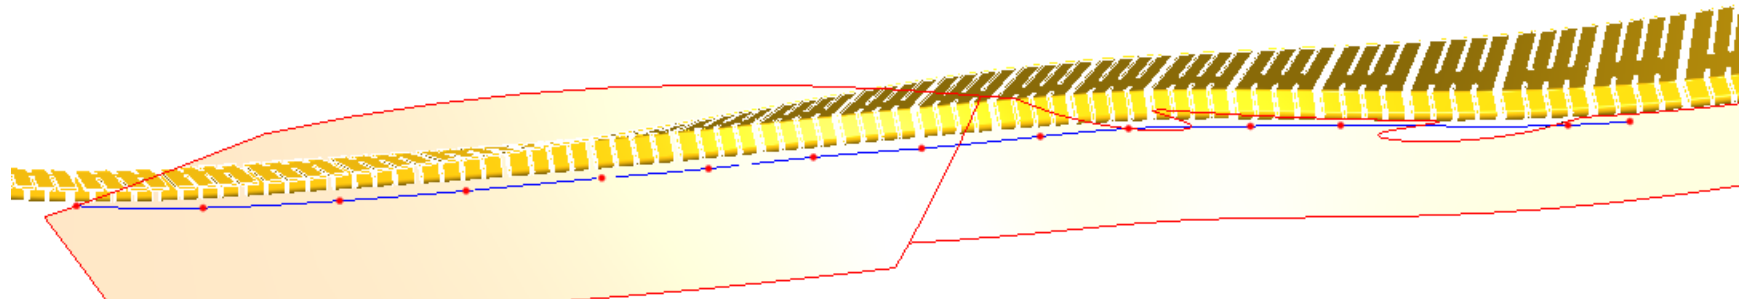
**Local section view**

Point data relative to the "B" default coordinate system

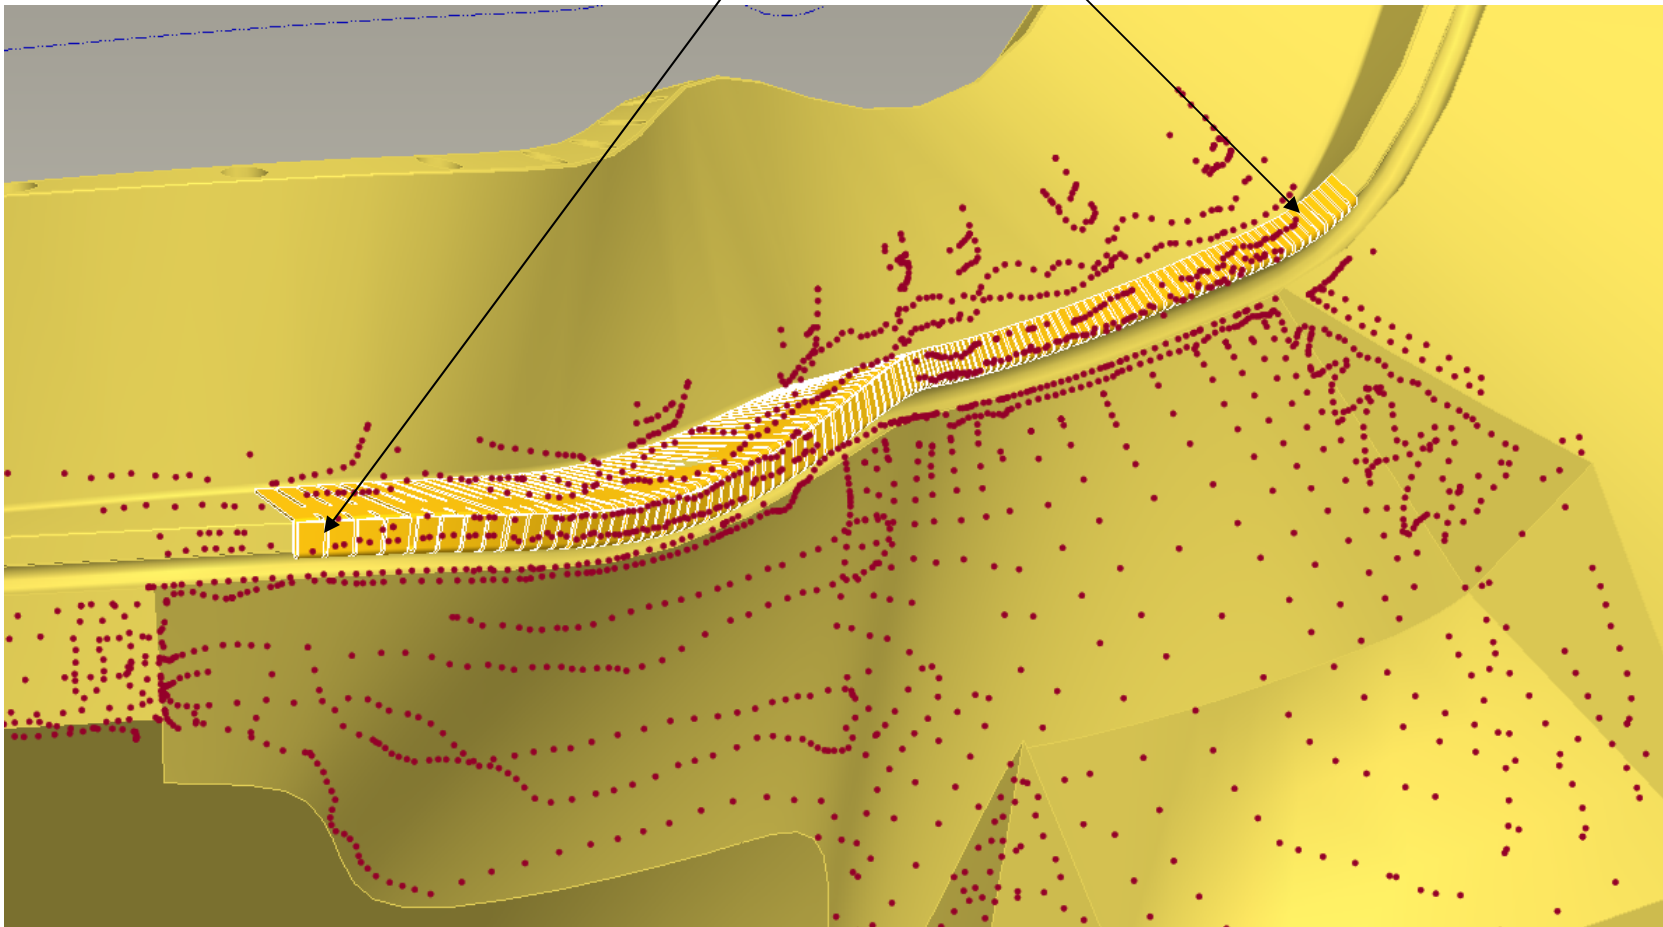
“C” MC is shown along  
with C1 scan points

All scanned points along the cladding surface are in  
the range of -0.006” to -0.042” below the CAD  
model surface of the cladding... good news.

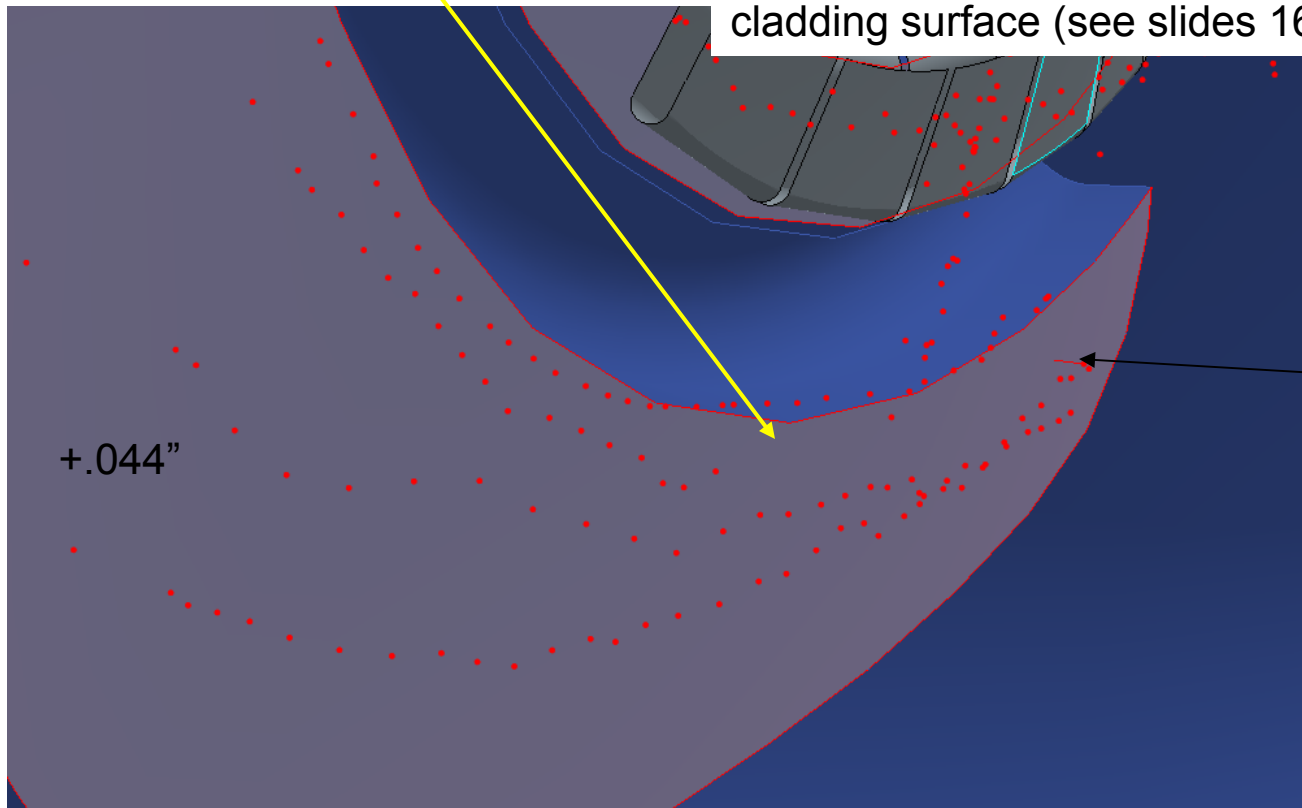
"B" MC is shown along with B1 scan points

-.050" to  
+.016

The new B1 scan data shows the surfaces are off the CAD model at a max condition on the order of +.058" and has a max value of +.092" off the cladding surface (see slides 16 and 17).

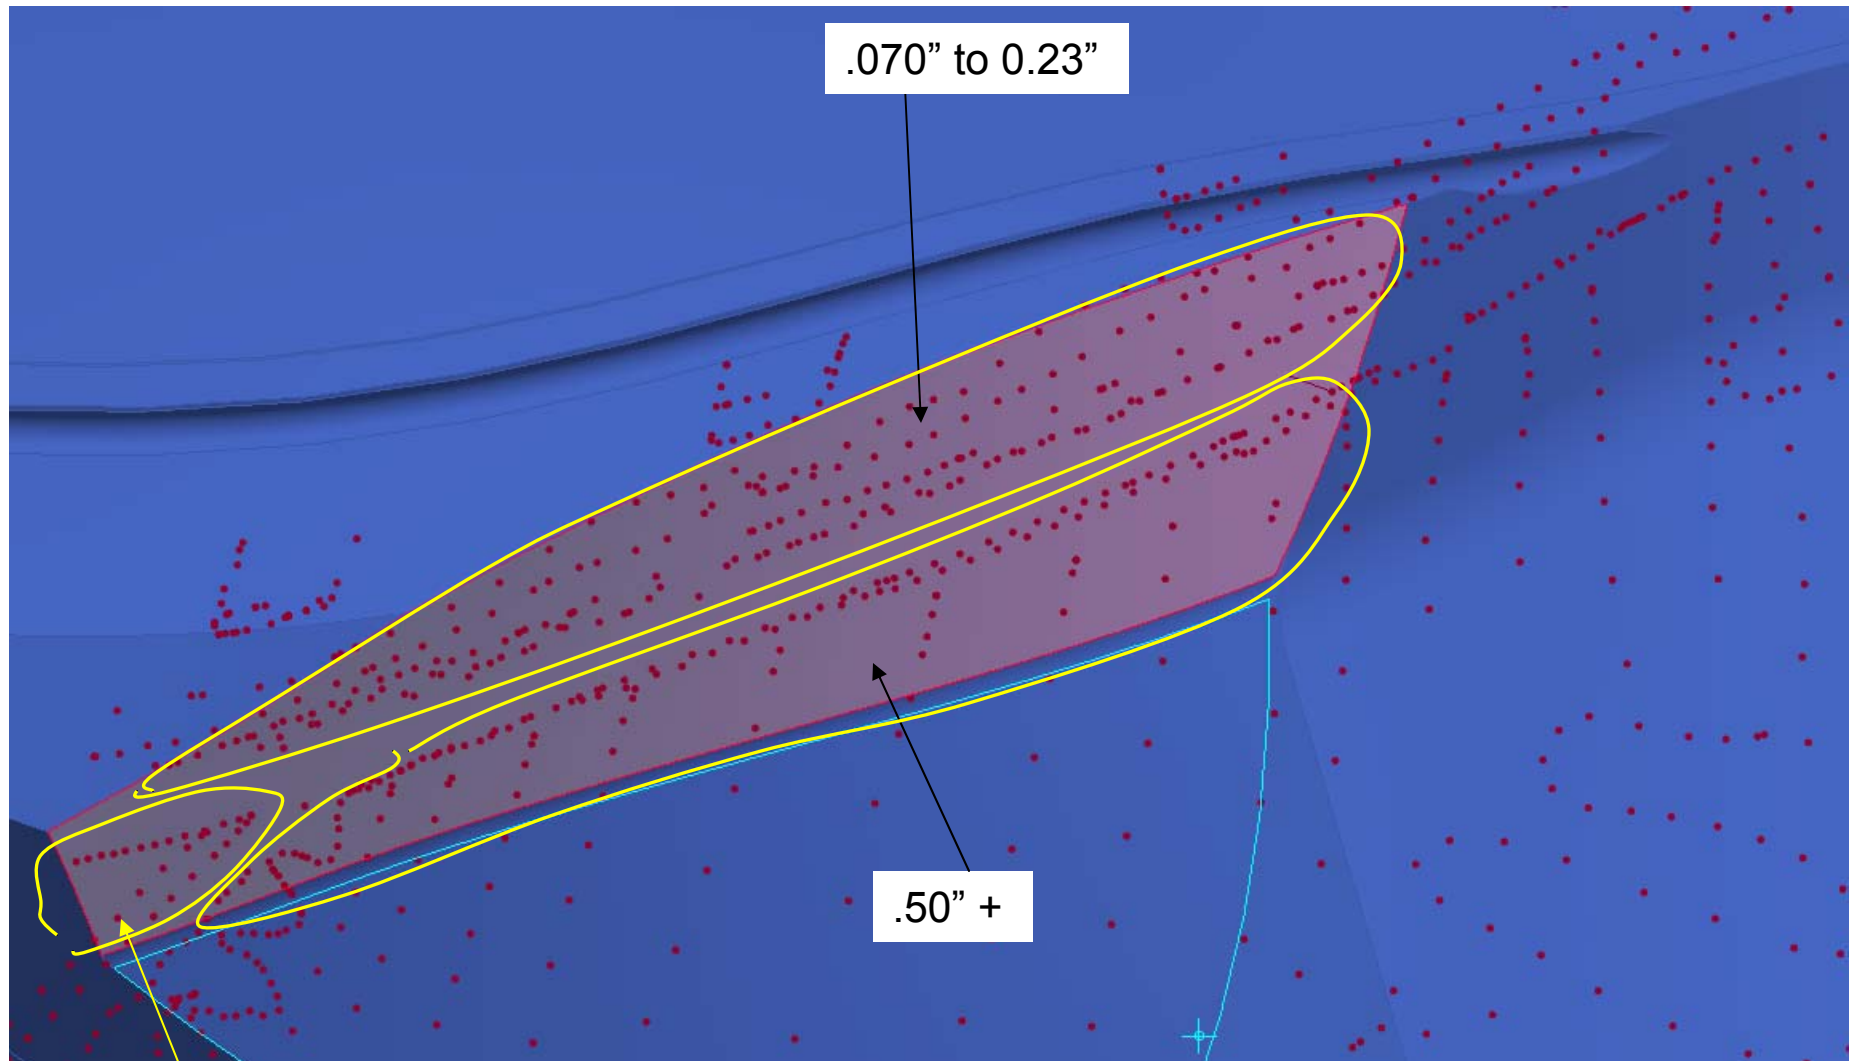
The recent C1 scanned points are shown as red points off the CAD model of the "B" MC.

0.23"

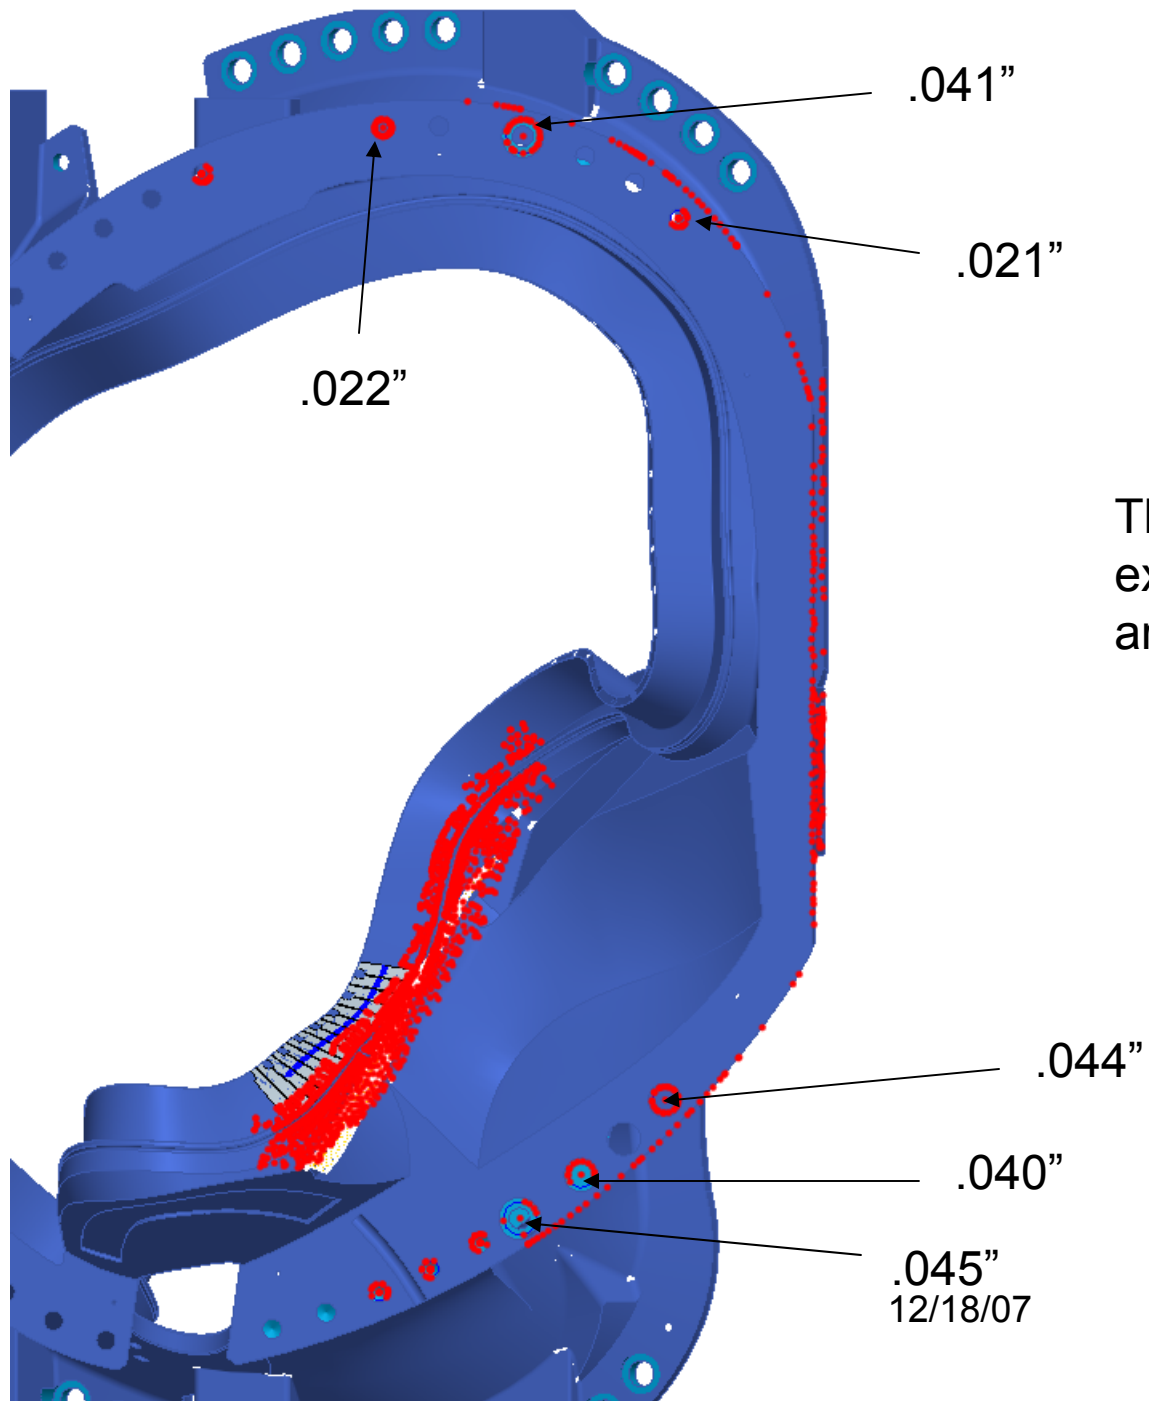
The values show the extent that the hole CL are out of tolerances.

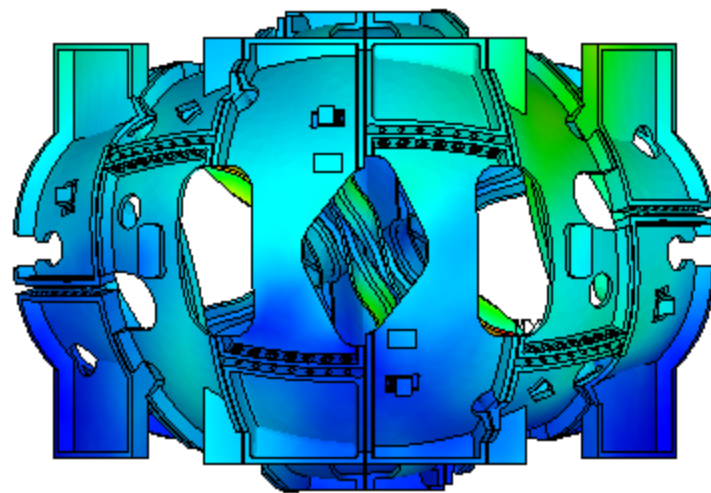
# Total Displacements of Shell - Usum

- The maximum displacement, 2.336 mm, occurs on tee in shell type B due to lateral deformation of web caused by the lateral force of the modular coil.
- Because of net vertical forces are equal and opposite with respect to the mid-span, the deformation at bottom of the mid-span is small.
- The smaller deformation at the inboard than the outboard is the result of higher shell stiffness in the inboard.
- The unit of the displacement is in meter

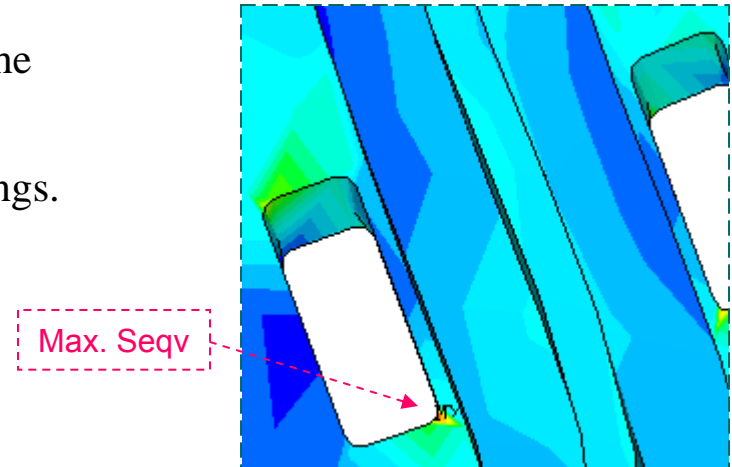
# Von Mises Stress of Shell Structure

- The maximum local von Mises stress, Seqv, occurs at the corner of lead opening in shell type B.
- The model was built without chamfers at the lead openings. With chamfer, the local stress will be greatly reduced.
- The next slides will display some high stress areas
