Part: SE141-114 / MODULAR COIL WINDING FORM TYPE

Drawing ID: SE141-101
W/O Links: 1-Type:W: 65709/5.0 Sub: 0

Problem: Visual review of A5 identified several tool marks on T section and other miscellaneous items. See attachment for details.

NC21265 – A5 Visual Review

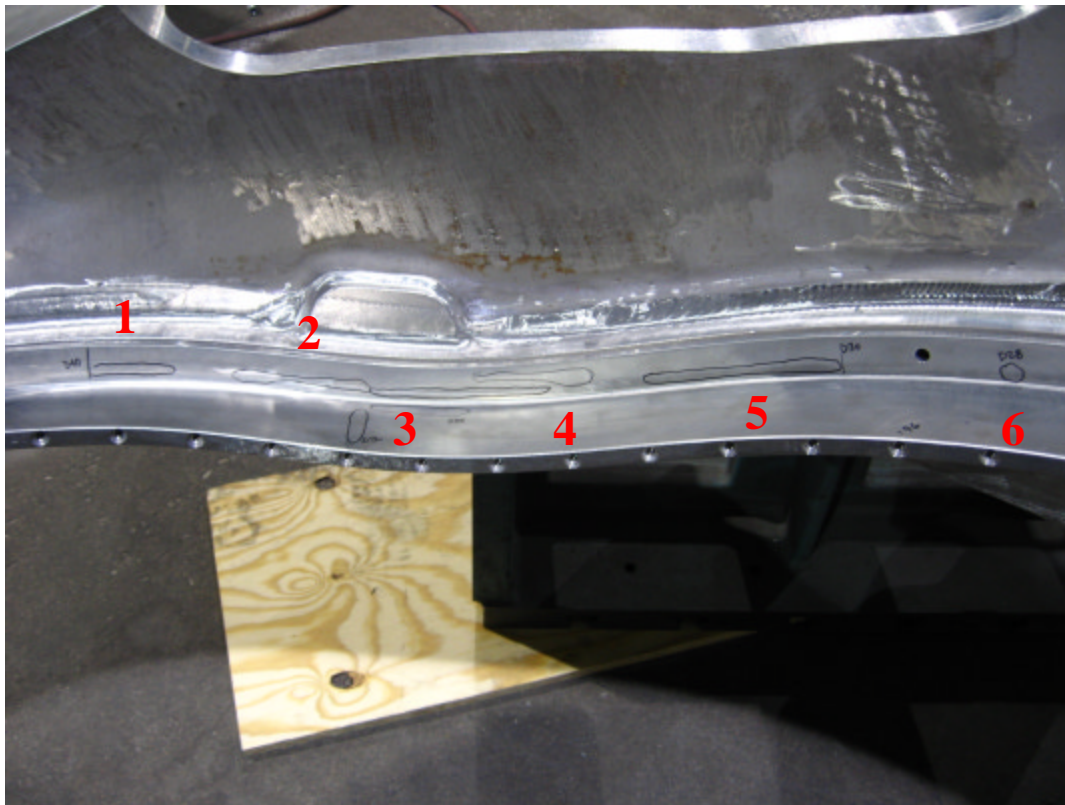
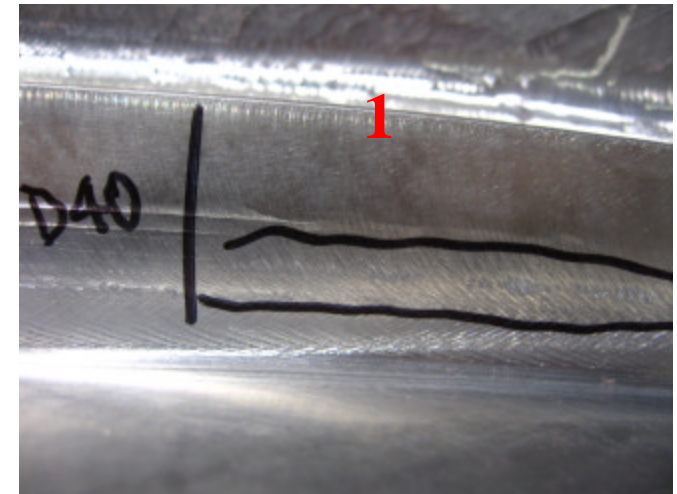
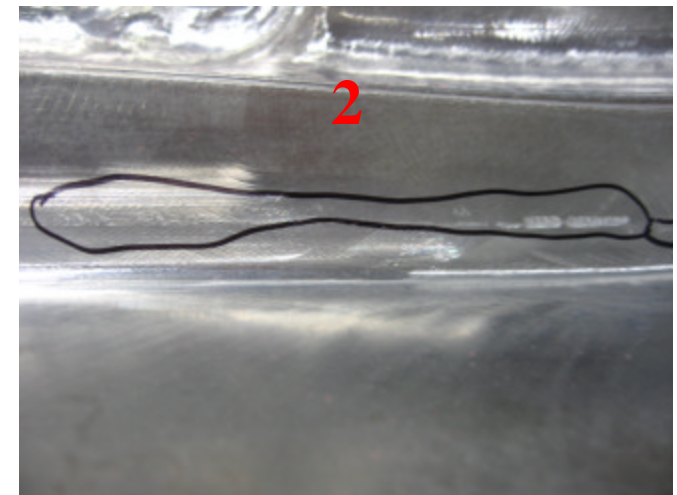
There are several shallow tool marks ($<.010''$) on the datum D side between T holes 28 and 40.

These are shown on slides 1 and 2.

The attached list was reviewed during a conference call attended by J. Chrzanowski, L. Sutton, F. Malinowski, L. Dudek, D. Williamson, T. Brown, and P. Heitzenroeder on 2/28/07. The surface defects are shallow (<0.010") and therefore are not an issue. During the call it was noted that the lead pad offset caused by a less than optimal choice of initial casting best fit location brought the pad uncomfortably close to the lead slots; MTM resolved this by grinding a 0.5" chamfer immediately (see attachment). The break-out of some of the bolt threads were also discussed, but there is adequate thread engagement beyond this so it is accepted as is.

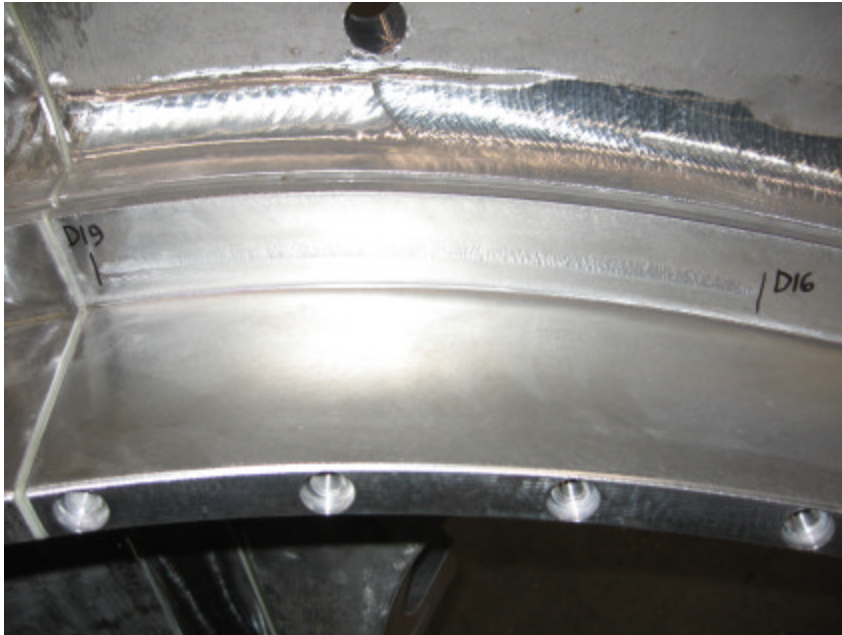
Shallow tool mark on D side short leg, between T holes D16 and D19.
Tool mark is <.005" deep.

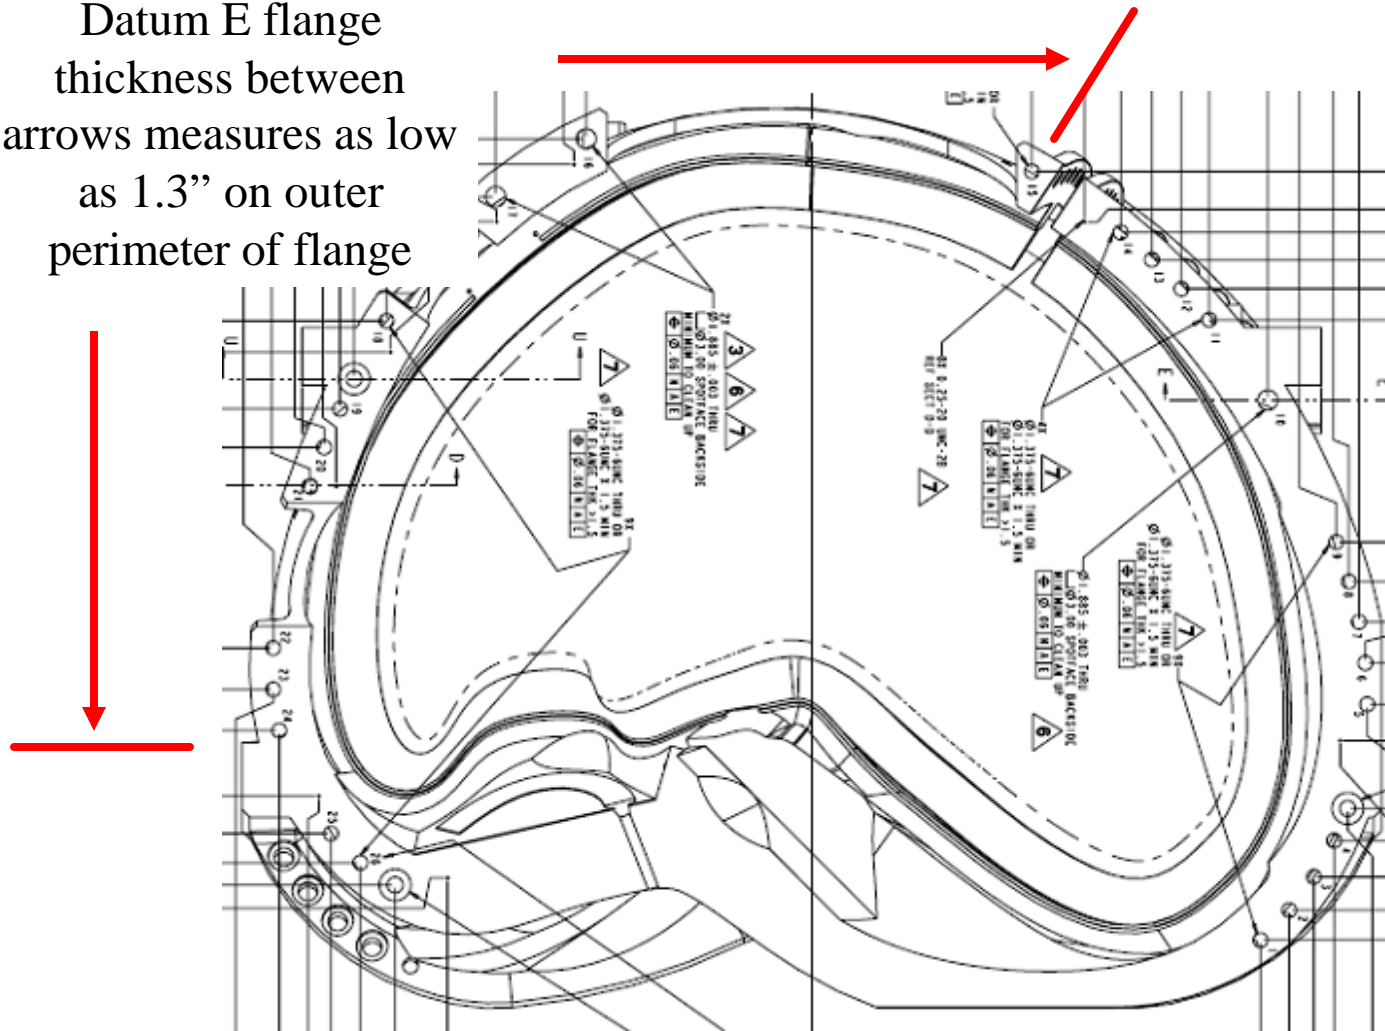
It appears that the casting stock was not balanced as well as it could have been when the casting was qualified on the 1st roughing operation at MTM. A rotation of approximately .400" near the lead block area would have improved this condition. This resulted in a thicker flange on datum D and a thinner condition on datum E (as reported in previous slide). This also affected the lead pad and the cast stock around the 2.5" holes (see next slide).

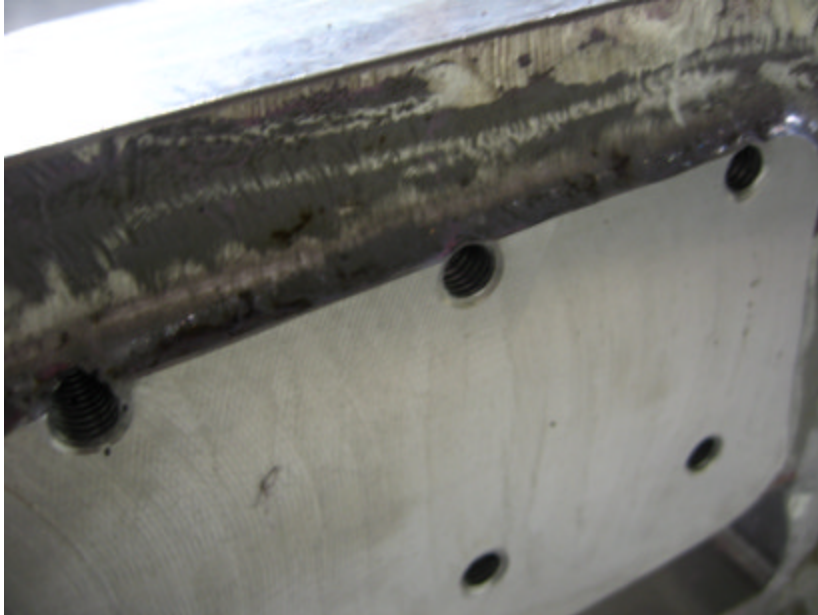
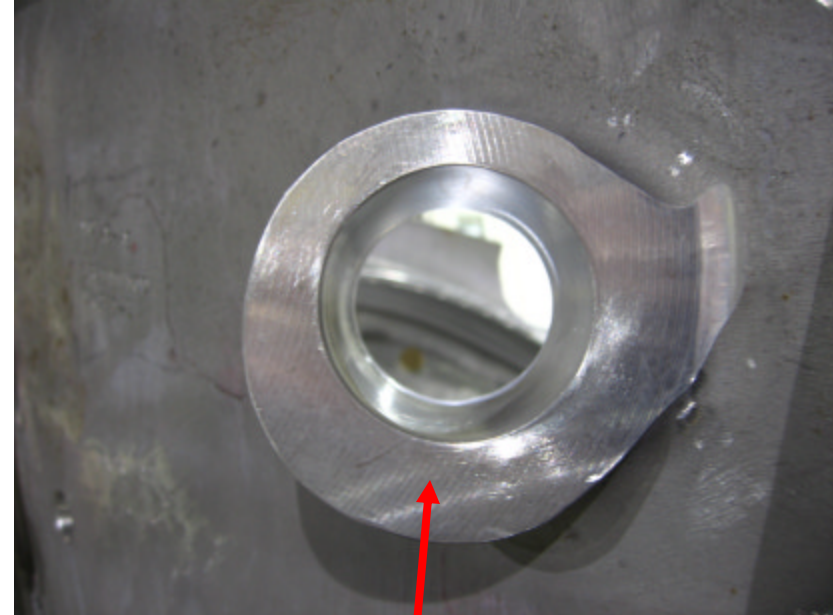
The picture above and the one in the previous slide show how the hole is shifted relative to the cast stock.

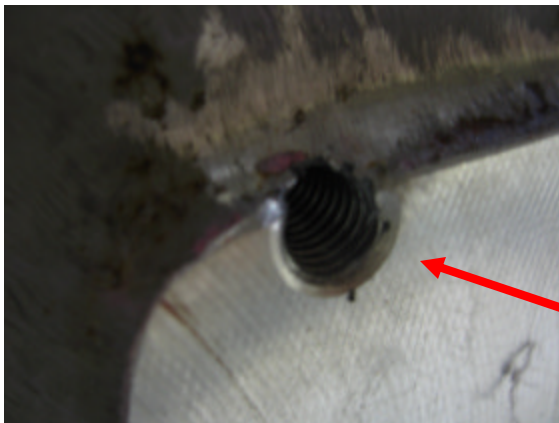
The 1st 2 ½ threads break out the edge of the hole.
This hole (and the other five) checks good with a thread gage.

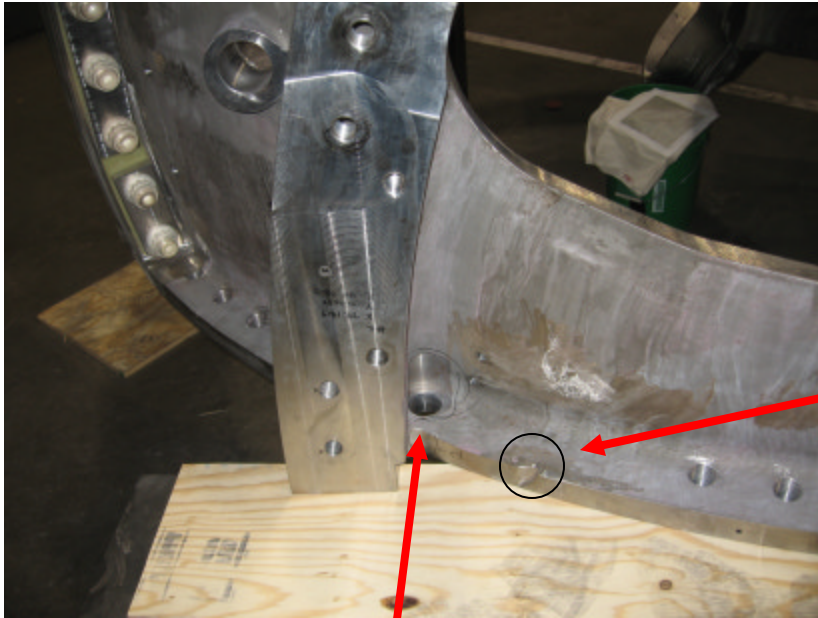
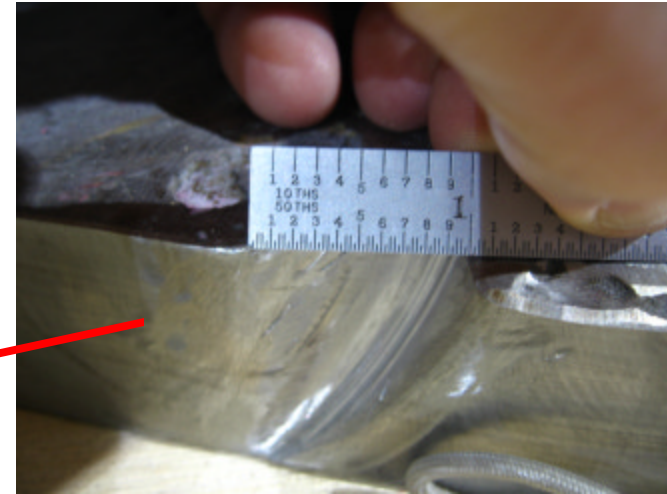
Tool Gouge on perimeter of Datum E flange,
approximately 1" wide by .50" deep.

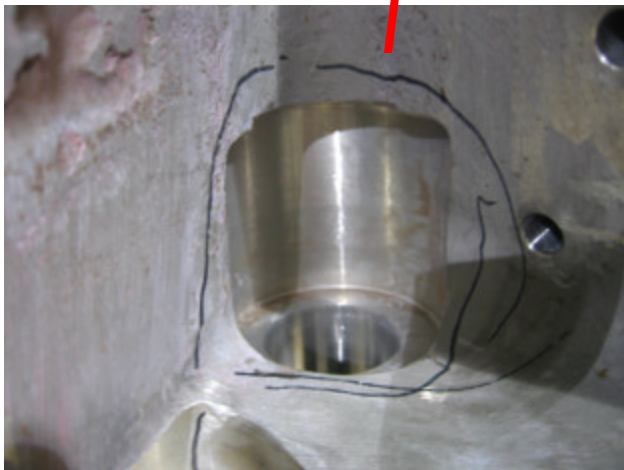
Picture to the left is
of the 3" counterbore
in the datum E flange
as reported on
NC21252 step 810.
Area shows heavy
stock around hole
(too much to grind).

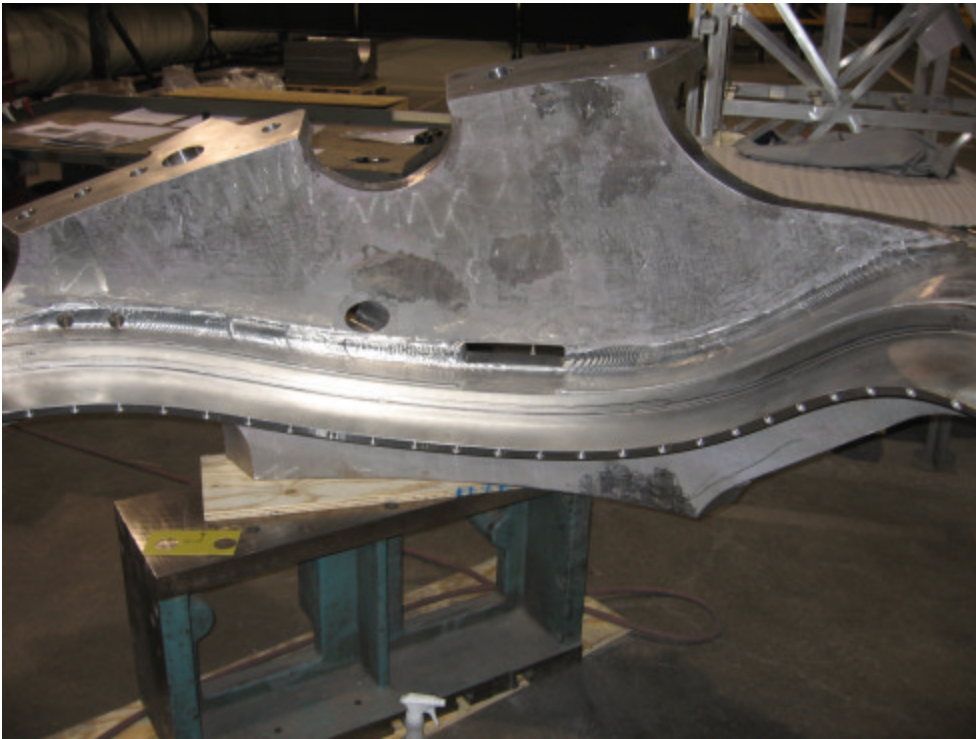
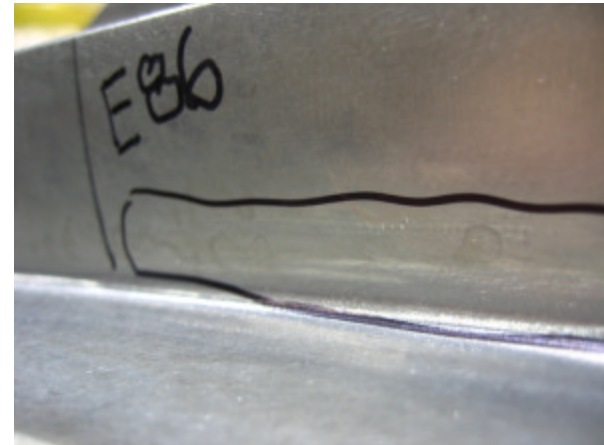
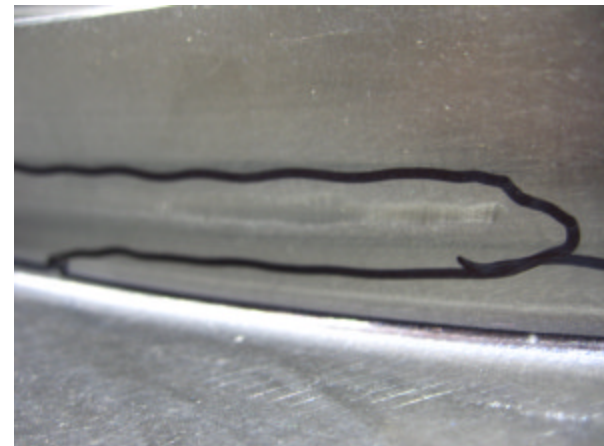
Shallow tool marks on short leg of E side from T hole E86 to E1 thru E12. Marks are less than .005" but in too big of an area to try to blend out. Pictures to the right are close-up of the tool marks but even in the picture they are hard to see

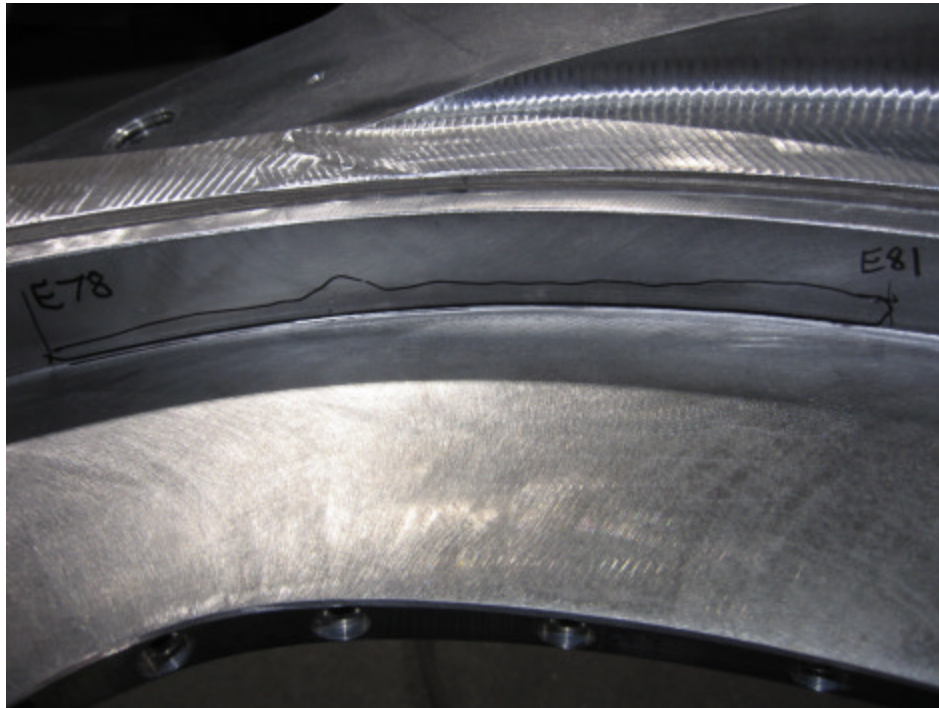
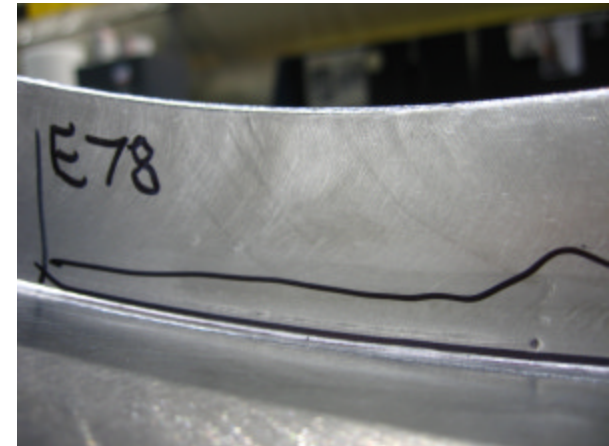
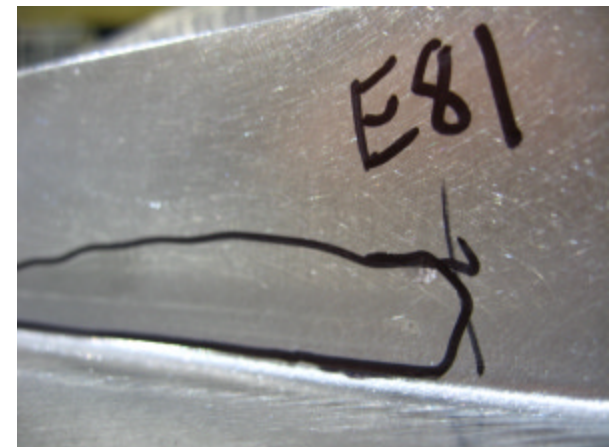
Another area of tool marks between holes 78 and 81 on the E side short leg. Again, very shallow ($<.005''$).

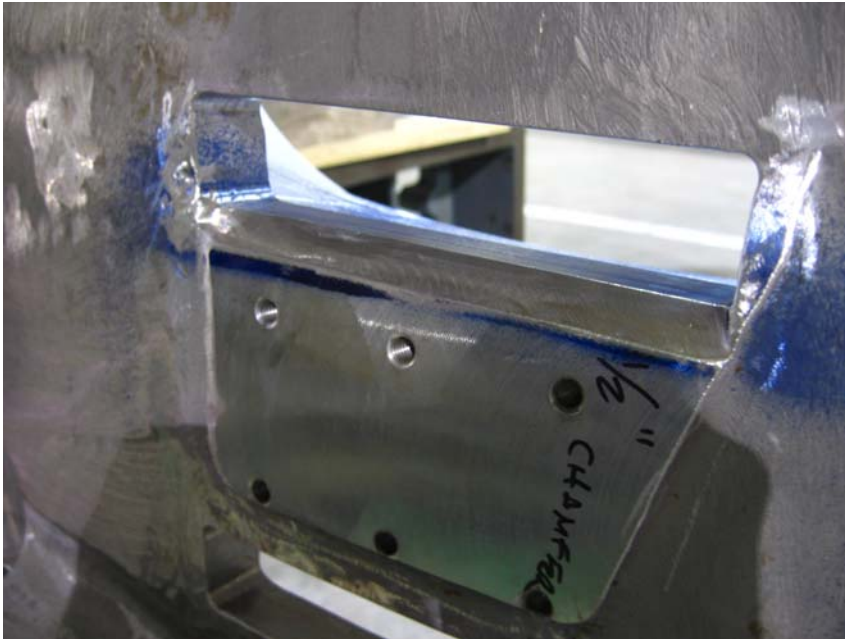
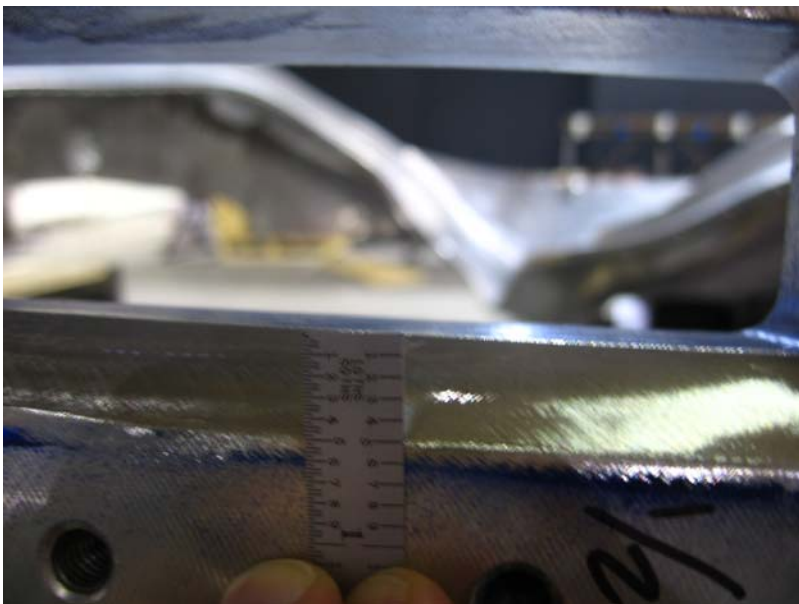
Photos showing chamfers added to lead pad
