Miscellaneous Machining and Casting Issues

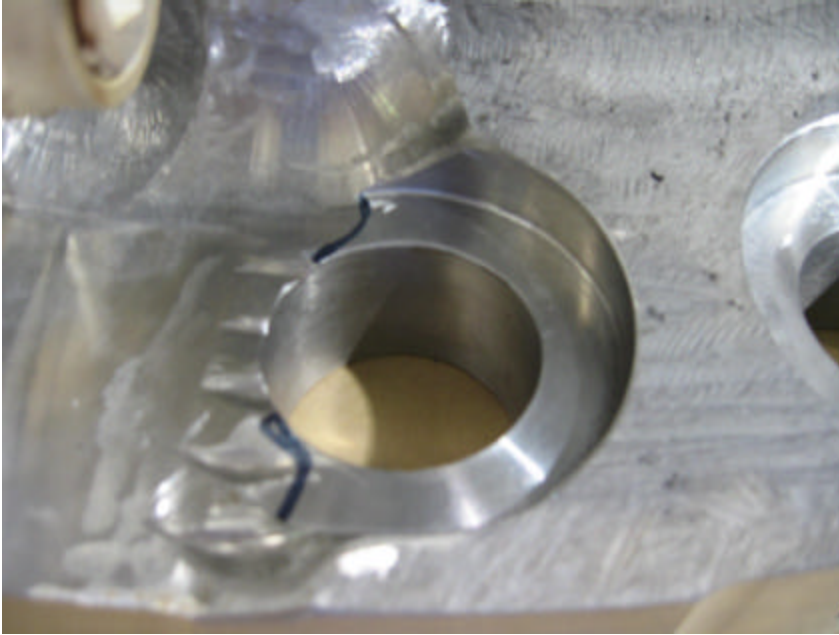
Counterbore adjacent to Poloidal Break on E Flange.JPG

Counterbore is next to Poloidal Break on the E flange. Approximately 60% of counterbore cleaned up 100%. The area of non cleanup has tooling gouges and is approximately .050" in depth.

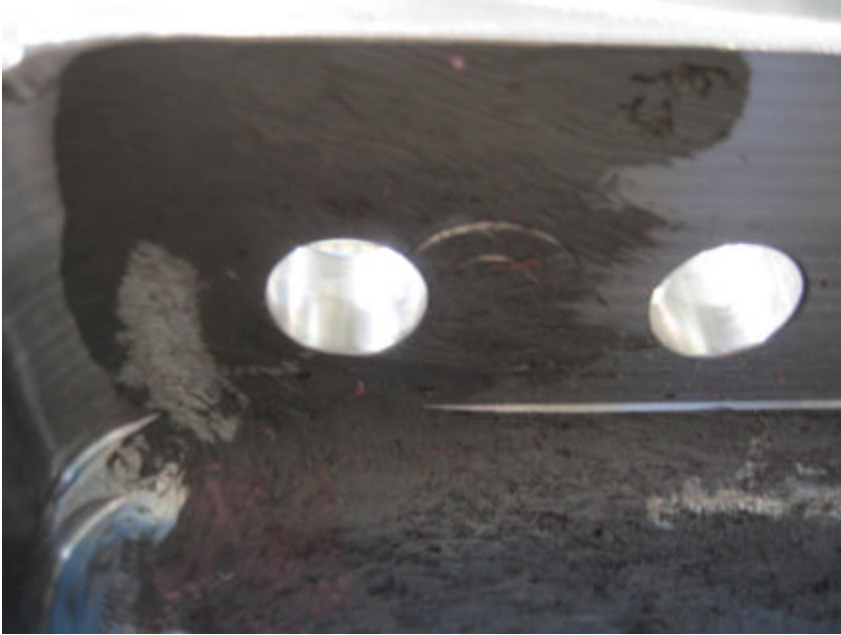
Noncleanup of foot on back side of D flange.JPG

This area is beneath the leg shown on sheet 4, zone C5. Instead of the 2.38" spot face on the back side, we typically machine this entire surface to a full cleanup. The two holes in this view do not have a 100% cleanup. The photo below shows that the flange thickness in this area is approximately 1.100" in the thinnest cross section.

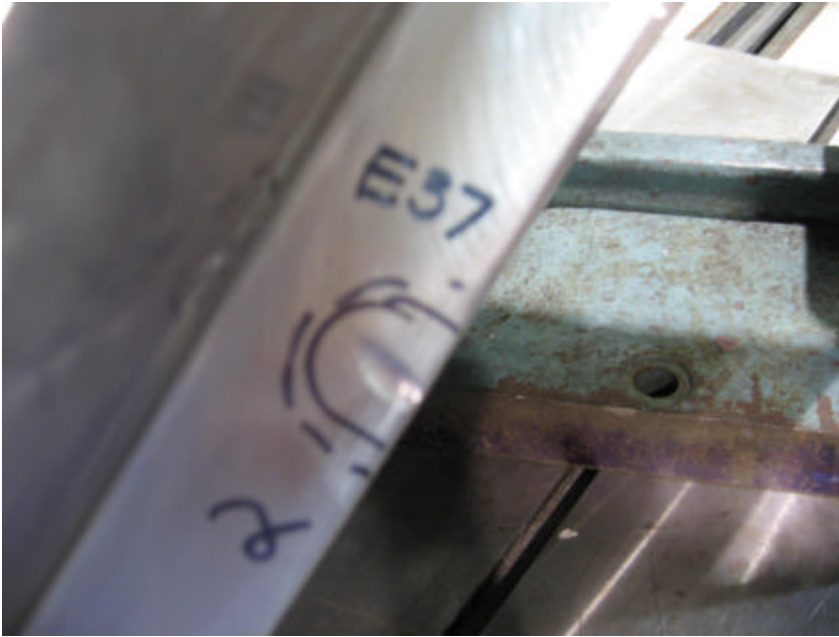
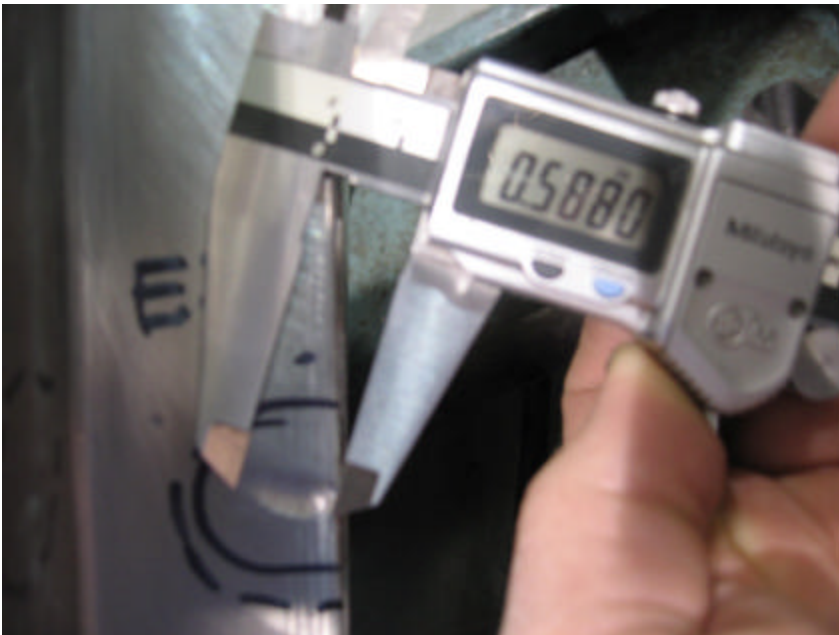
Tool Gouge short leg E37 wide view.JPG

This is a tooling gouge on the short leg of the “T” on the E flange side located close to hole 37. The gouge is approximately .590” in length by .200” wide and .005” in depth.

Tool Gouge short leg E side adjacent to hole 37.JPG

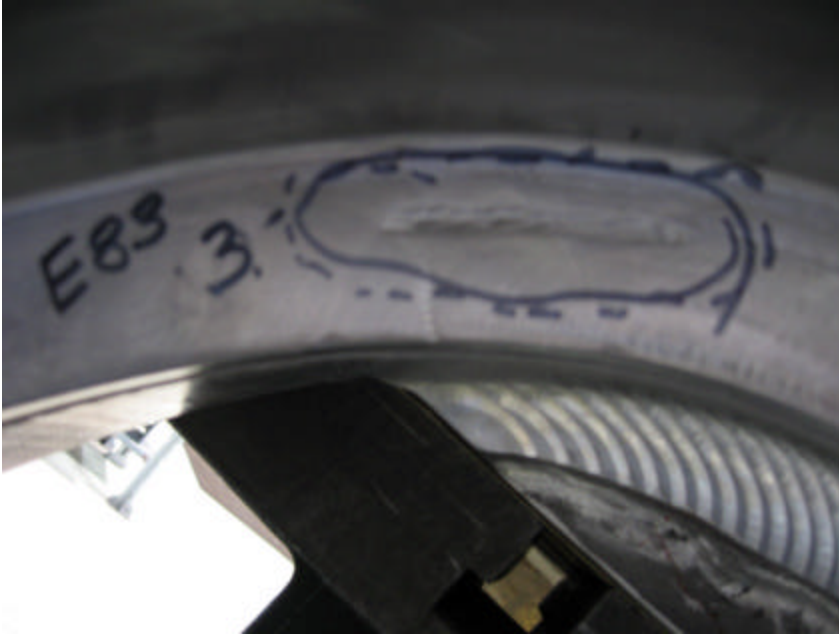
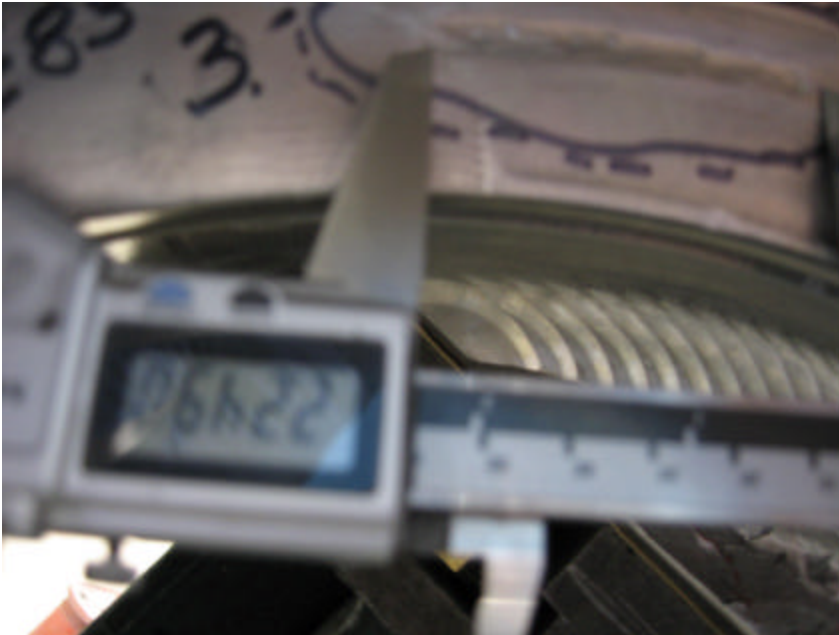
Tooling Gouge short leg E83 wide veiw.JPG

This is a tooling gouge on the short leg of the "T" on the E flange side located close to hole 83. The gouge is approximately 2.200" in length by .200" wide and .008" in depth.

Tooling Gouge short leg E side adjacnet to hole 83.JPG

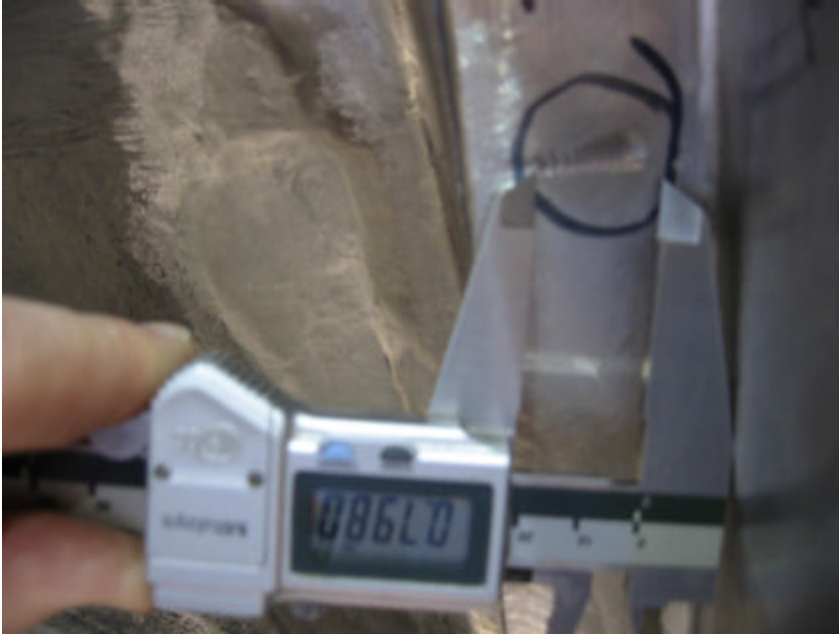
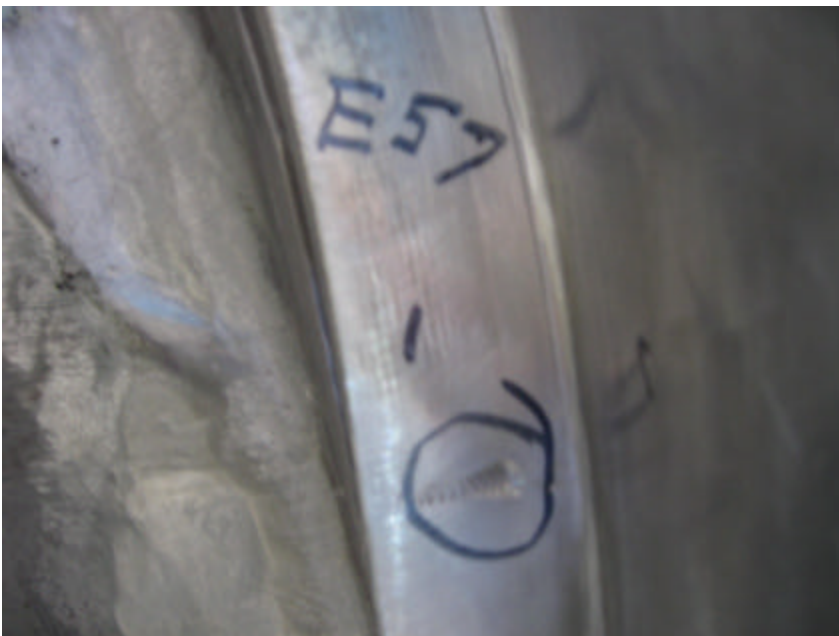
Tool Gouge short leg E side adjacent to hole 57.JPG

This is a tooling gouge on the short leg of the “T” on the E flange side located close to hole 57. The gouge is approximately .800” in length by .200” wide and .010” in depth.

Tool Gouge short leg E57 wide view.JPG

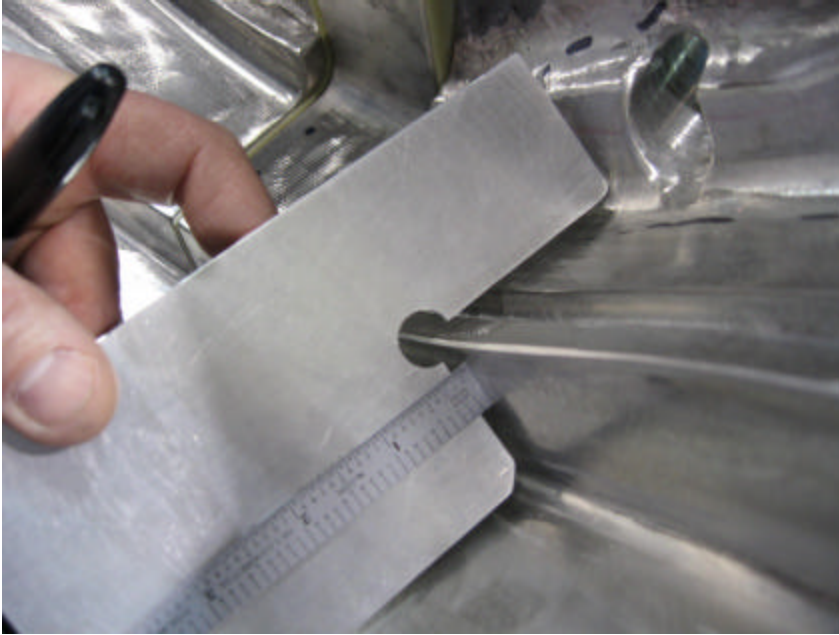
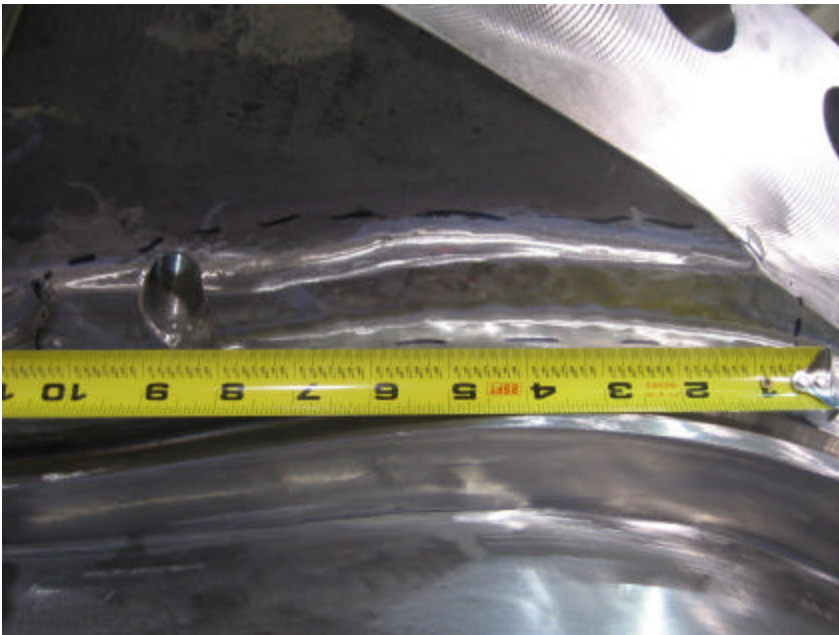
D side interference below VPI groove location 1.JPG

These pictures show the interference below the VPI groove located adjacent to poloidal break on the D side from hole 11 to 13. The interference to the gage is approximately .100" - .200" over a length of about 10".

D side interference below VPI groove location 1 wide view.JPG

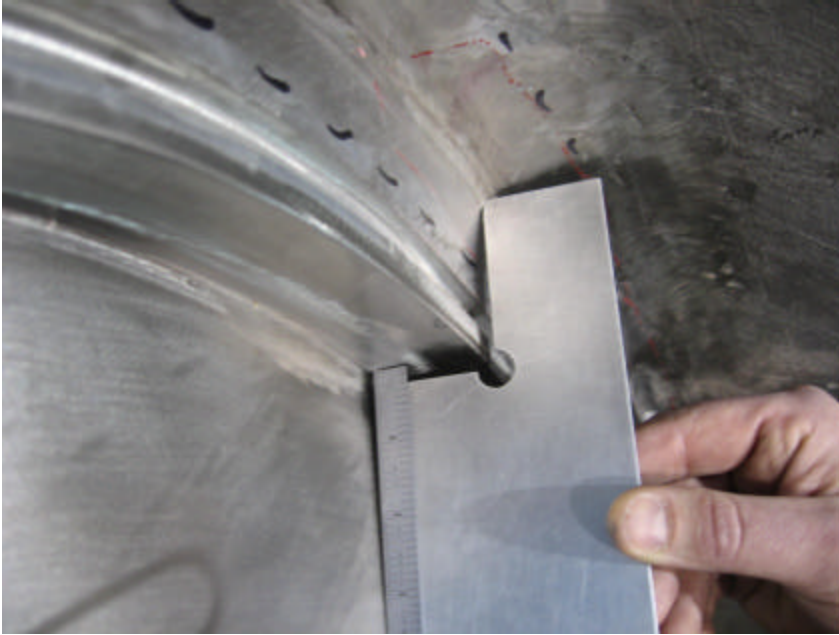
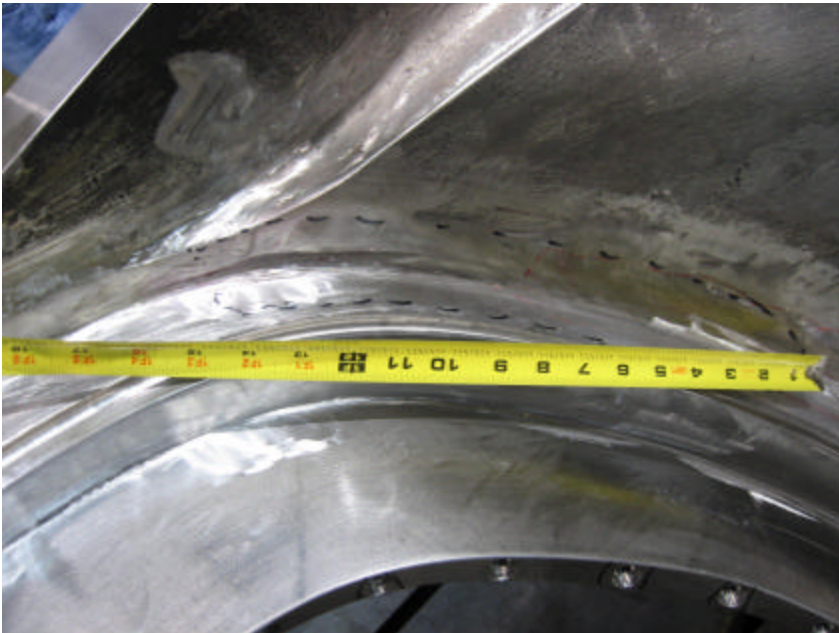
D side interference below VPI groove location 2.JPG

These pictures show the interference below the VPI groove located on the D side from hole 45 to 50. The interference to the gage is approximately .200" - .300" over a length of about 15".

D side interference below VPI groove location 2 wide view.JPG

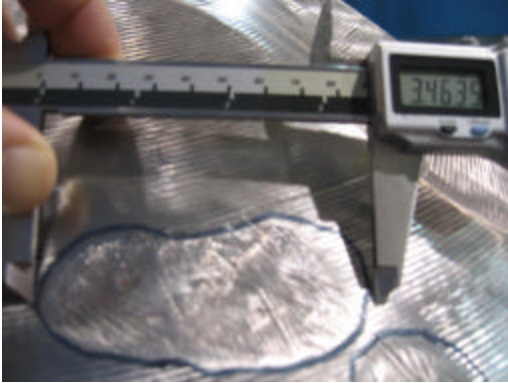
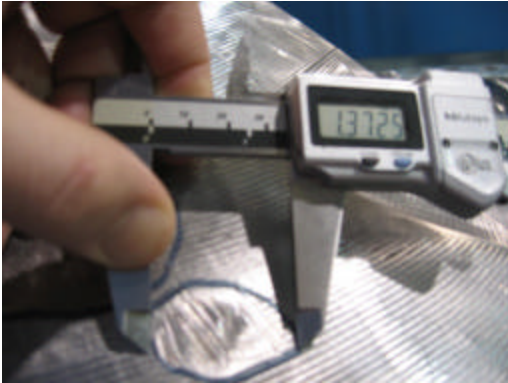
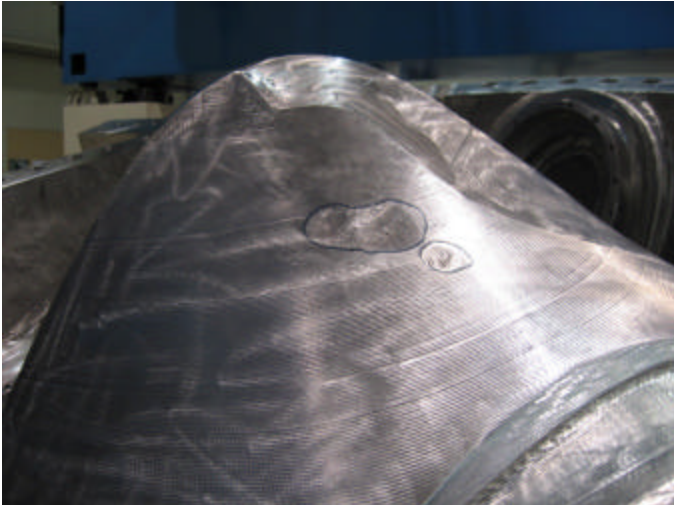
Casting noncleanup on D side large wing.JPG

Casting noncleanup on D side large wing 2.JPG

Casting noncleanup D side large wing wide view.JPG

The above pictures show noncleanup after final machining on the large flange of the D side. The depths are approximately .02 - .04".

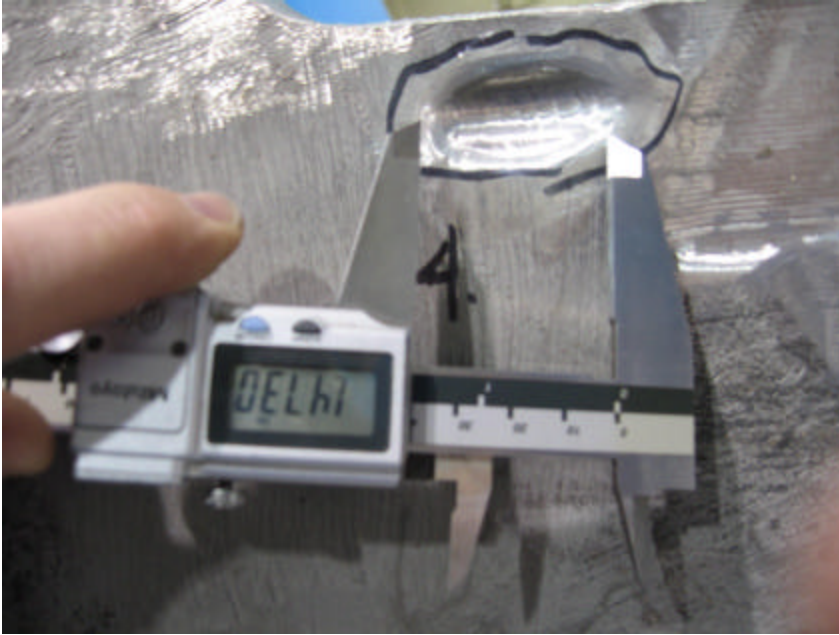
Tool Gouge in cast wall D side section PT11 sheet 7.JPG

This photo shows a tooling gouge in the cast wall located below the 6.5" opening shown on sheet 7 section view PT11. Gouge is approximately 1.470" x .800. The casting wall in this area measures 1.3". The gouge is approximately .25" in depth.
