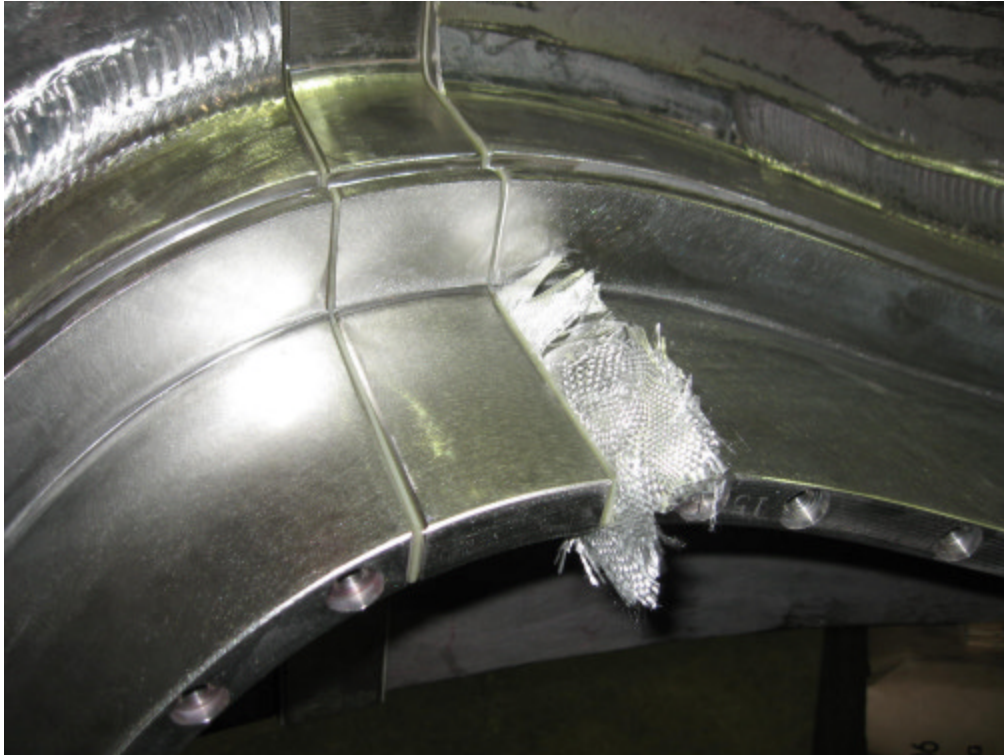
One side of the $\frac{3}{4}$ " section of T accepted a .018" shim. The maximum allowable gap is .005". This area was repaired using fiberglass filler and now a .005" shim will not pass through this area.
