**SUBJECT: Subcontract S005242-F for NCSX Modular Coil Winding Forms  
PPPL Non-Conformance Report (NCR) 3684**

Attached *for information* is dispositioned Princeton Plasma Physics Laboratory (PPPL) Non-Conformance Report 3684, dated 30 November 2006 titled NCSX – Modular Coil Winding Forms.

<b>Status</b>	5 - Corrective Action Needed	<b>Trend</b>	01-Deviation From Doc/Proc
<b>Department</b>	NCSX	<b>Division</b>	WBS 141
<b>Source/Org</b>	VENDOR		
<b>Item Dwg/Part#</b>	SE141-114, r8 - MCWF A-4	<b>Procurement #</b>	S005242-F
		<b>Cost Center</b>	9450 1*** 1404
<b>RAP#</b>	3209	<b>Job Doc #</b>	S005242-F
		<b>Vendor</b>	Energy Industries of Ohio
<b>RAP Title</b>	NCSX - Modular Coil Winding Forms

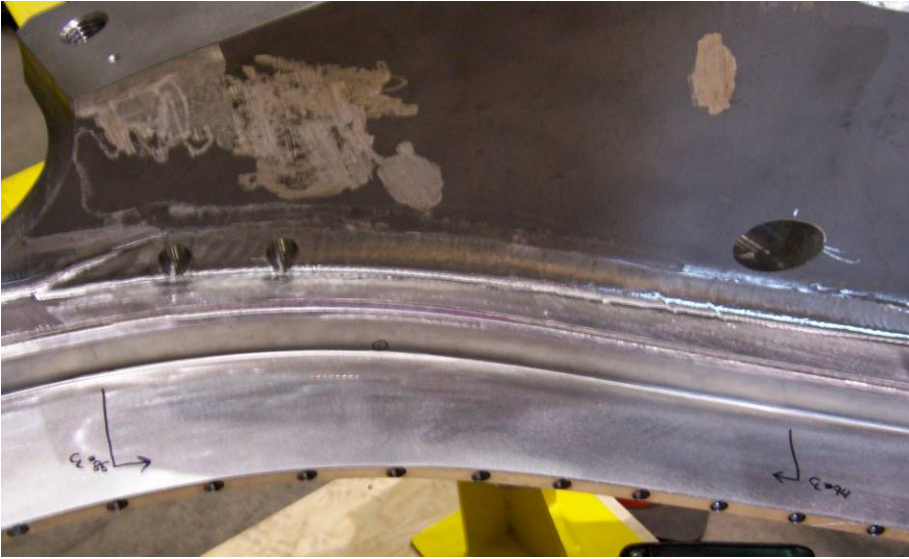
MCWF A-4 shows the following conditions (photos attached) exceeding the tolerances of SE141-114, R8:  
 1) Between Holes #86 to #94 the legs of the Tee (septum) have a step down area that dips, on the long leg, .008" to .028" from the flat portion of the leg. MTM's measurements of the long leg in this area show it .002" to .003" above nominal, so the "gully" ranges from .010", just at the upper limit of the tolerance of .020" profile equally distributed bilaterally (+/- .010"), to as much as .020" below that tolerance. There is a similar, though more shallow, "gully" on the short leg.  
 2) Between Holes #48 & #52 the radius between the long and short legs of the Tee exceeds the specified .11" +/- .01".

This photo shows the location - between Holes #86 to #94 on the side of the casting facing up on the shipping skid.

Note in both photos the shadow along the base of the tee. This is step, readily detected by hand, from the flat of the tee down toward the radius.

The "gully" areas should be filled in with CTD 540 epoxy / glass bead to provide an even surface and support for the winding. This condition will be discussed with EIO/MTM during the next Quality call to avoid this condition with future castings.

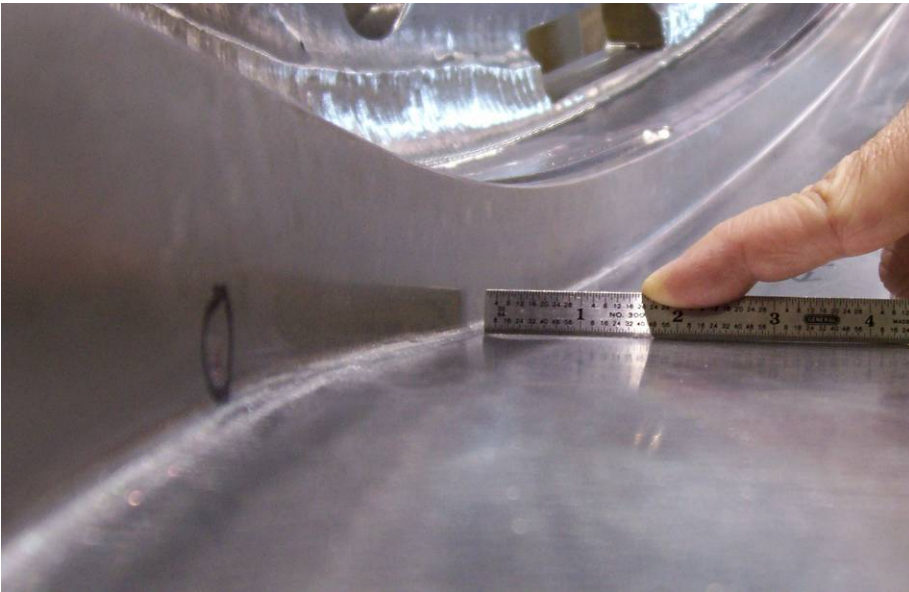
The next one shows a straight edge reference.

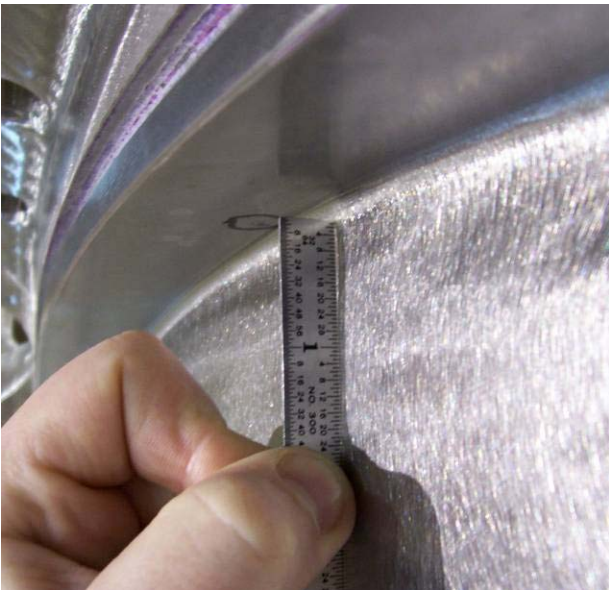
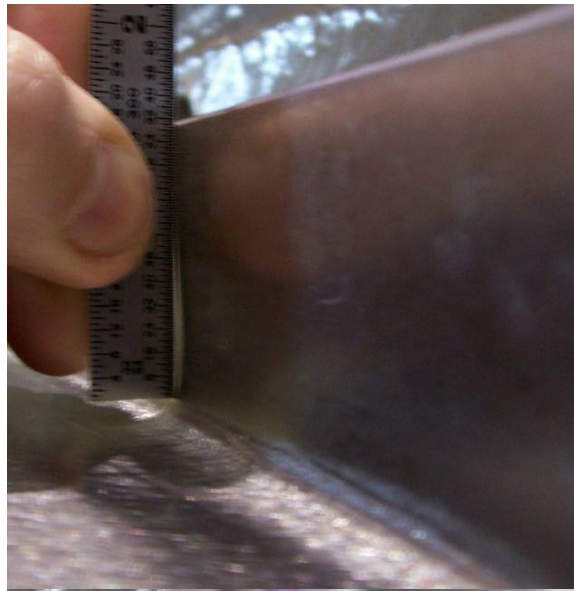
More shots of the straight edge on the long and short legs of the tee.

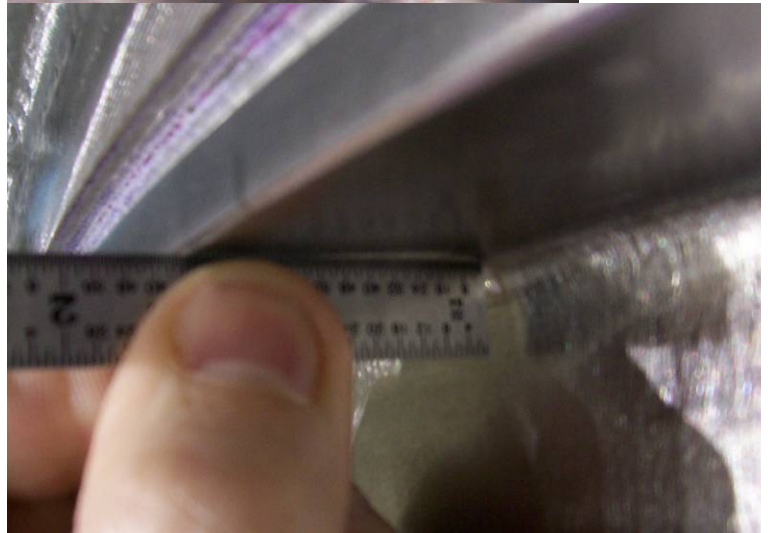
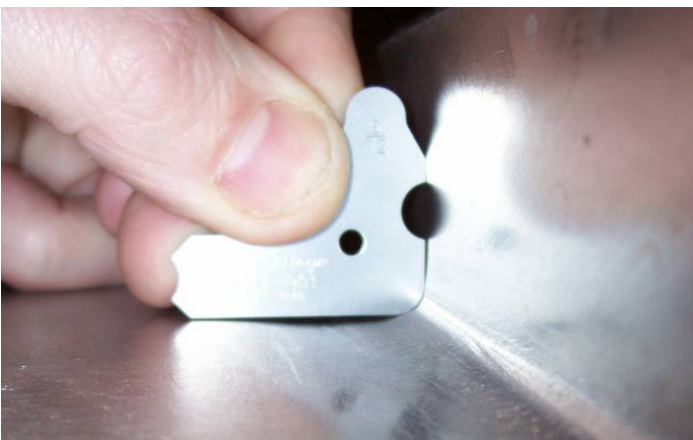
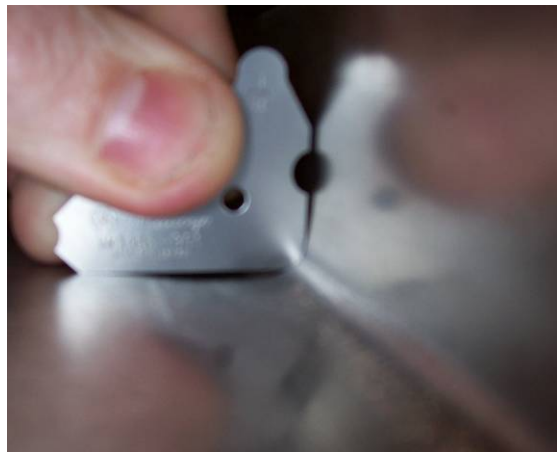
The first photo shows a 5/32" gauge. The second is the required 1/8" radius gauge

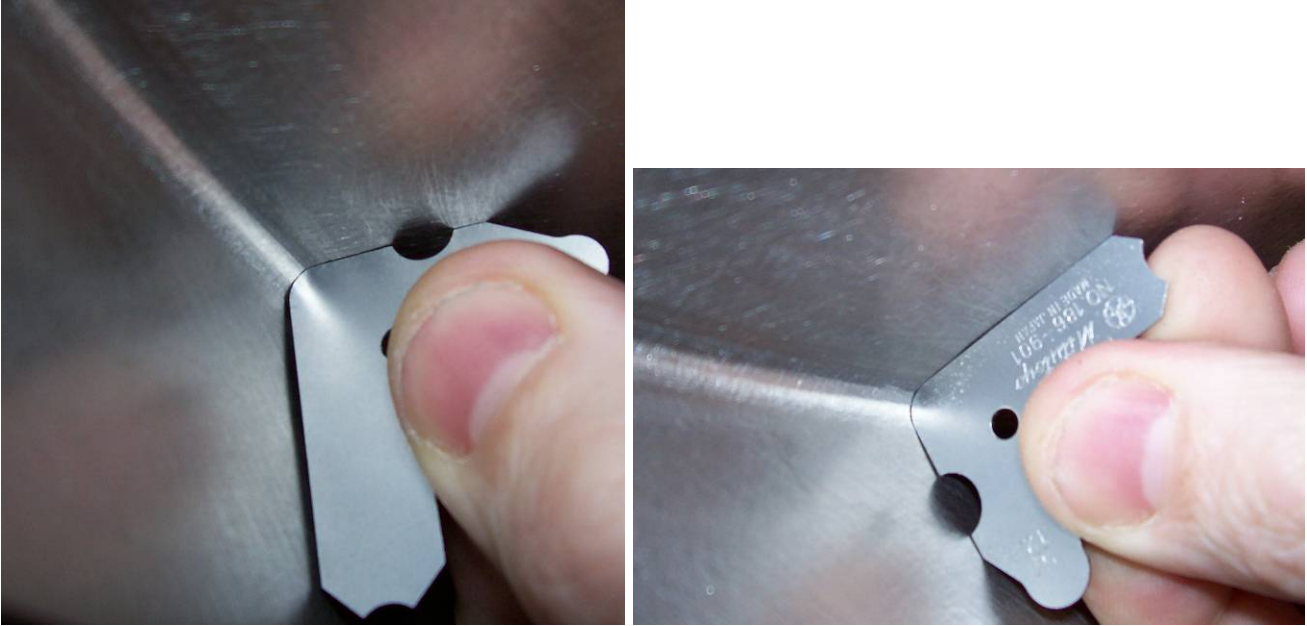
These photos show a short area, between holes #48 & #52 on the bottom side (as-shipped) of the casting, where the radius did not pass the gage check.

The first shows the required 1/8" gage and the second shows the next size bigger 5/32" gage.
