Lead Block Slot Condition

B1 and B2

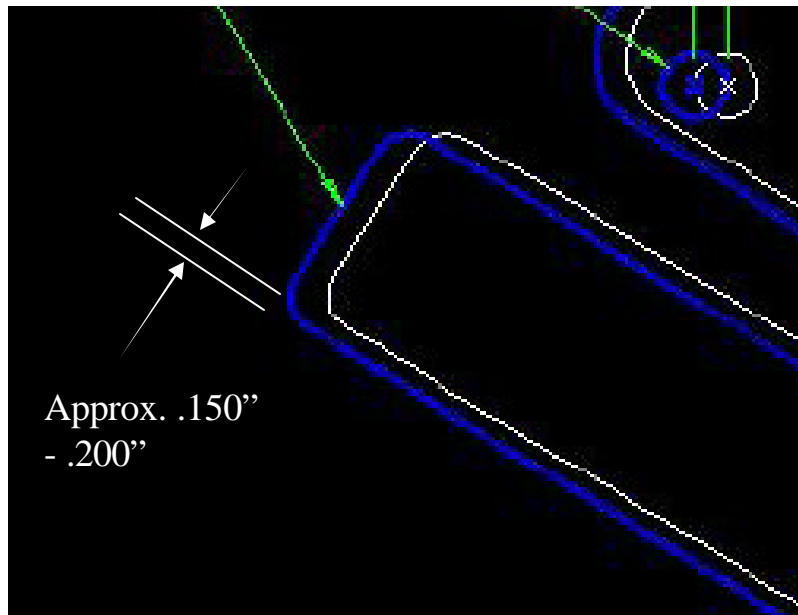
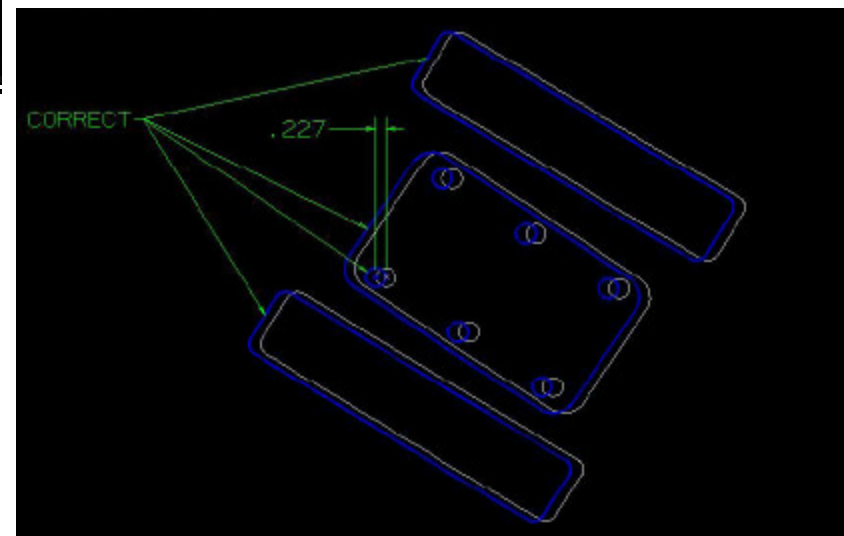
The slots are off approximately .150" to .200" along the long side and .175 to .225" along the short side.

The face of the pad on B2 has been machined to the correct thickness which required approx. .5" of material removal.

B1 still has the additional .5" of stock.

- Assuming that the out of tolerance conditions would functionally be acceptable, MTM proposes that B1 remain unchanged.

- Correct the location of the lead block slots and holes. This would move the holes onto the surface of the pad which would eliminate the need for the earlier proposed filler block. The slots would then have the condition described on page 2.

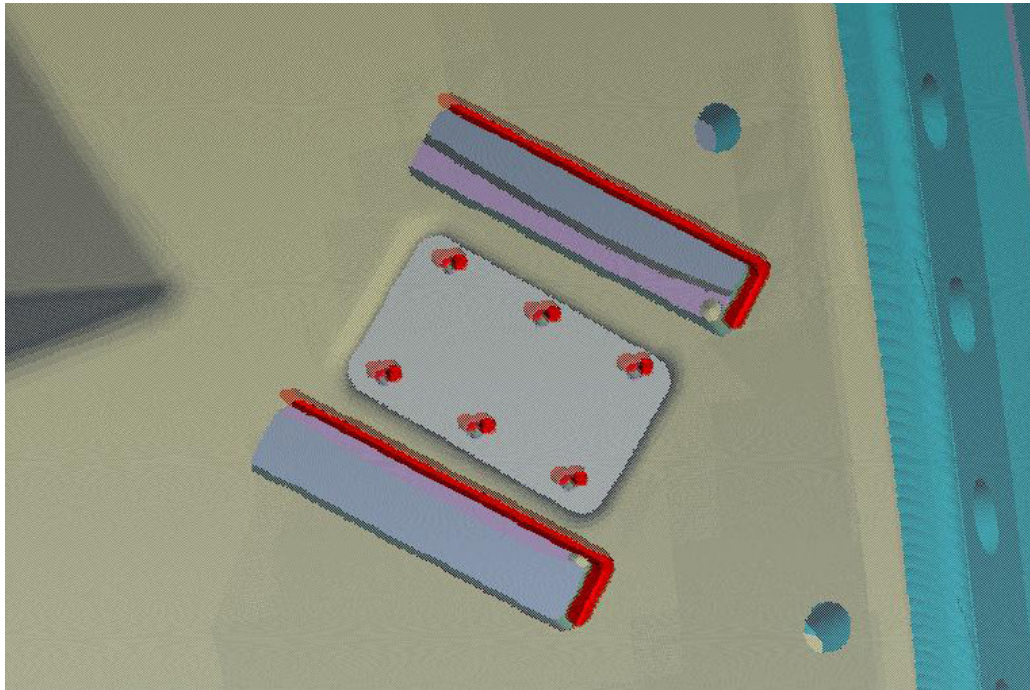
The red color around the slots would represent areas that are presently machined that would be outside of the slot tolerance if the slots are moved to their correct location.
