Corrective Action 1538
Carondelet Division
Corrective Action Type NCR
Date 1-13-06 Revised 2-28-06
CA Originator C. Ruud
Applies to: B-1 Coil

Areas of Note

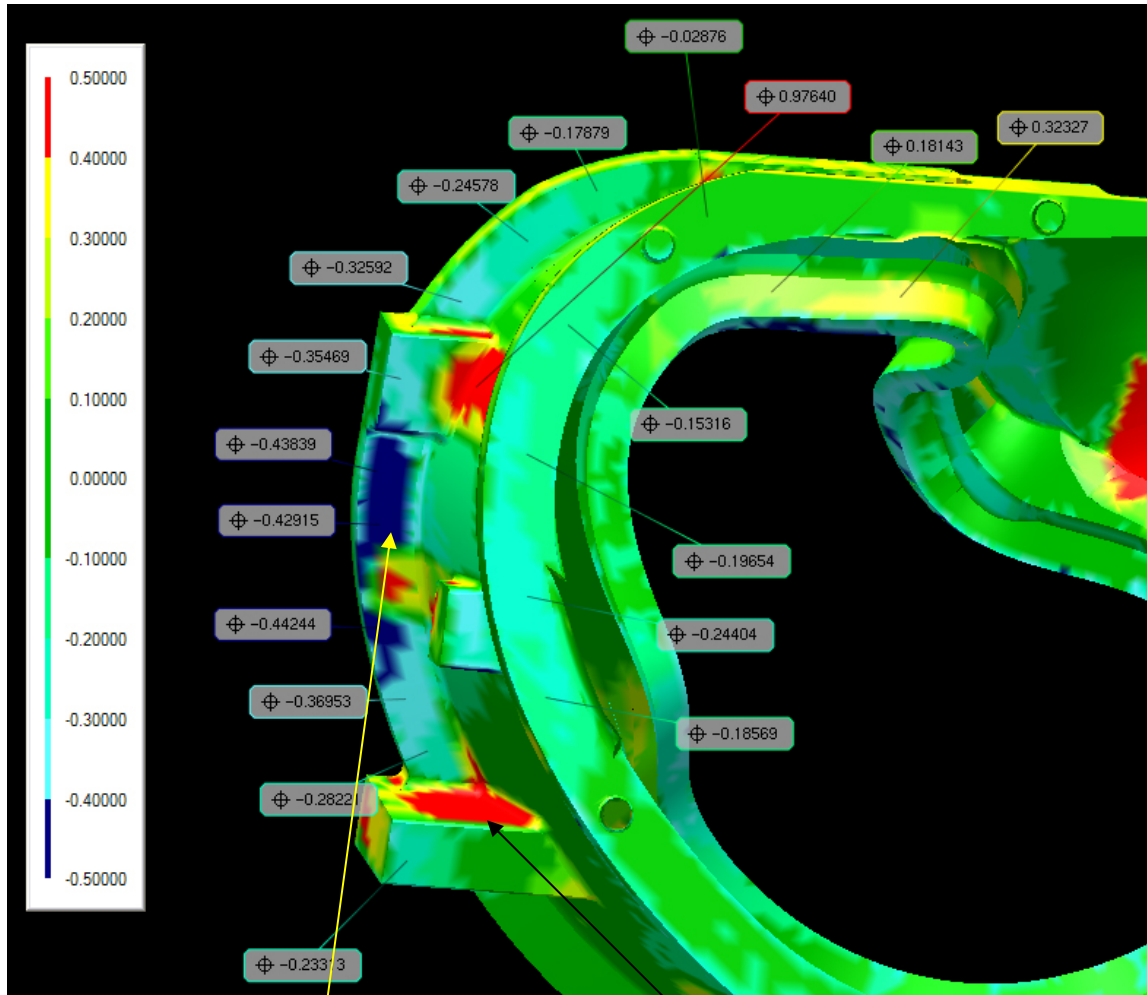
Area 1:

An area on the back-side of the cope flange is showing a surface profile approximately 7/16" below expected. This area will be addressed for Coil B-2 by adding approximately 7/16" stock into this area in corebox #9. On B-1 we will build up this area by welding. The opposite side will require additional machining to remove the excess.

The red area on the side of the ear is not a riser pad or any other expected condition. This will need to be further analyzed with our scan

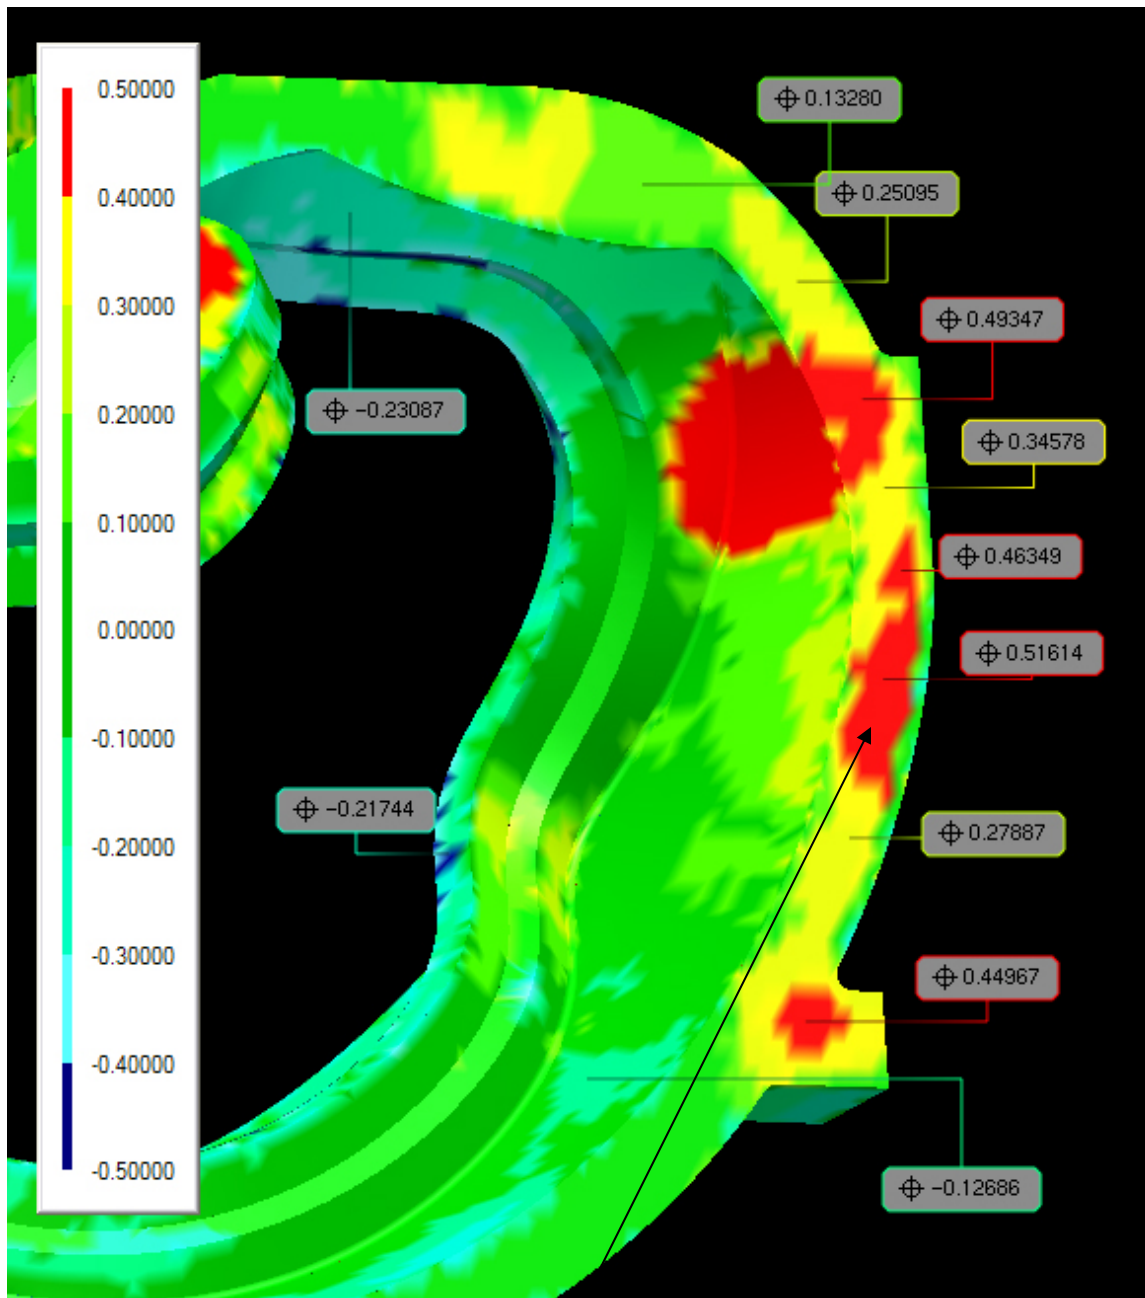
Area 2:

This area is on the opposite side of the flange of Area 1, but cannot be immediately related to Area 1. A riser sits directly over this spot and the excess stock could be a result of the riser contact not being cut down flush to the flange. At this point, as planned, all of the riser contact areas show the same excess stock condition. They will be worked down closer to the intended flange surface later in the process.

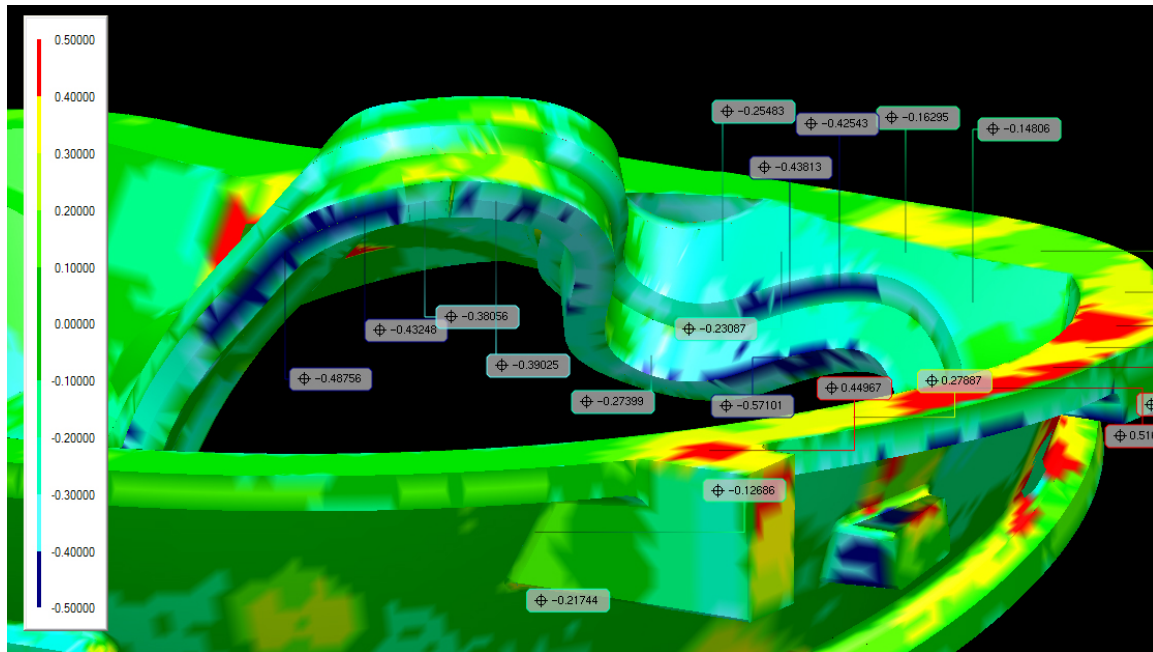
Area 3:

There are a few areas around the race track that display a loss of machine stock anywhere from 3/8" to 9/16". There was 1" machine stock planned in this area, so stock still remains, but the tooling will be inspected for flaws and repaired as needed.

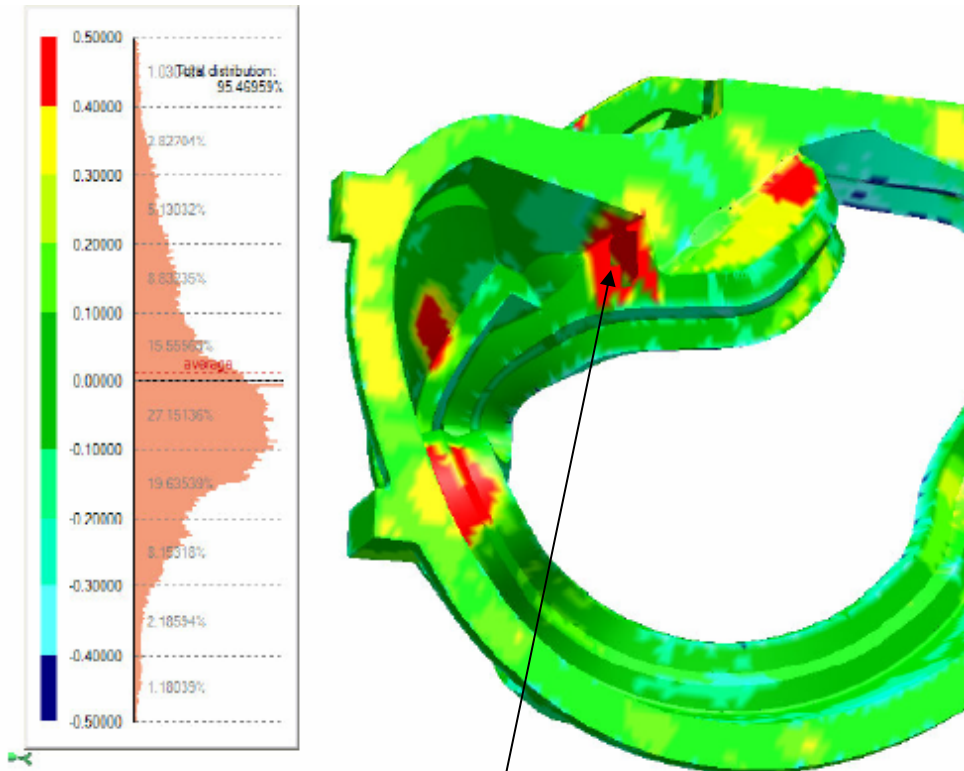
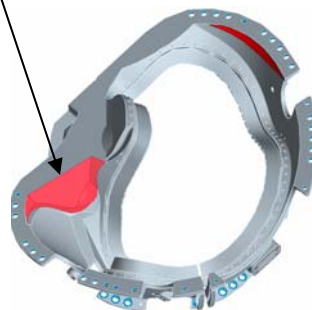
Area 5:

This wing area interface contains a riser pad that will require removal. The rest of the interface seems to be within a +/- 0.2" profile, but due to the color scheme used I cannot tell if it tends toward the plus or minus side of that tolerance. Our layout scan will be clearer in this regard.

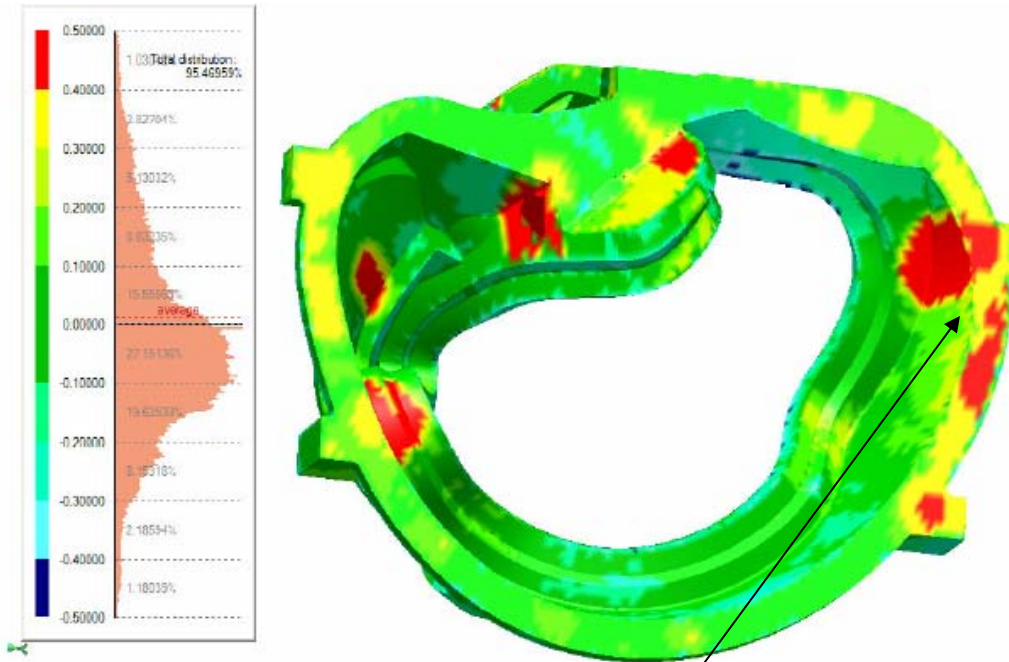
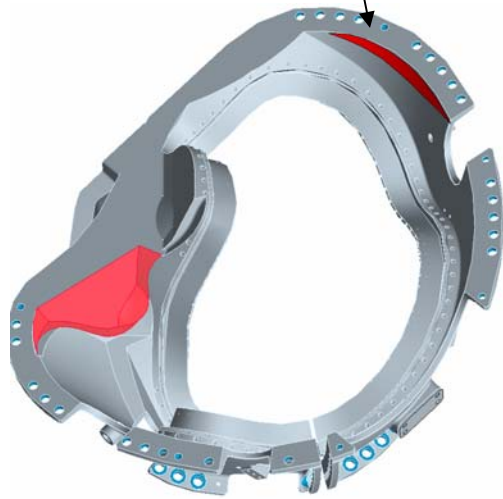
Area 6:

The narrow wing interface here is partially covered by a riser contact that will require removal. The balance of the area is 0.2-0.4" above the intended profile and will require material to be removed.

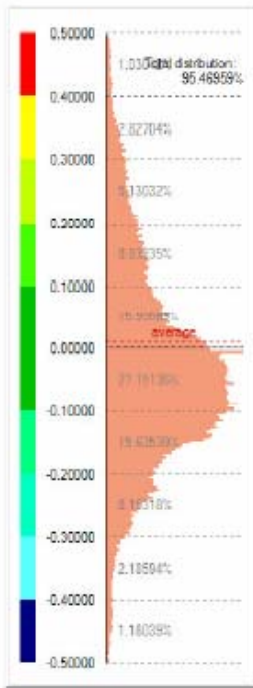
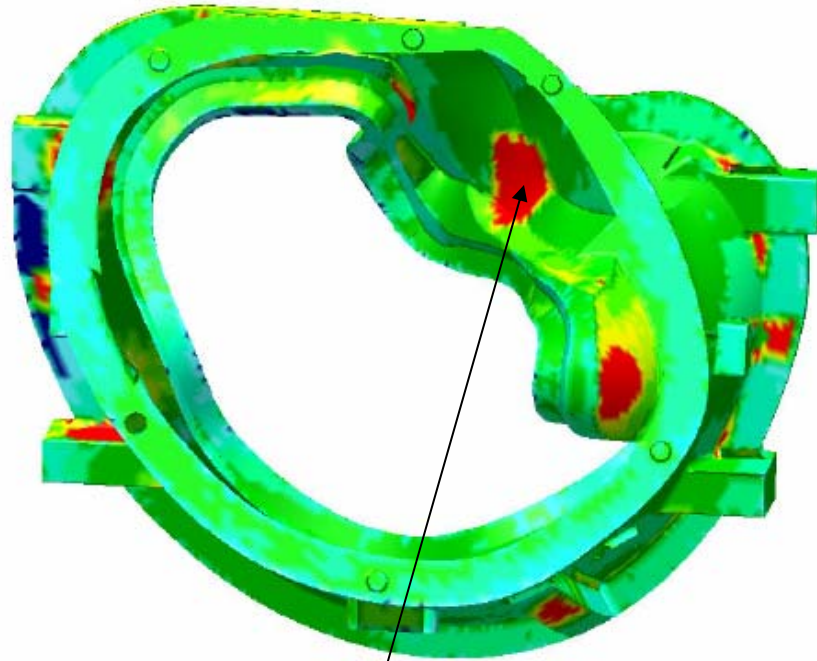
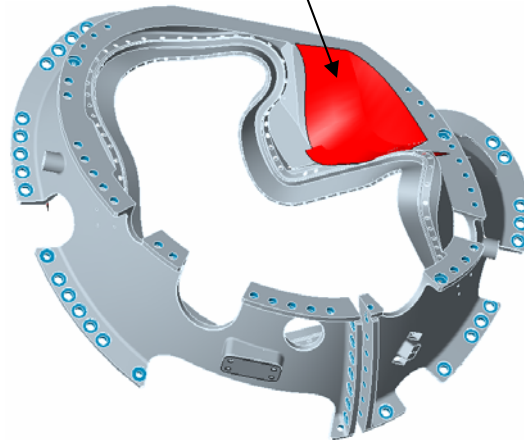
Area 7:

This wing area interface contains a riser pad that will require removal. The balance of the area is contained within the +/- 0.2" tolerance band, but once again due to the color scheme, I am not able to discern which side of the tolerance the part tends toward. Our scan will show this clearly.
