Part: SE141-116 / MODULAR COIL WINDING FORM TYPE

Drawing ID: SE141-116 Revision: 8

65707/5 (C5)
SE141-116

Rapid response NCR disposition for MCWF C5

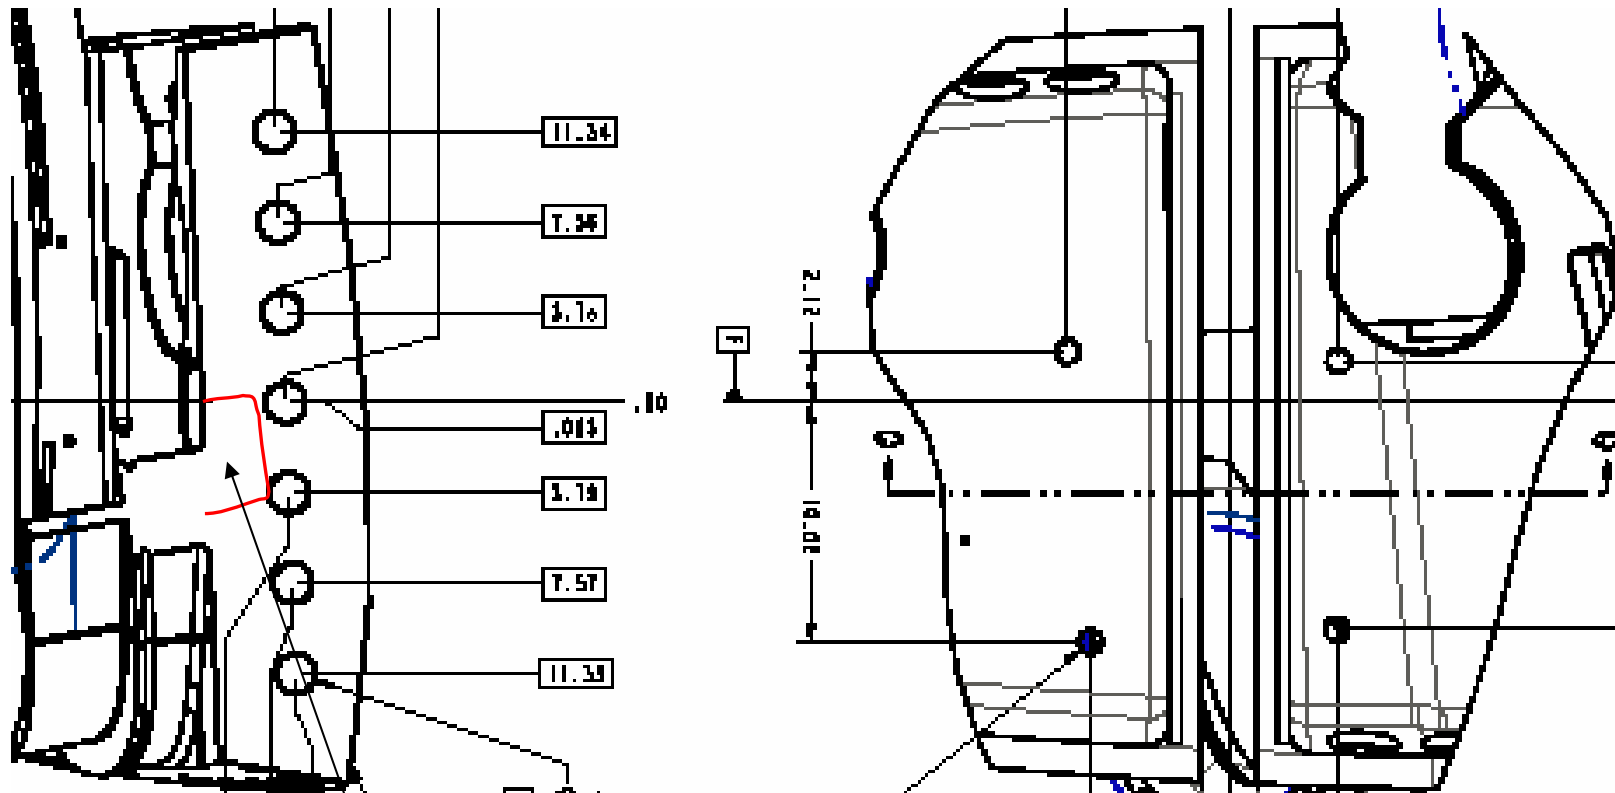
Outer portion of poloidal break between the poloidal break flanges was machined off of centerline approximately .100". The inner portion of the break (T section) was machined on location which caused a mismatch in the break surface.

MTM inadvertently undercut the surface of the T by 0.080 inches as shown in the following figure. A conference call attended by Ray Sheppard of EIO, Mike Griffith of MTM, David Williamson of ORNL, and Phil Heitzenroeder of PPPL was held at approximately 5:30 p.m. on 3/29/06 to discuss this and MTM's proposed resolution. The right hand figure shows their proposed repair, which is to machine the slot width to 2.350 inches rather than 2.250 inches. The cast shim plate will be machined to the 2.350 inch dimension to compensate. Mike Griffith noted that even with this increased slot width the break flange thicknesses will still be within tolerance. David and Phil agreed with this proposed repair. EIO will write this up as a formal NCR for formal disposition tomorrow.

Flange area of poloidal break finished machined .100" off location to this side.

The area of the T section inward including the area highlight in red has been undercut into this surface approximately .08". This area has been cut on location.

PROPOSED REPAIR
Machine the left side of the break above to the correct location per the drawing. This will blend into the area of the T that is currently undercut. Machine the T section on the right side of the break to match the flange surface that was cut off of location (approximately .100"). The slot width will finish at 2.350" rather than 2.250". In order to accommodate the oversized slot, the shim thickness will need to be machined to 2.225 rather than 2.125". The additional .100" of stock will be added to only one surface on the shim and profile machined accordingly (see picture on next page).
