Customer: ENERGY INDUSTRIES OF OHIO

Contact: NANCY HORTON
E-Mail: NKHFlowen@aol.com

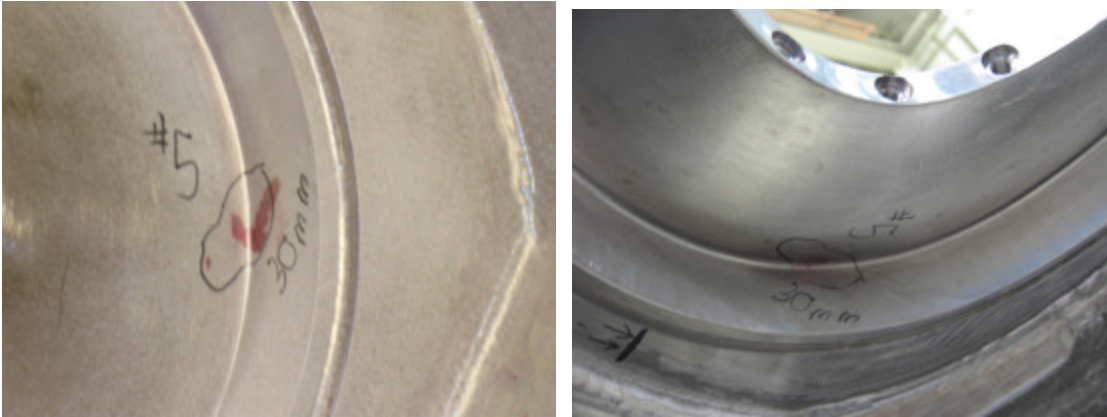
4. 1.2" linear located on D side beneath hole 28. This is the same area noted on the RT rejection for film 26-30.

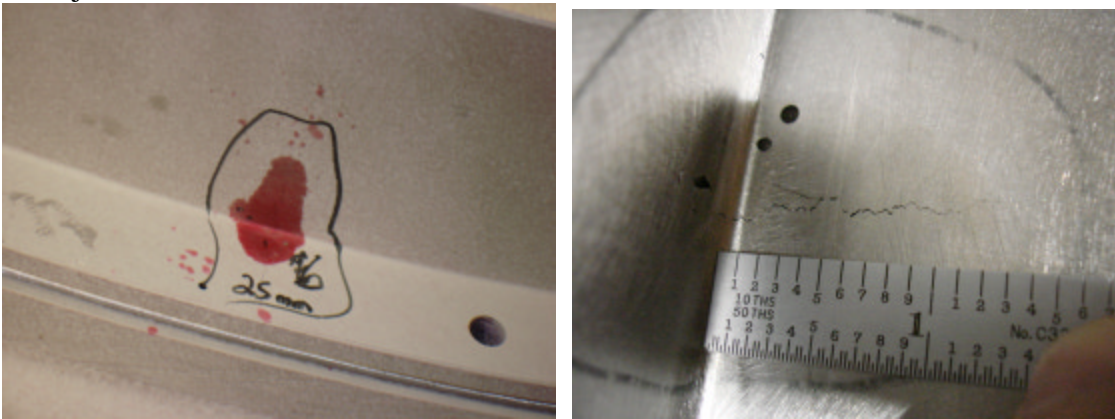
5. 2" linear indication on the long leg of T (D side) between holes 43 and 44. This indication is in the High Stress Region as identified in the CSPEC for the A castings. This is the same defect noted in RT shot 41 to 45.

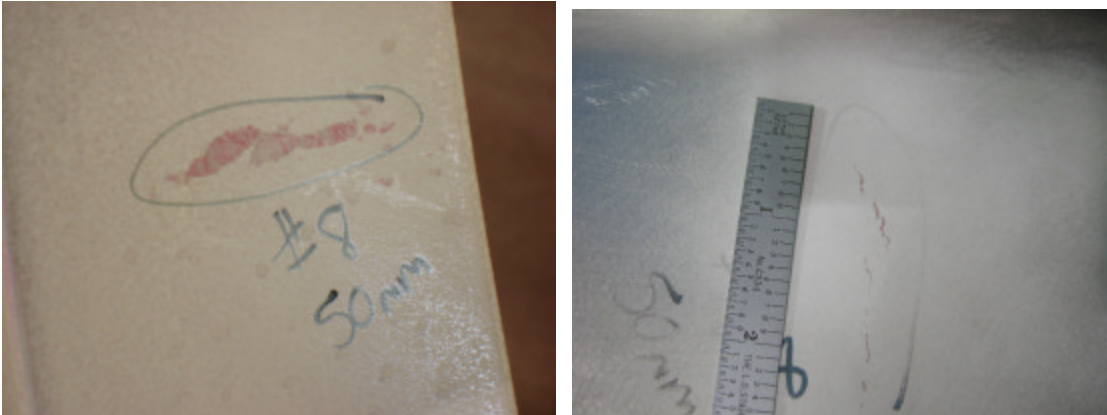
PT Inspection Results of A4 – NC20733
