**Part: SE141-114 / MODULAR COIL WINDING FORM TYPE**

Drawing ID: SE141-114                      Revision: 6  
Links: 1-Type:W: 65709/1.0 Sub: 1 Op: 50

Problem: Reference sheet 4, zone G7.

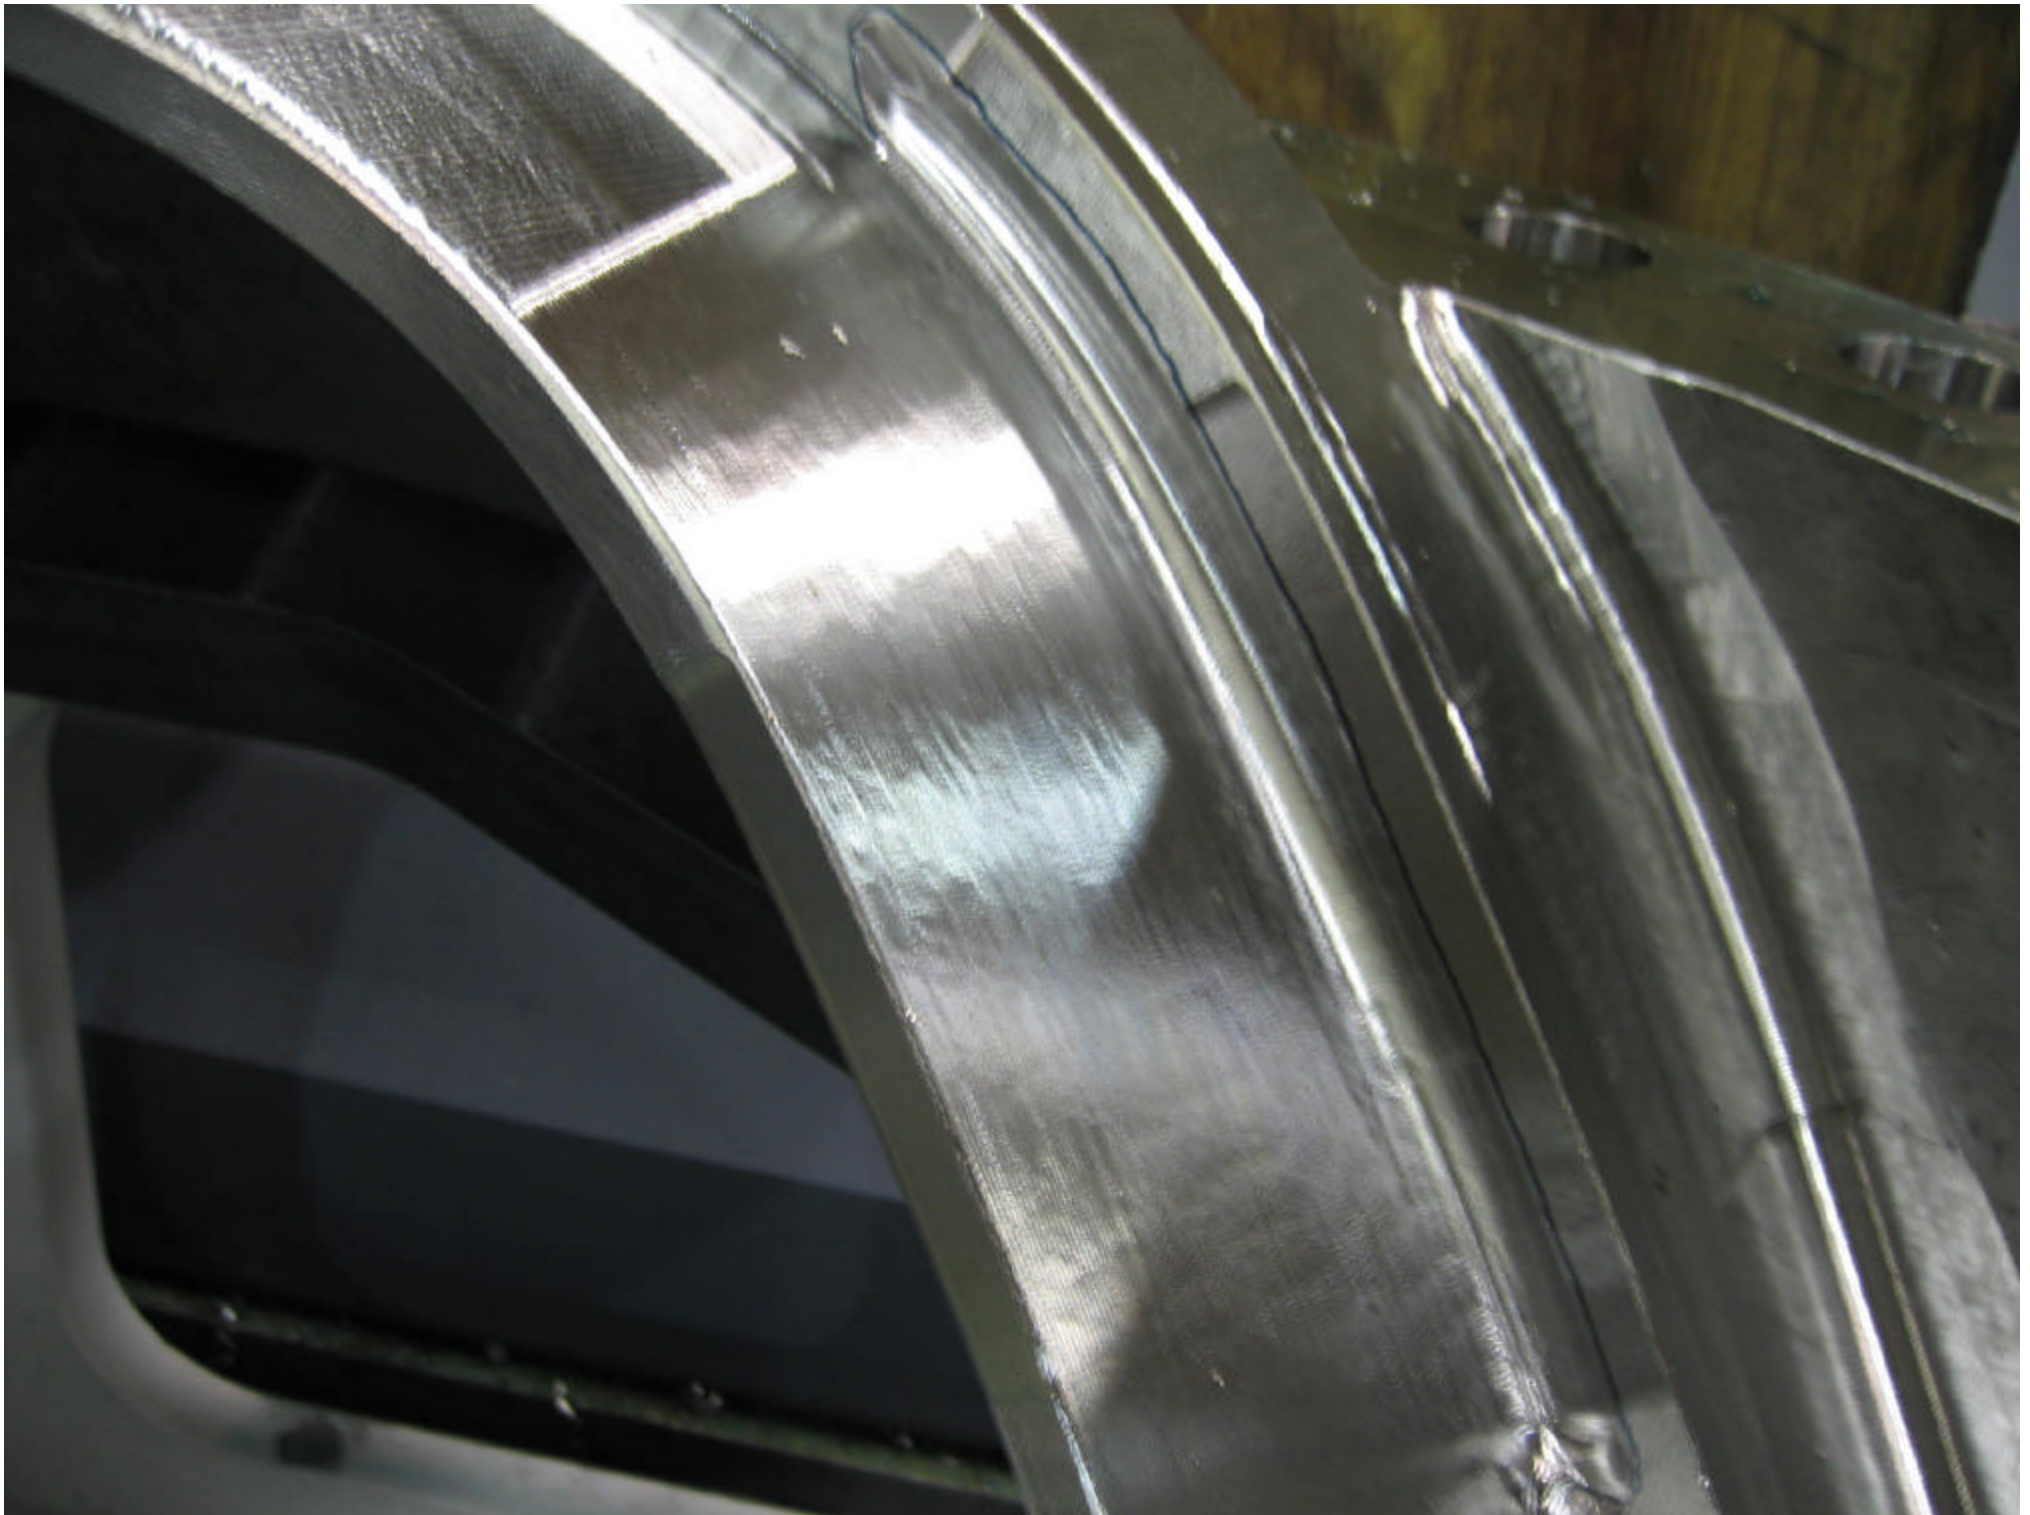
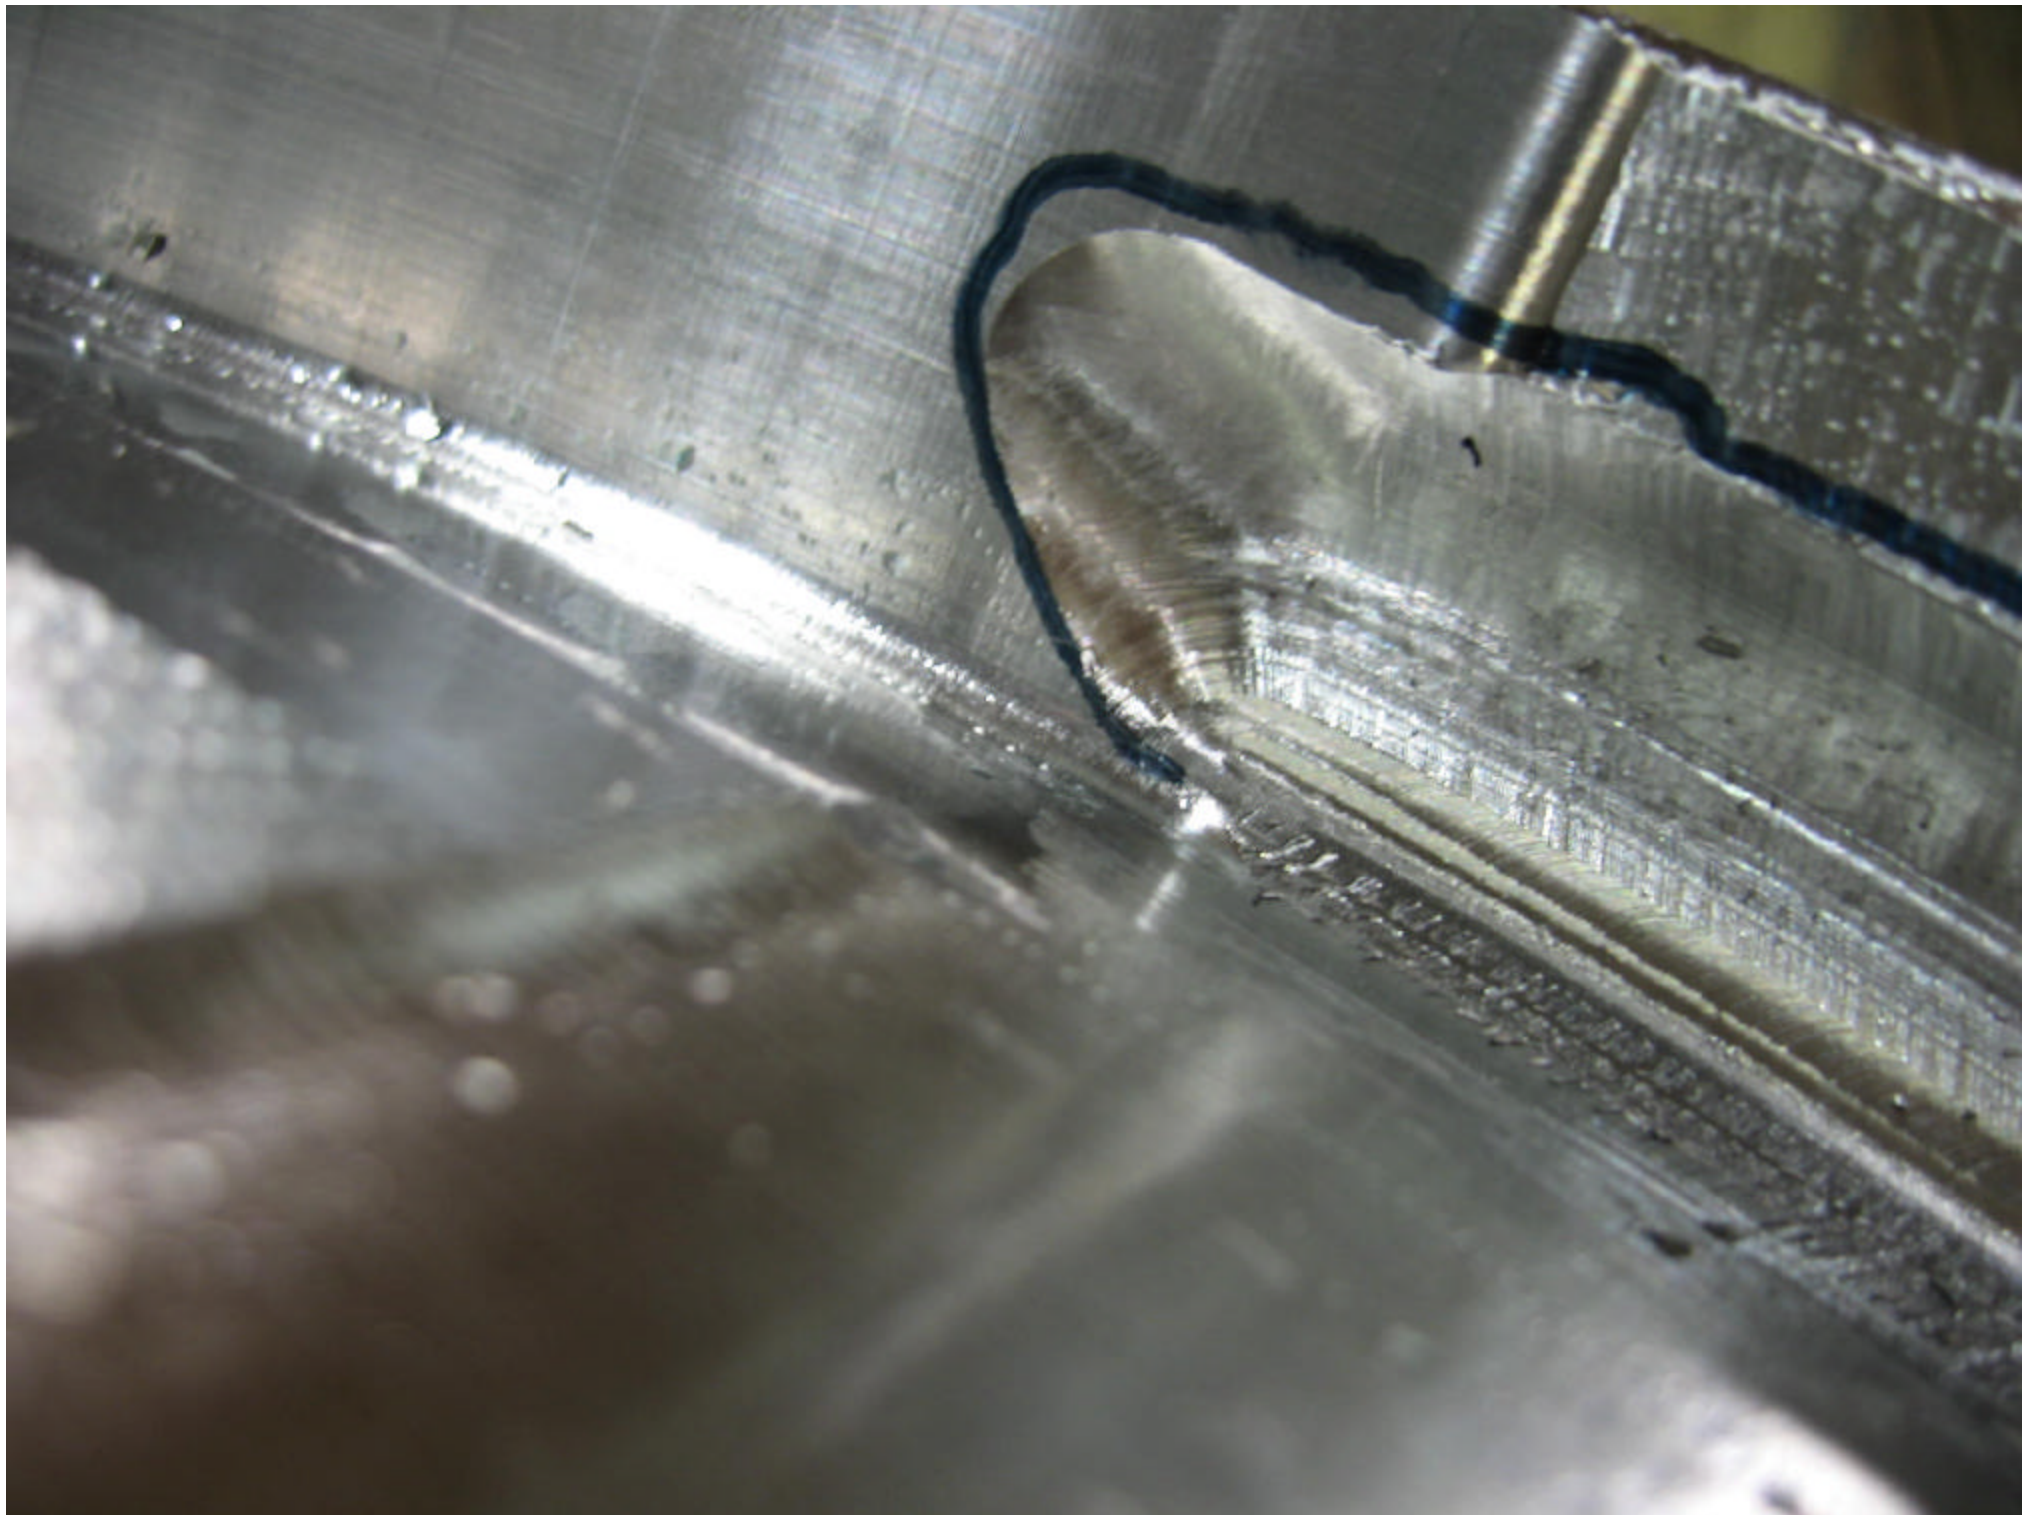
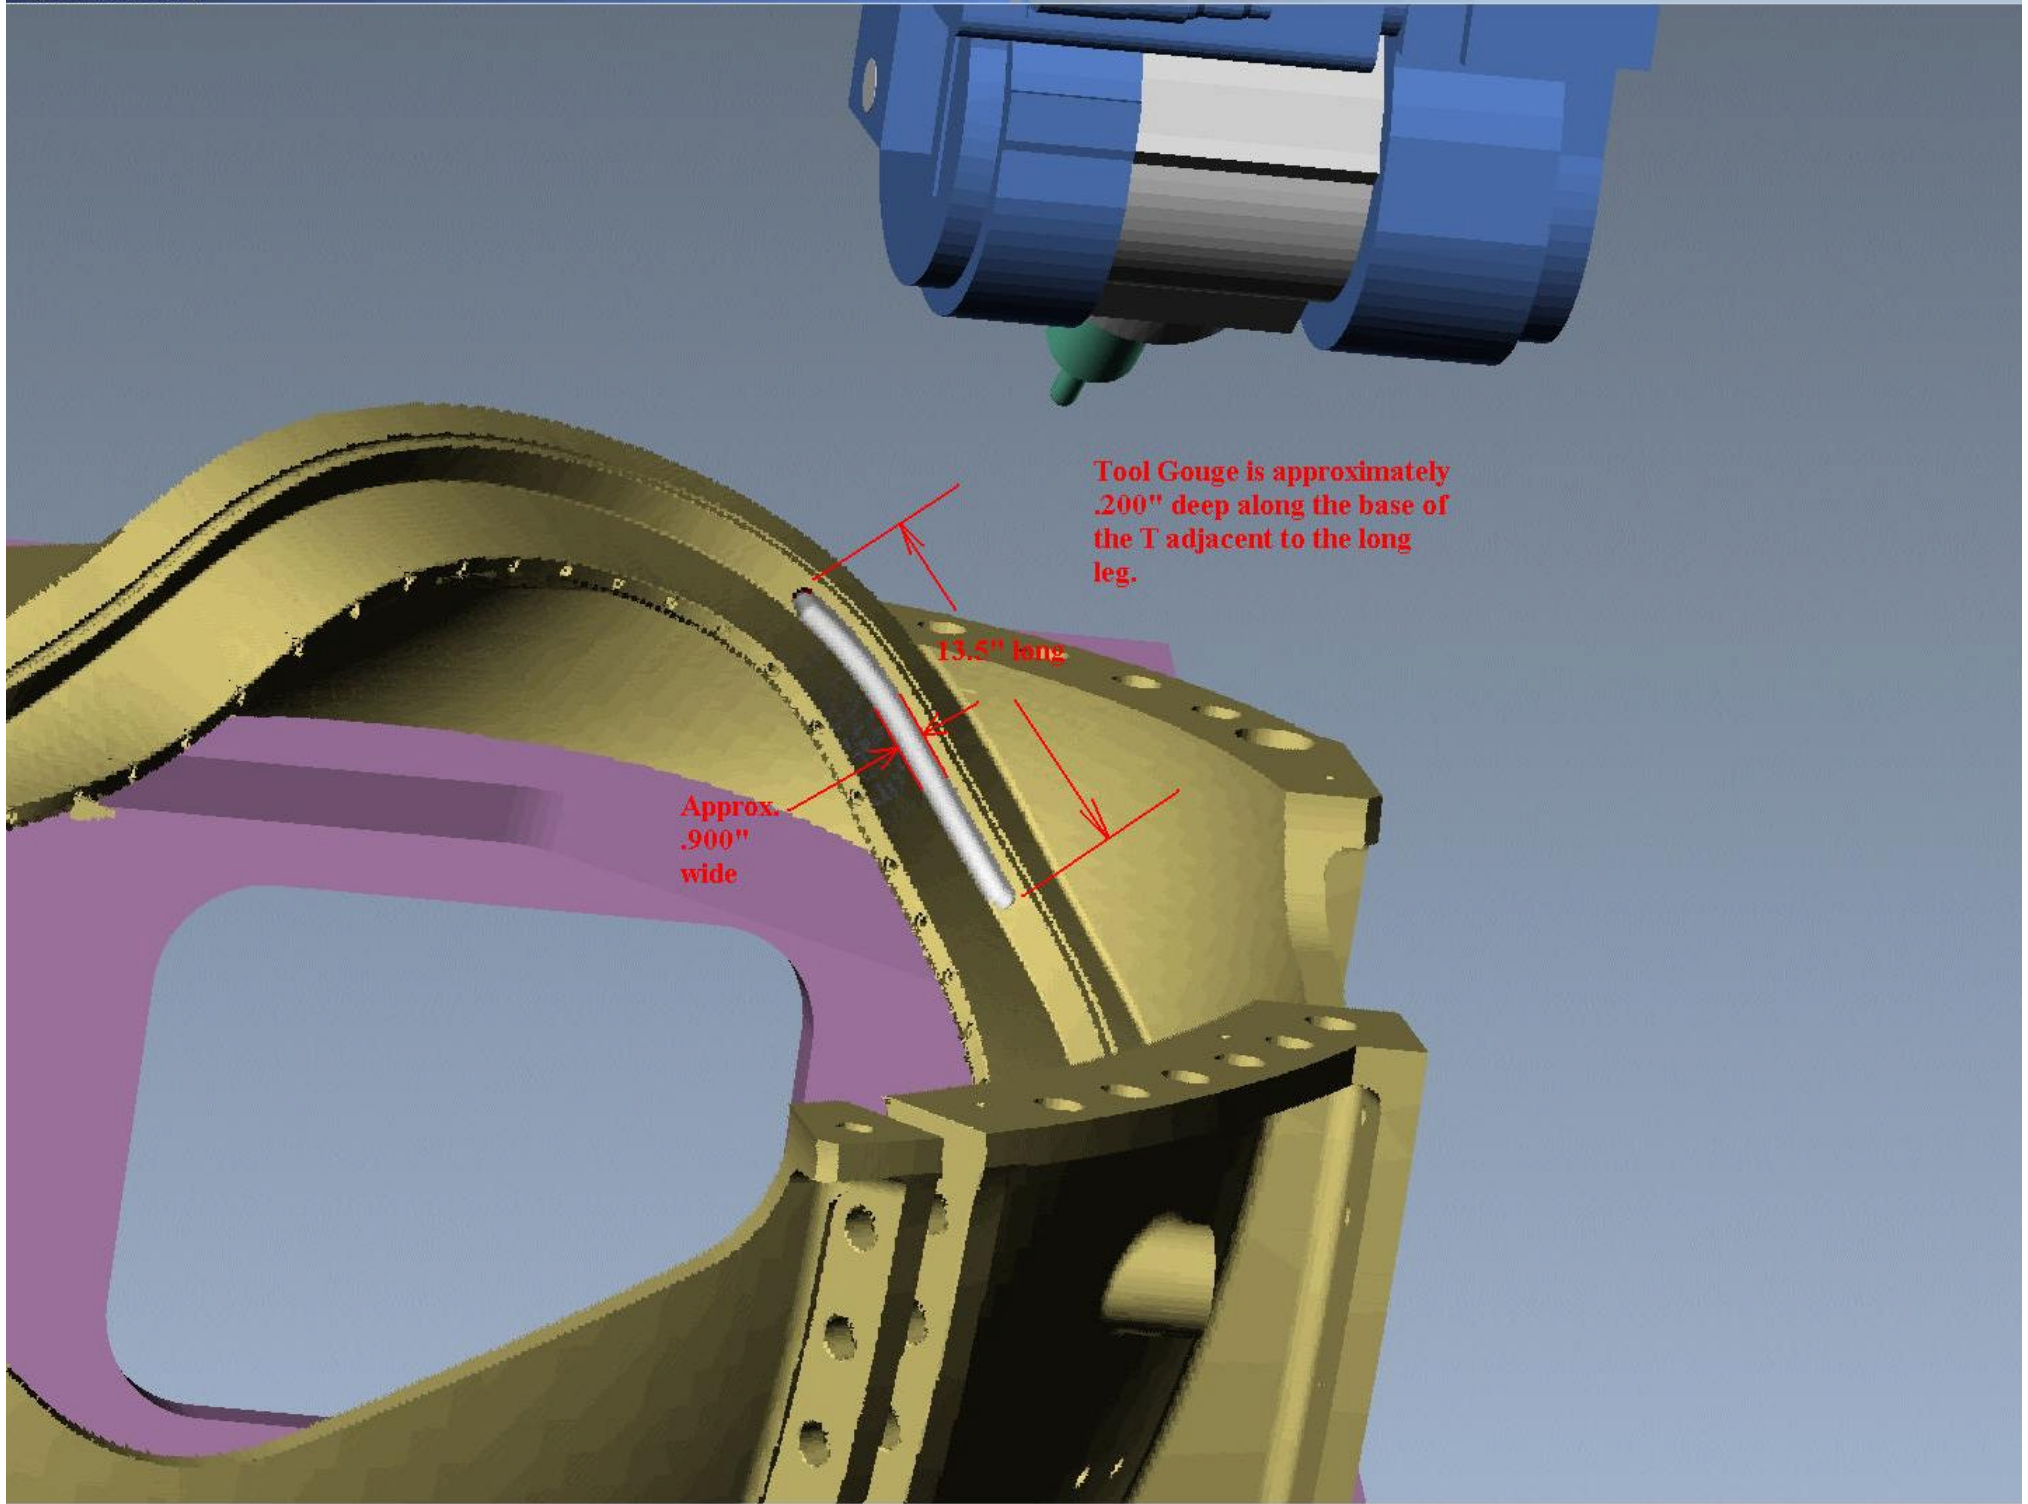
There is a tool gouge along the short leg of the T section on the Datum -D- side. The gouge is approximately 13.5" long, .900" wide and .200 deep. See attachments for clarification.

Description: There are 2 root causes here.

- 1) The tool gouged the wall because the toolpath was generated incorrectly. The check surface (back wall) was not selected and therefore the toolpath gouged the back wall.
- 2) The toolpath (n/c program 31501) was released as a good program because the verification did not show / flag an error of the toolpath violating the design model.

Tool Gouge is approximately  
.200" deep along the base of  
the T adjacent to the long  
leg.

13.5" long

Approx.  
.900"  
wide

Propose to weld repair the tool gouge. Indicators would be applied on and around the T section to monitor any part movement caused by welding. The welding process would altered as needed to minimize movement. A local mag permeability and PT inspection would be performed. This gouge is located on the short leg in the area designated as "High Stress". During the RT of the High Stress area an additional shot would be taken of the repaired area. It is likely that this RT shot would prove inconclusive due to it's location.

NCSX agrees with MTM's recommended disposition to weld repair, followed by local mag. perm. Inspection, PT inspection, and RT during the RT of the high stress area. MTM is requested to provide documentation after the repair is completed.
