**Customer: ENERGY INDUSTRIES OF OHIO**

**Part: SE141-115 / MODULAR COIL, TYPE B**

Drawing ID: SE141-115                      Revision: 8

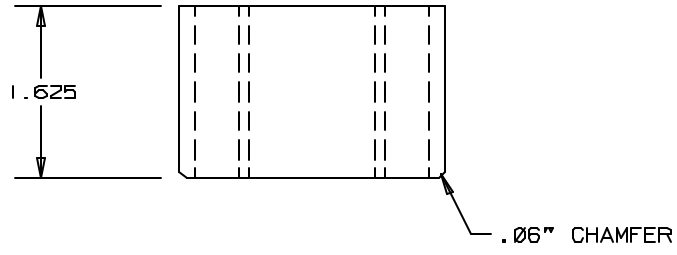
MCWF FLANGE INSERT

Problem: Sheet 5, zone D4.  
8 of the 1.375 threaded holes on datum -E- are out of position by a 1/2 inch (holes 19 thru 26).

Ø 1.375-6 UNC2B

Ø2.50-6 UN-2B

MTM RECOMMENDS REPAIRING HOLES PER ATTACHED REWORK PROPOSAL.

MTM's re-work proposal (attached) is accepted, with the understanding that the insert will be made of Stelalloy ( to assure that magnetic permeability and strength requirements will be met). The strength of this repair is not an issue since the insert is threaded into the flange with 2.5-6 UNC threads and then tack welded in place.
