Part: SE141-116 / MODULAR COIL WINDING FORM TYPE

Drawing ID: SE141-116-1MTM Revision: 6A

SE141-116 C5
NC19718 attachment.

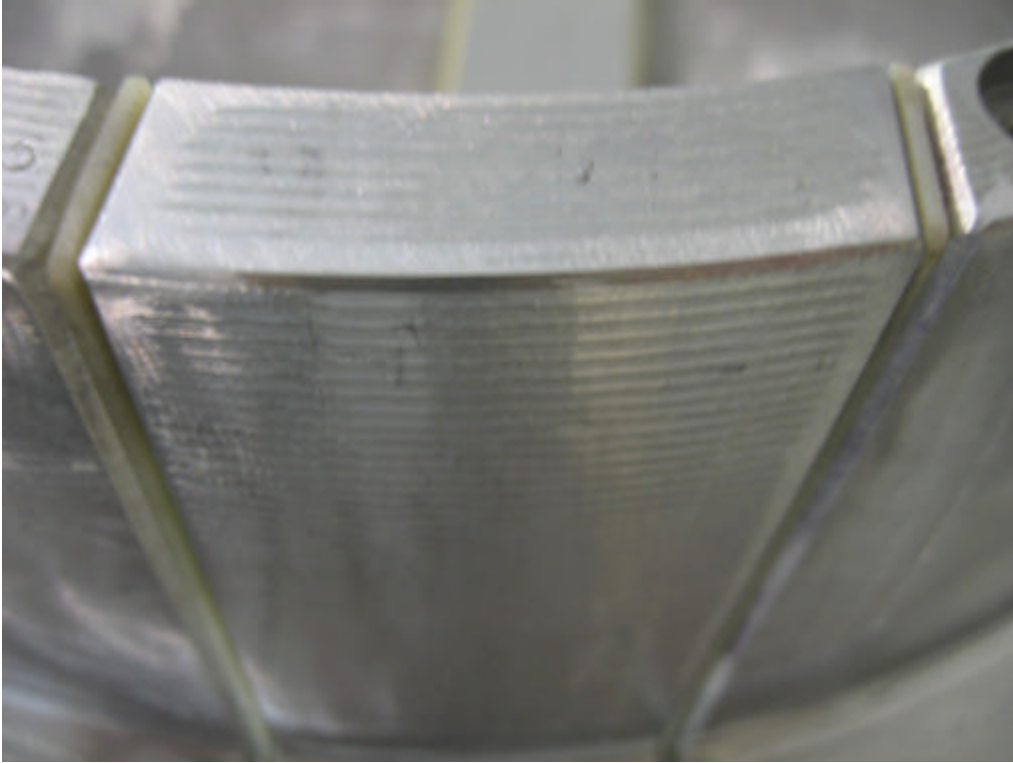
Poloidal Break view – Chamfer on casting (.09”) is larger than chamfer on shim (.06”).

The noncleanup and gouges shown in the attachment were reviewed and accepted as is. NCSX will evaluate each of these and may opt to fill those located in winding surface areas with cryogenic grade epoxy filler.

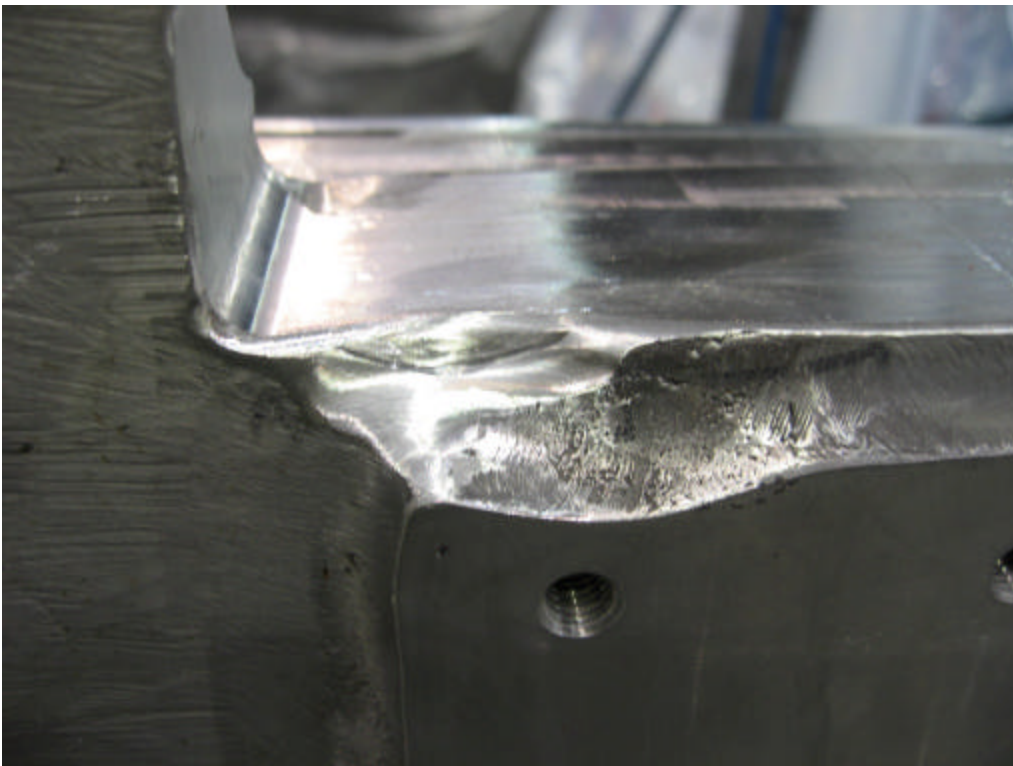
Tool Gouge blended out between pad and lead block slot.

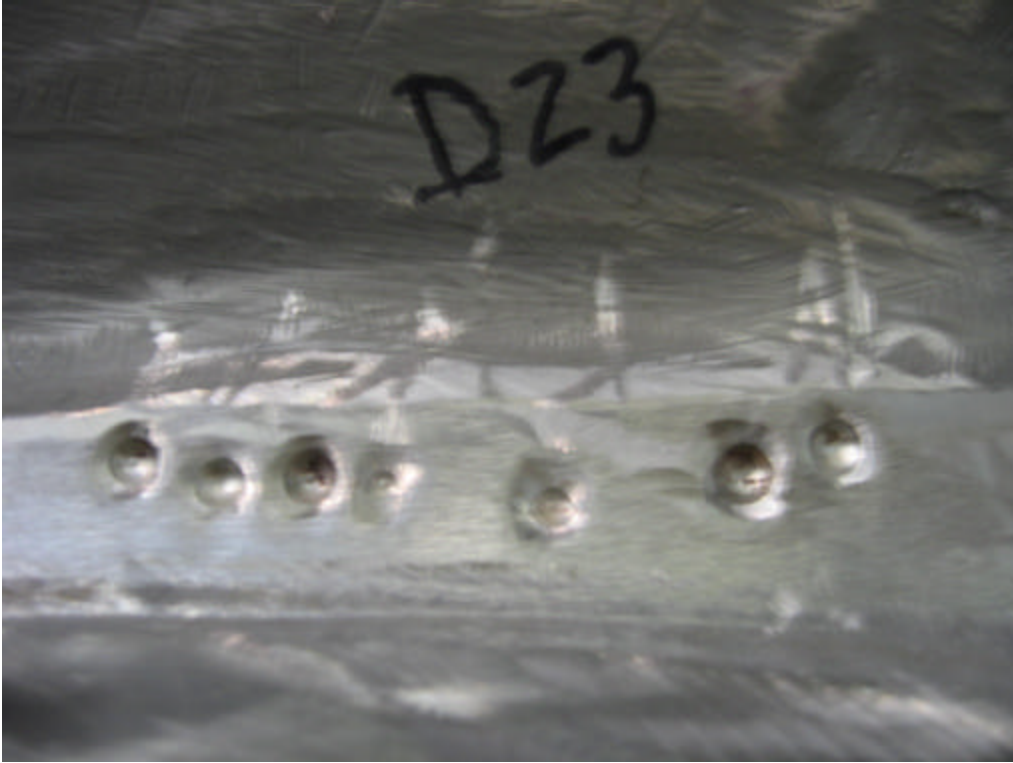
Excavated areas of high permeability beneath VPI groove in radius at casting wall.

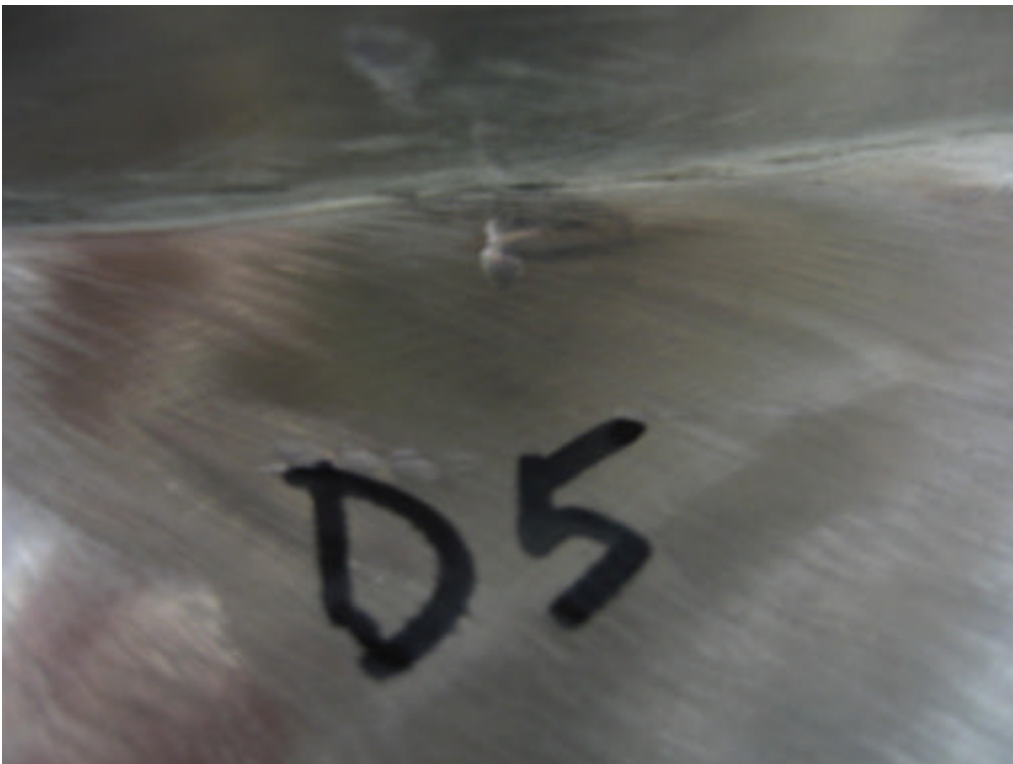
Small cutter noncleanup between long and short legs (.120", .005" deep)

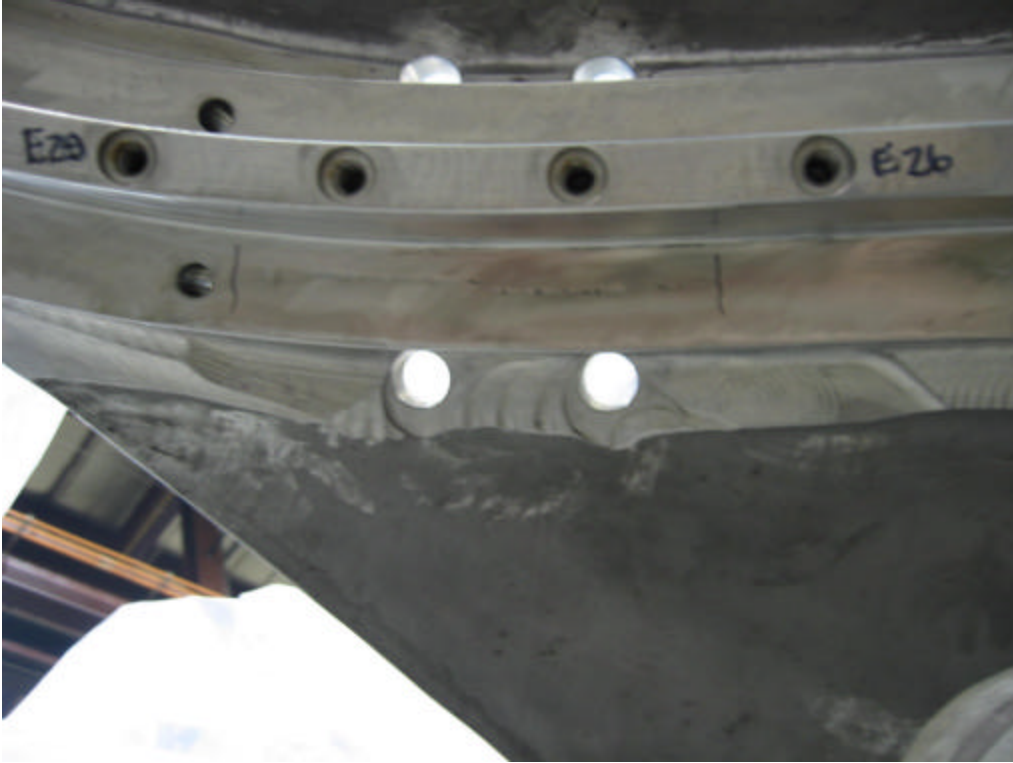
Wide view of cutter noncleanup on short leg between holes 26 and 29 on E side.

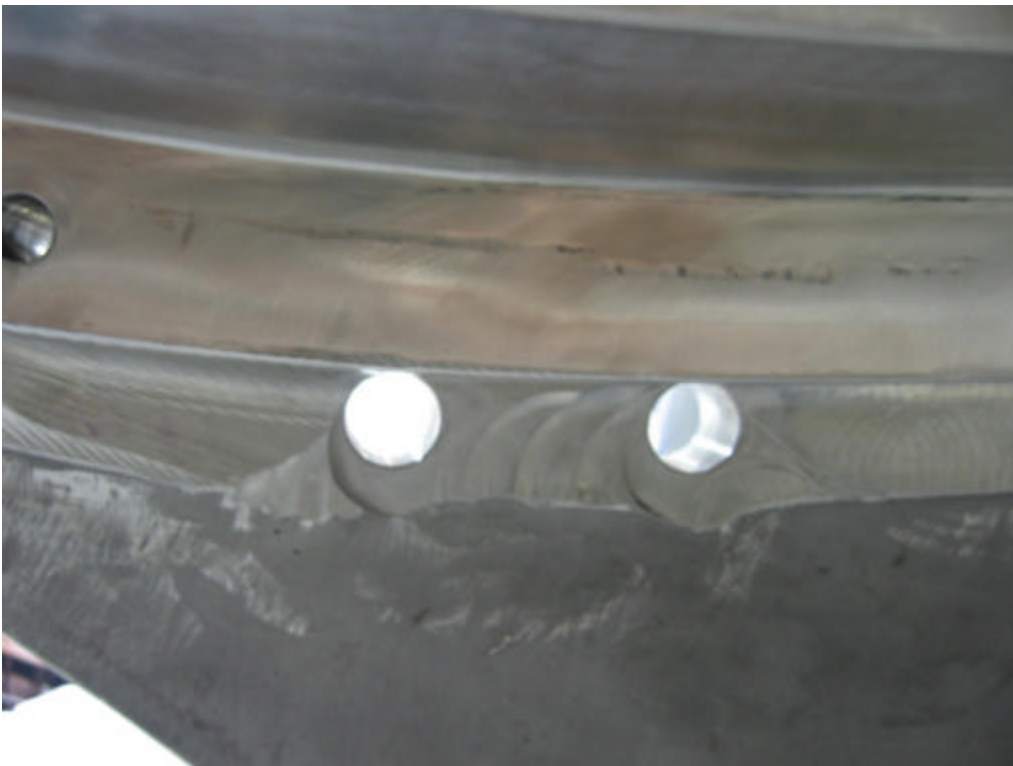
Close up view. Noncleanup is approx. .008" at the max depth and max. of .100" wide.

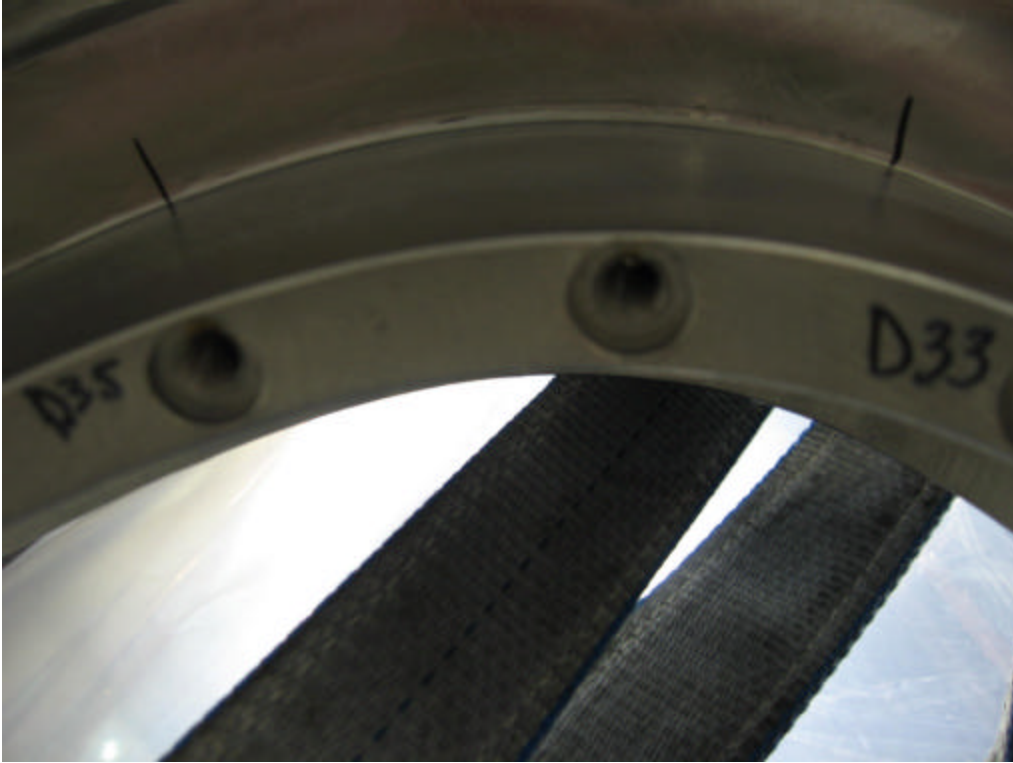
Area of cutter noncleanup near radius between D33 and D35. Approx. .008" max depth.
