A-1 RT, electrical testing, Magnetic Permeability and deburring of machined areas not yet done. CMM inspection is still in progress. Mike hopes to start RT in the morning and follow with magnetic permeability, electrical testing, & deburring.

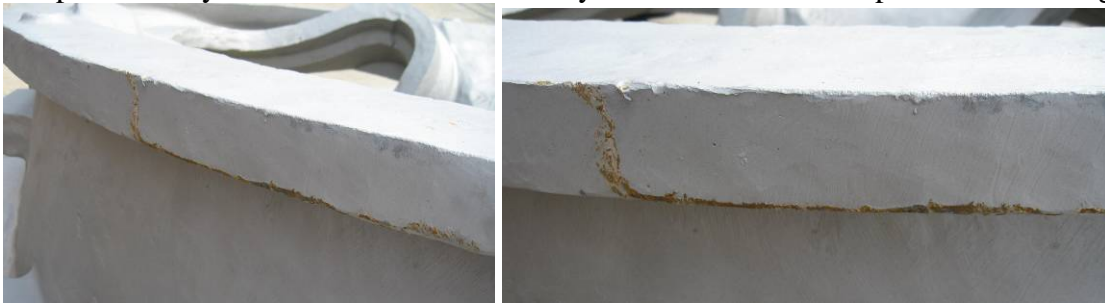
We saw B-3 and noted a large rust area, photo below. We did not have a Severn gage and so did not measure the permeability. This areas looks like it may be the result of a scrape across the flange.

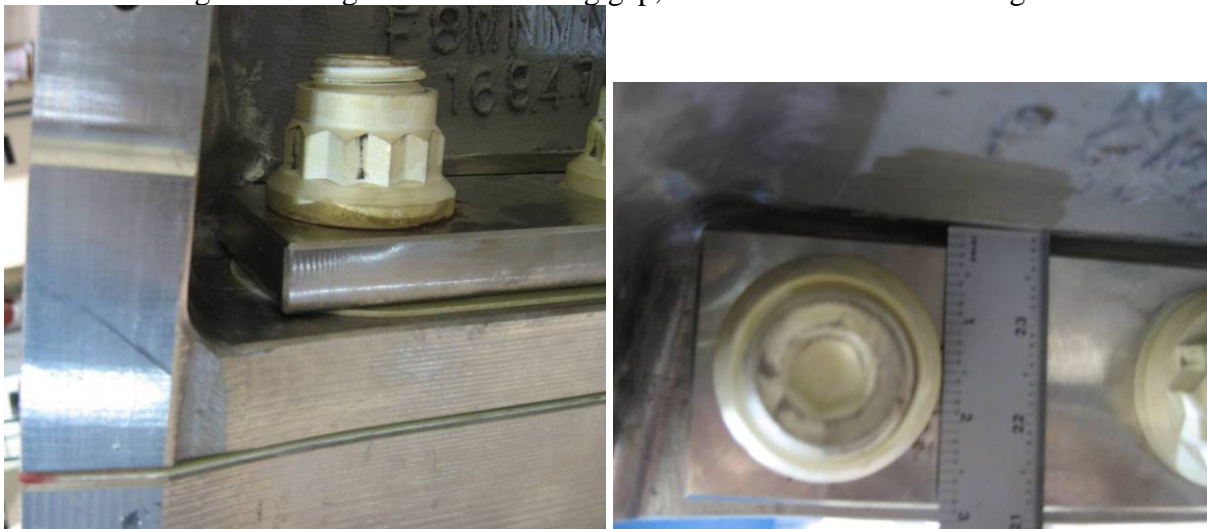
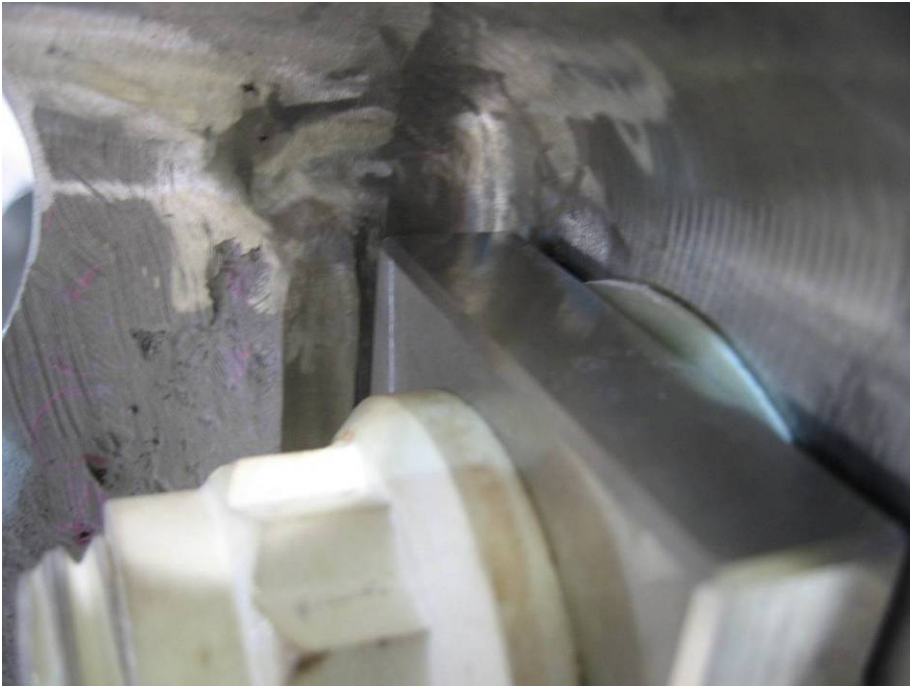
G-11 at Bearing Plate. Edges rounded leaving gap, Also comes close to casting at corner.

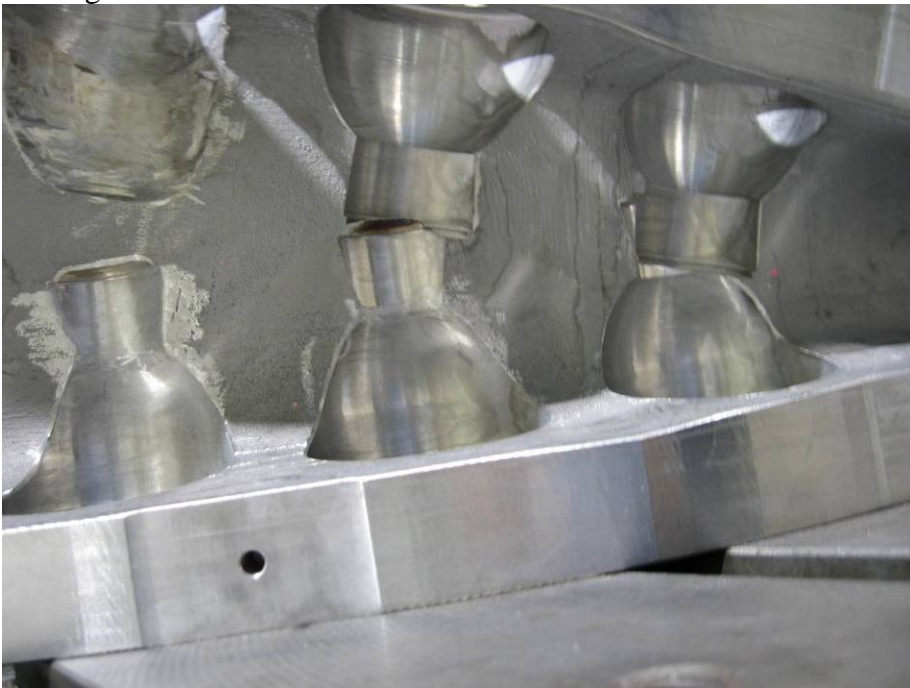
Areas ground for counterbores.

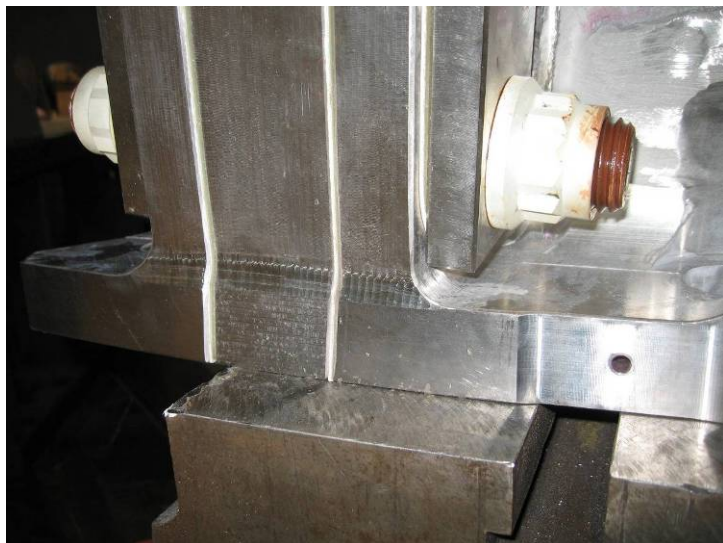
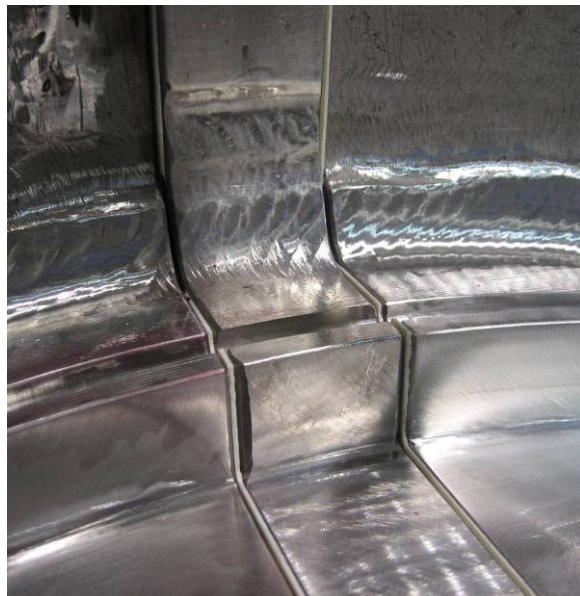
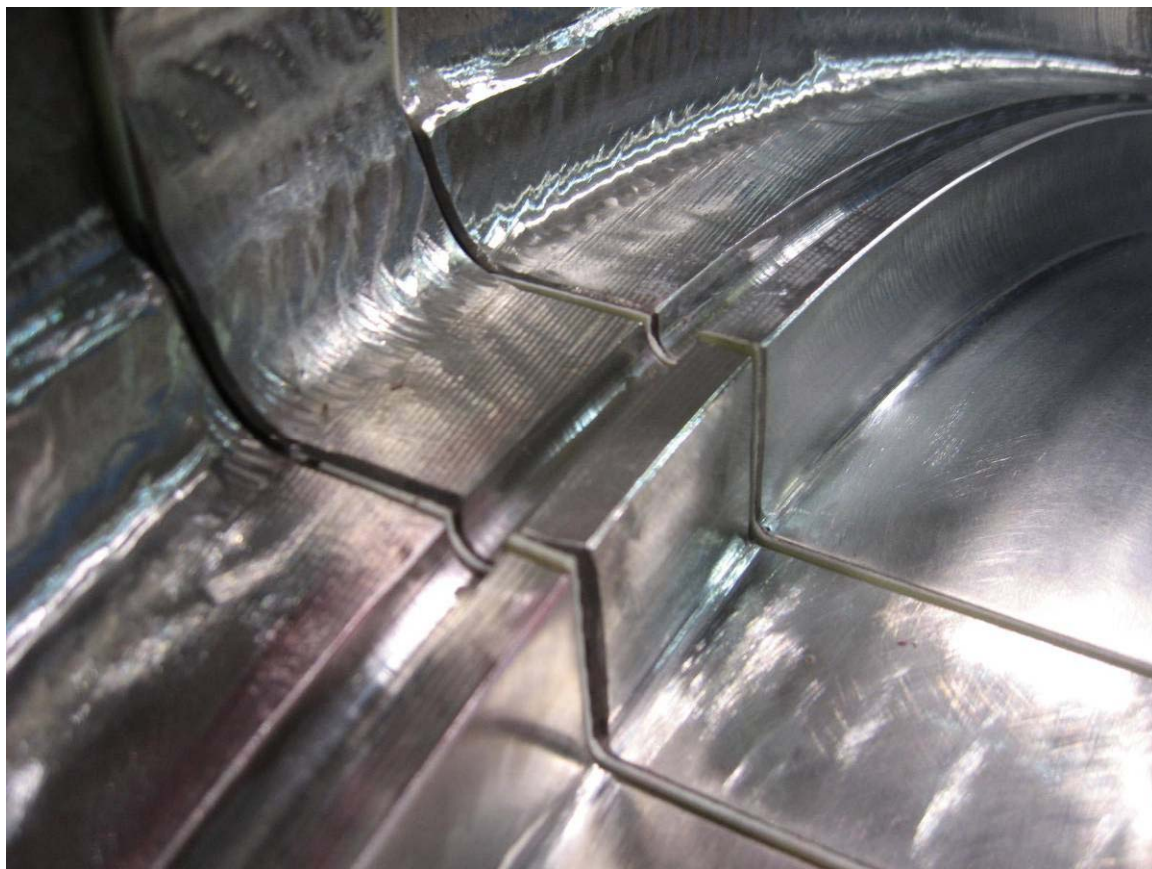
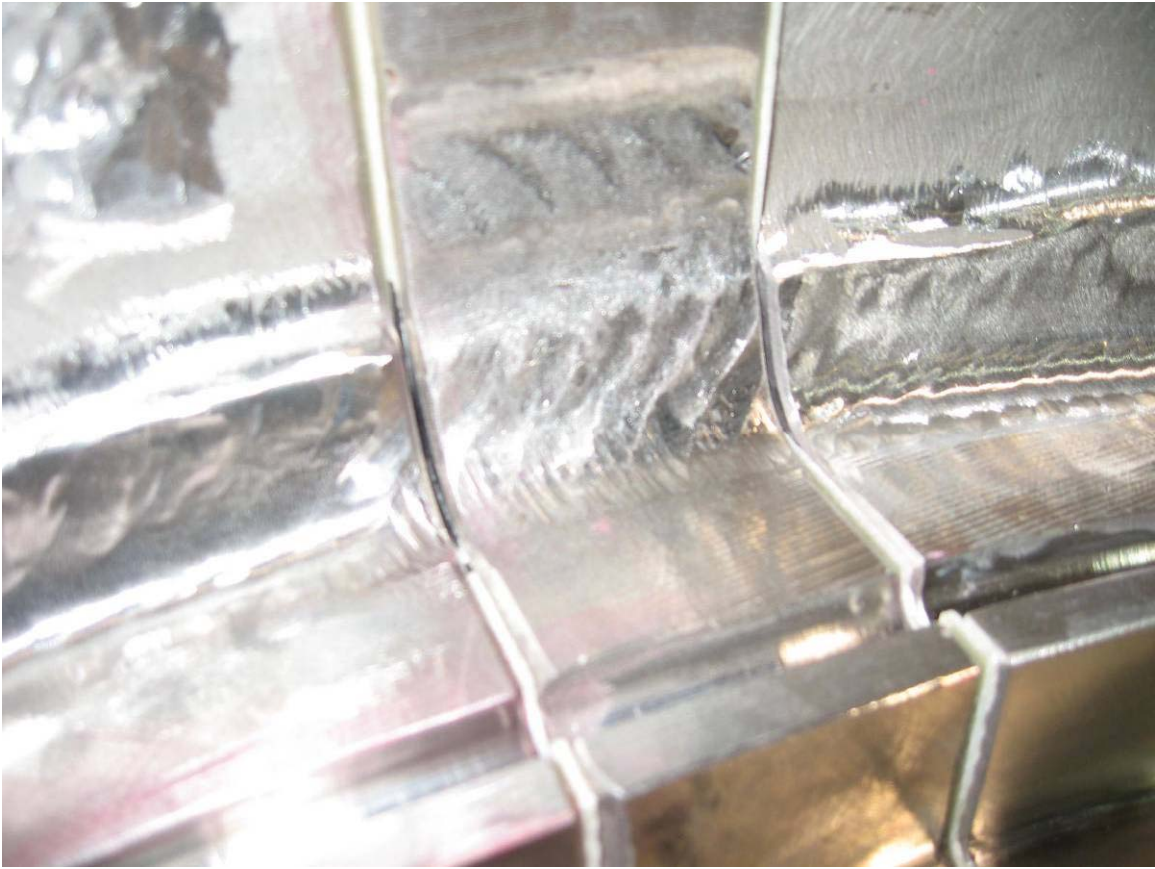
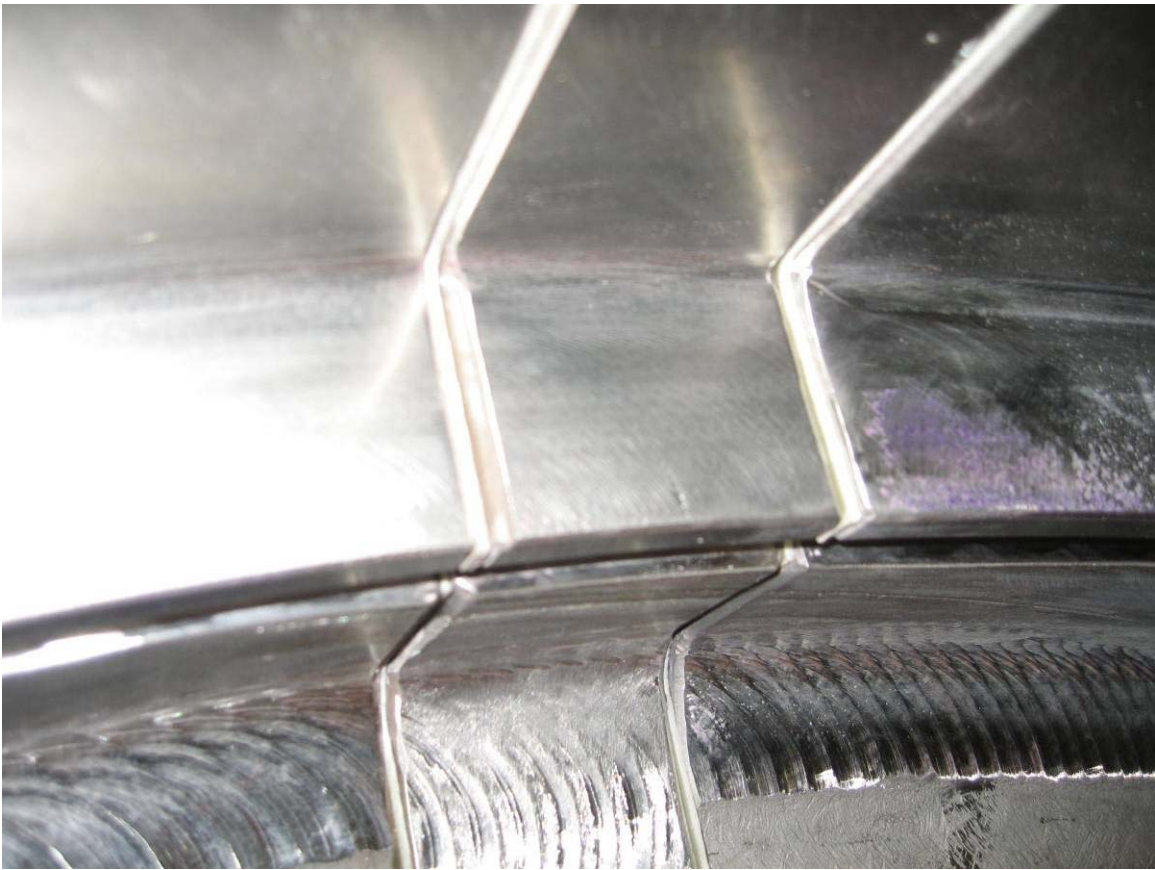
Poloidal Break Fit-Up. Significant gaps where machined-to-print G-11 does not match machined-to-contour Shim. Hardware is final, Stellite plates and A286 studs.

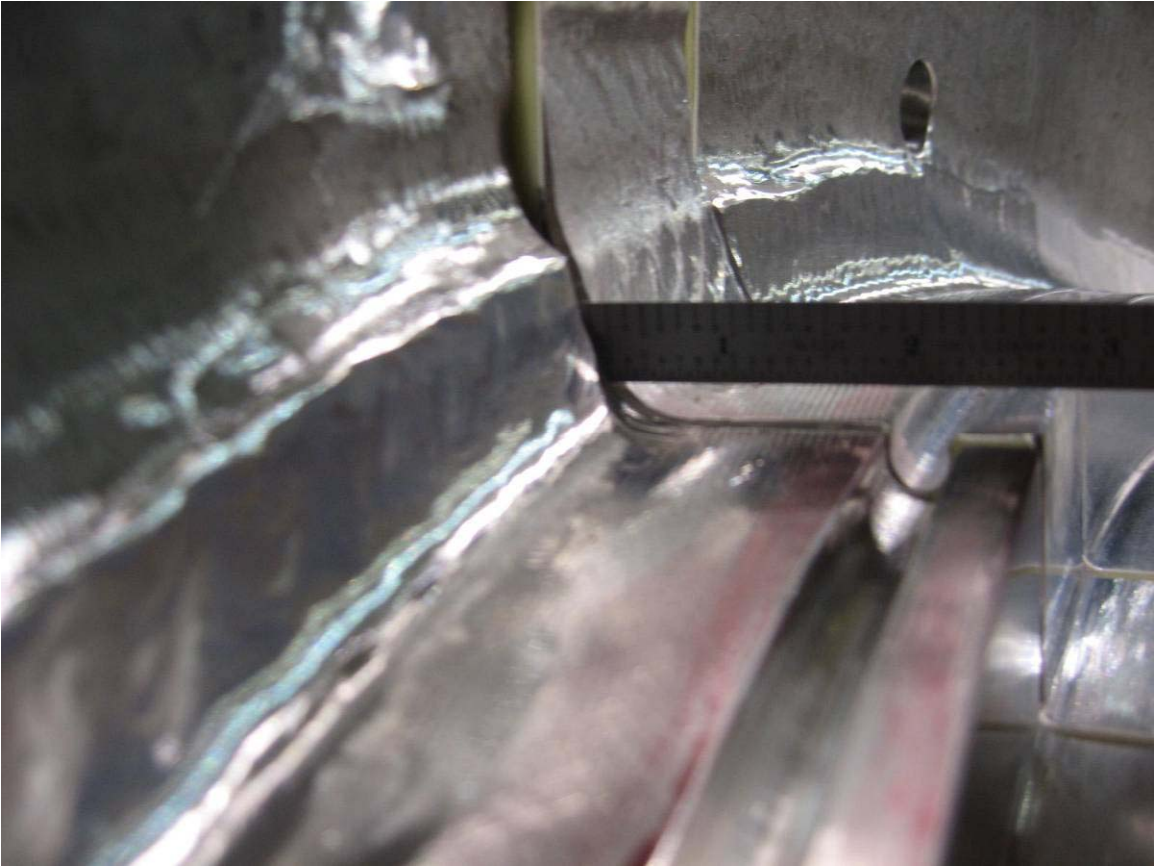
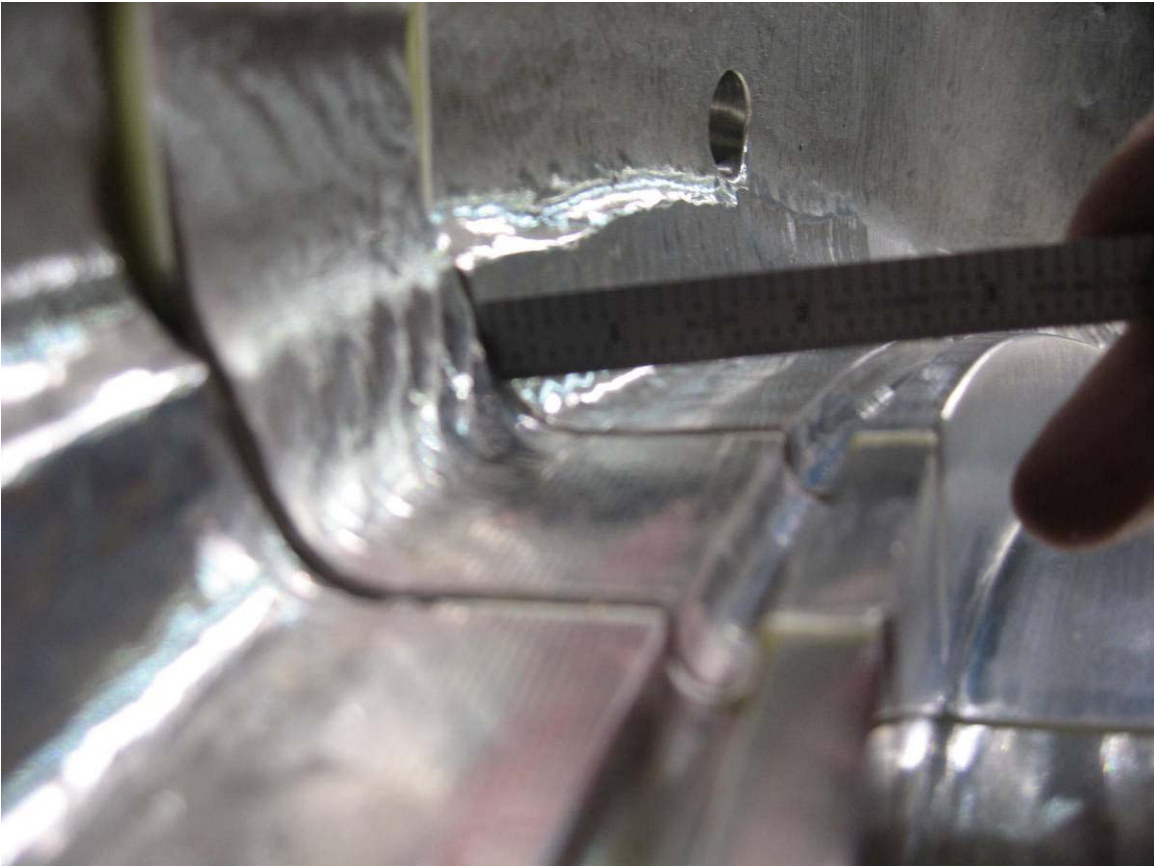
Scale inserted about .25"

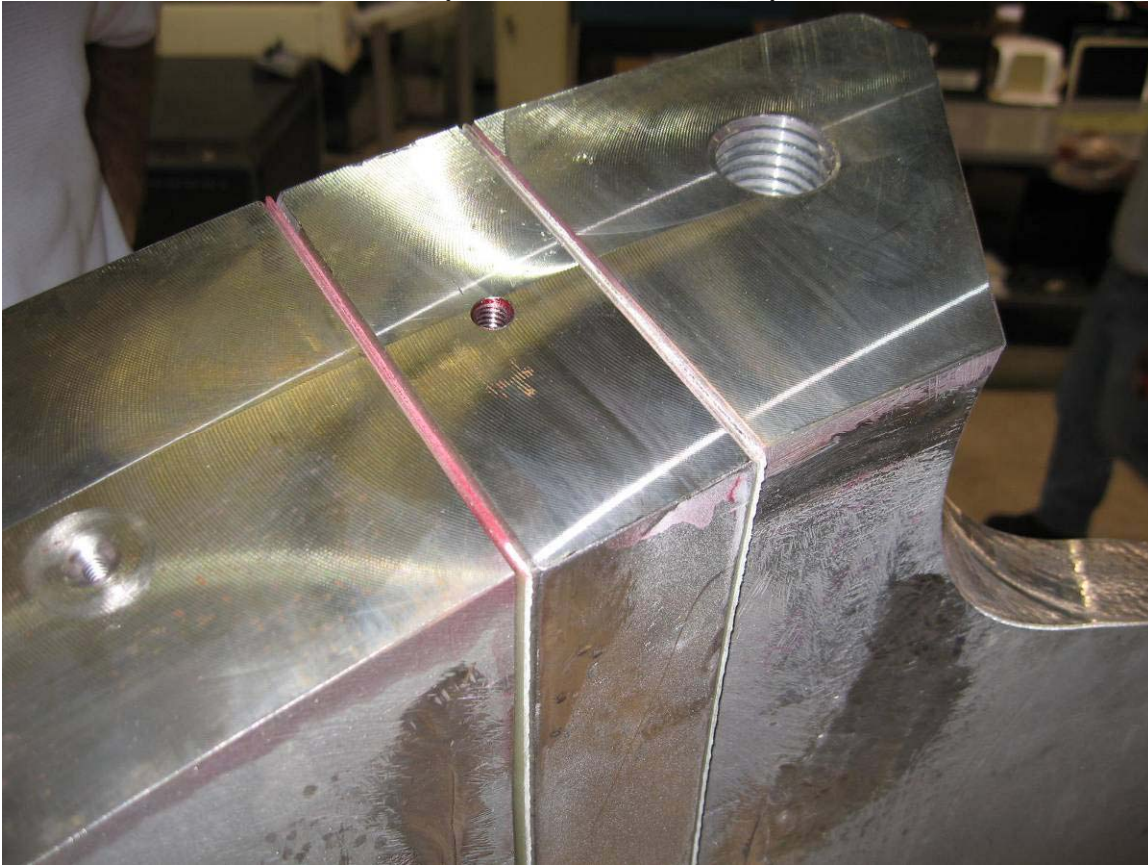
Penetrant on G-11. Break has not yet been tested electrically.

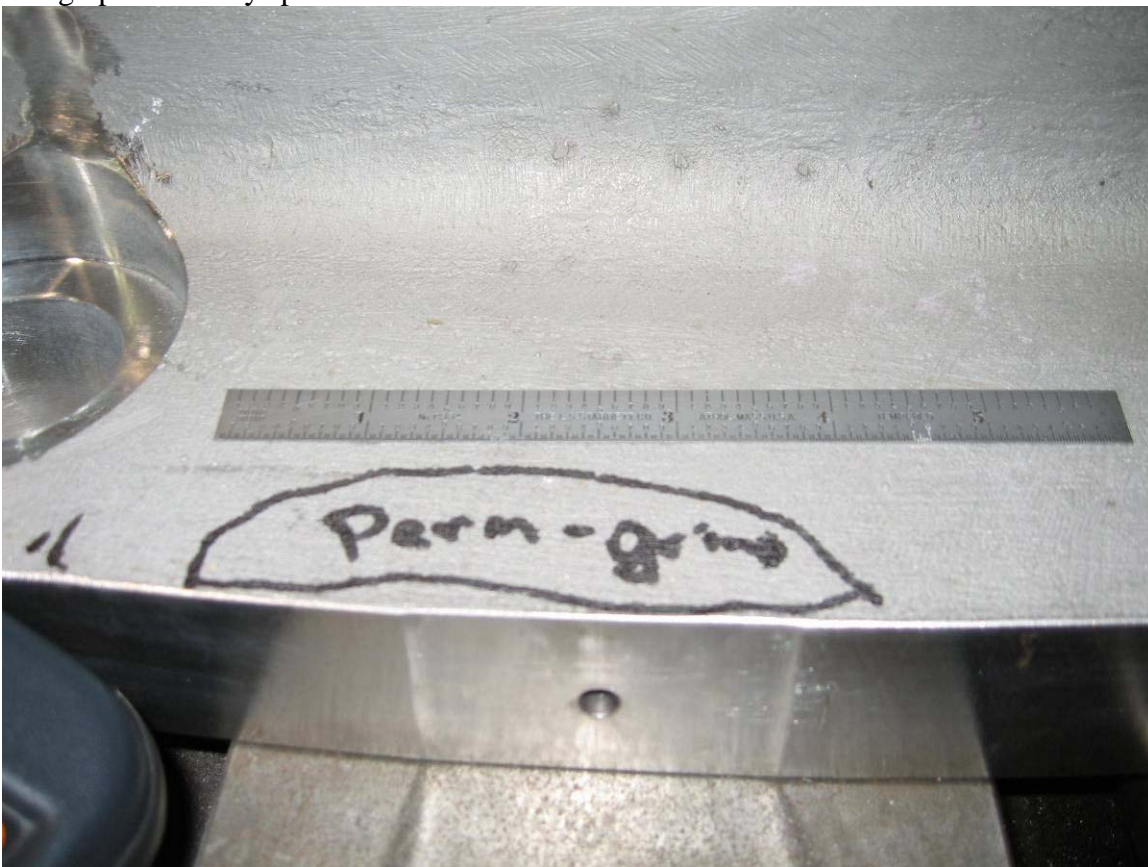
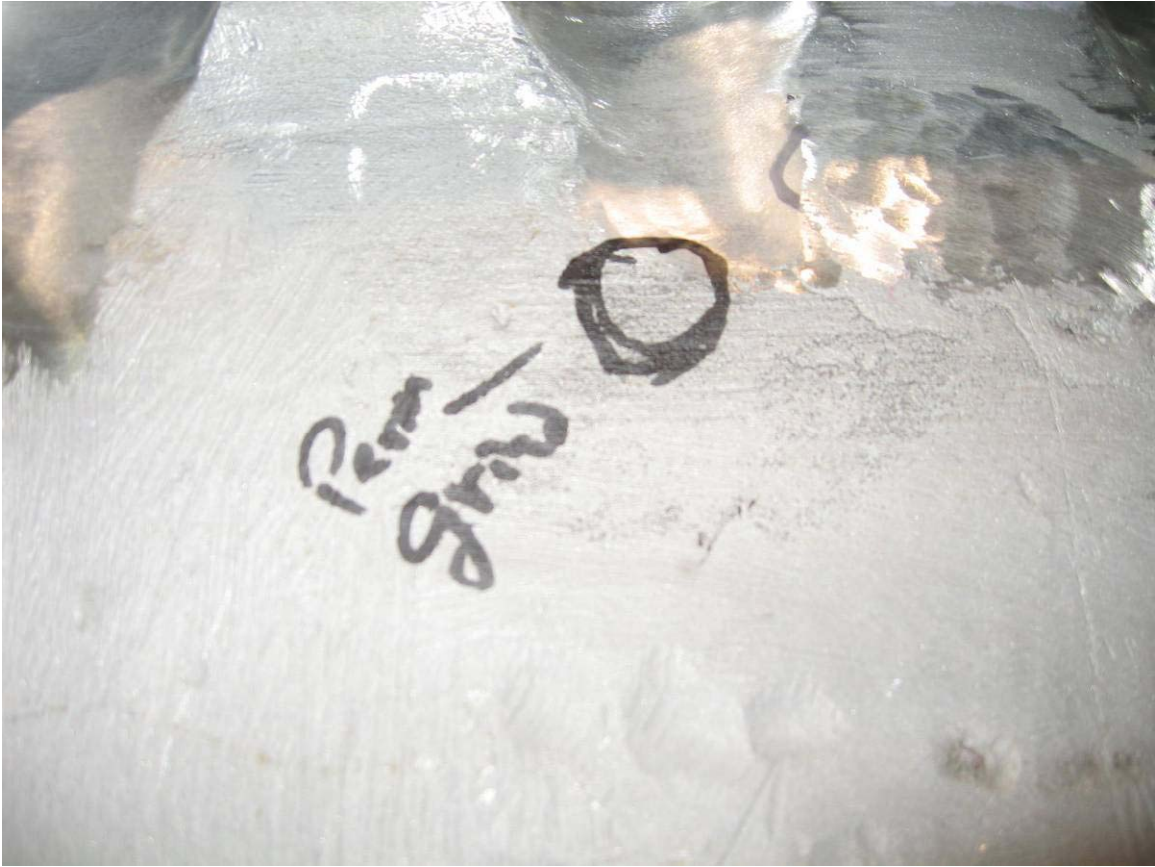
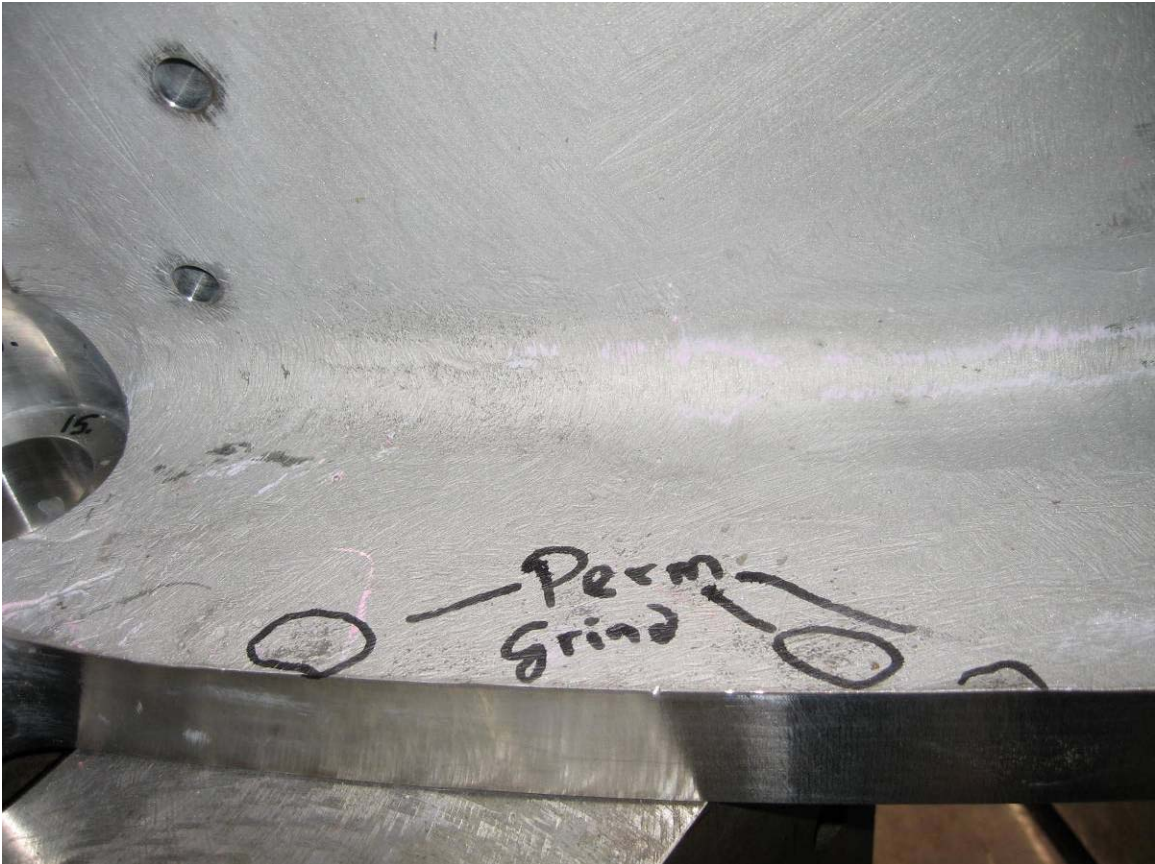
We checked random spots on A-1 for magnetic permeability and found 5 areas, all darker color, that held at 1.02 mu. All were marked for grinding. Final deburring has not yet been done and several areas were marked for blending or thread clean-up.

5 High permeability spots found and marked. All were darker areas.

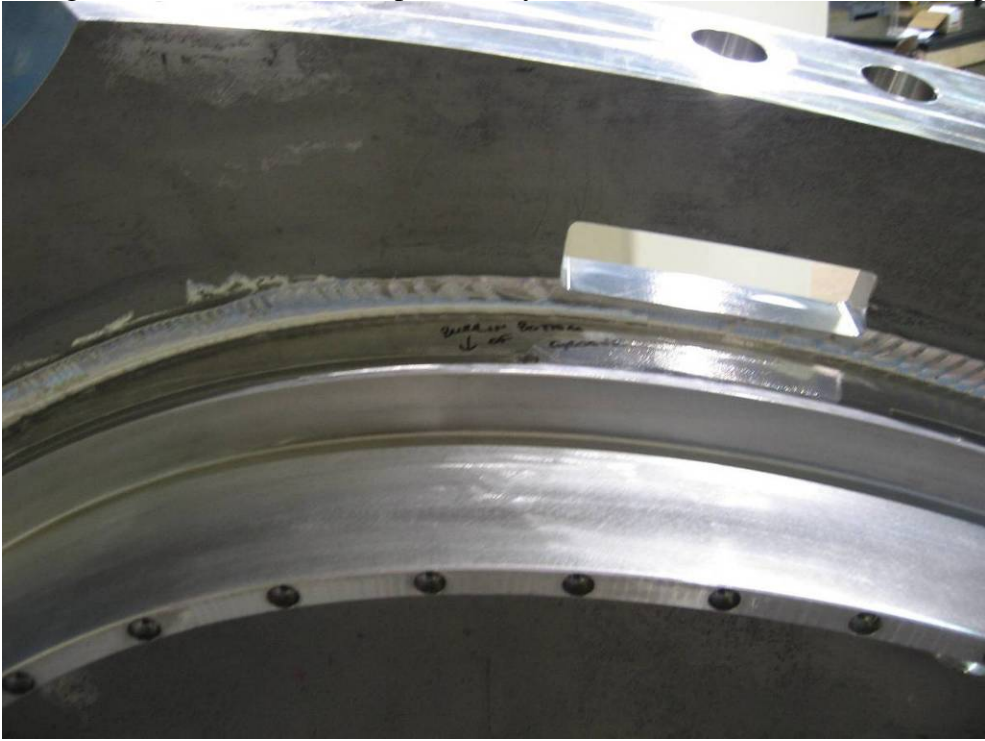
VPI groove looks good other than this one spot already identified and marked for clean-up.

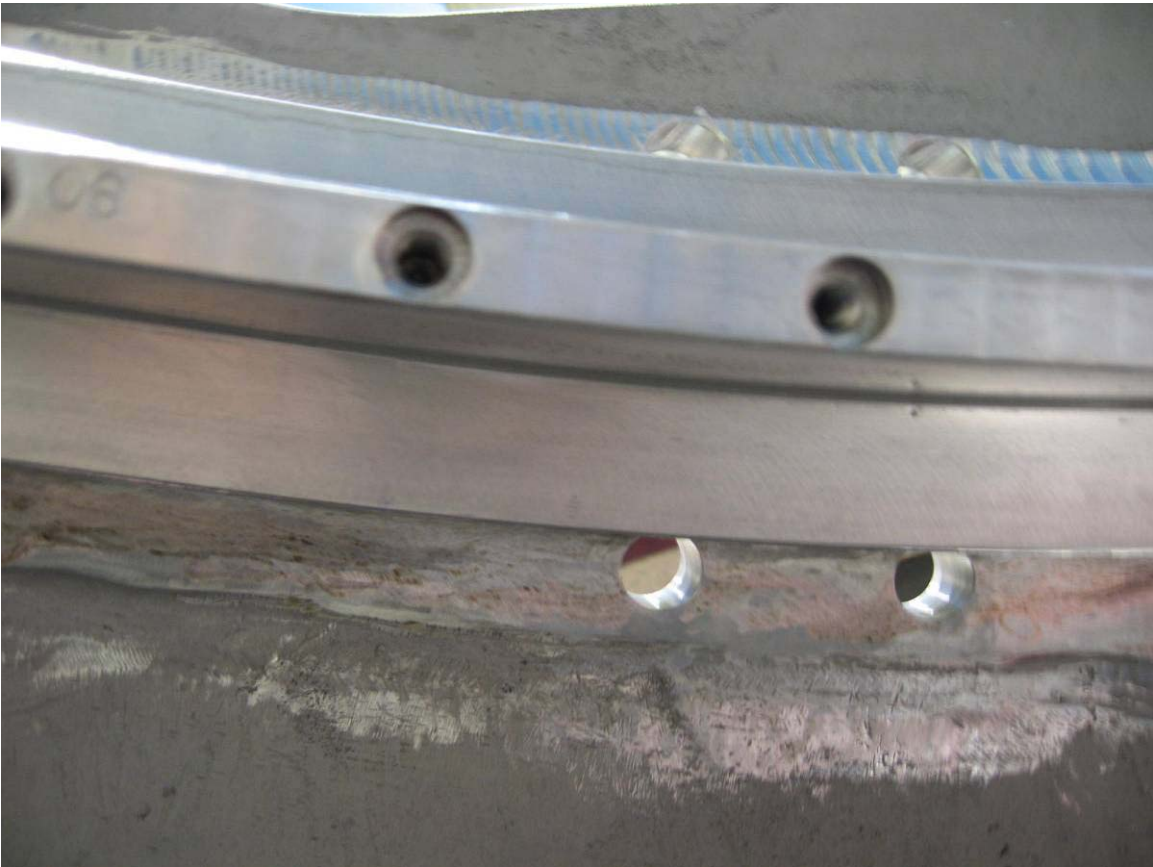
There are 2 small pits (right side of photo below) in the short leg of the tee. One is at hole 89 and the other between holes 87 & 88.
