Corrective Action 1625
Carondelet Division
Corrective Action Type NCR
Date 3-1-06
CA Originator C. Ruud
Applies to: A-1 Coil

Crack like defect found during machining of A-1 coil.

Corrective Action 1371
Carondelet Division - CA / PA / RGA Database
Corrective Action Type NCR
Date 8/23/2005
CA Originator R. Suria
Applies to: A-1Coil

Corrective Action 1403
Carondelet Division - CA / PA / RGA Database
Corrective Action Type NCR
Date 9-30-05
CA Originator C. Ruud
Applies to: C-3 Coil

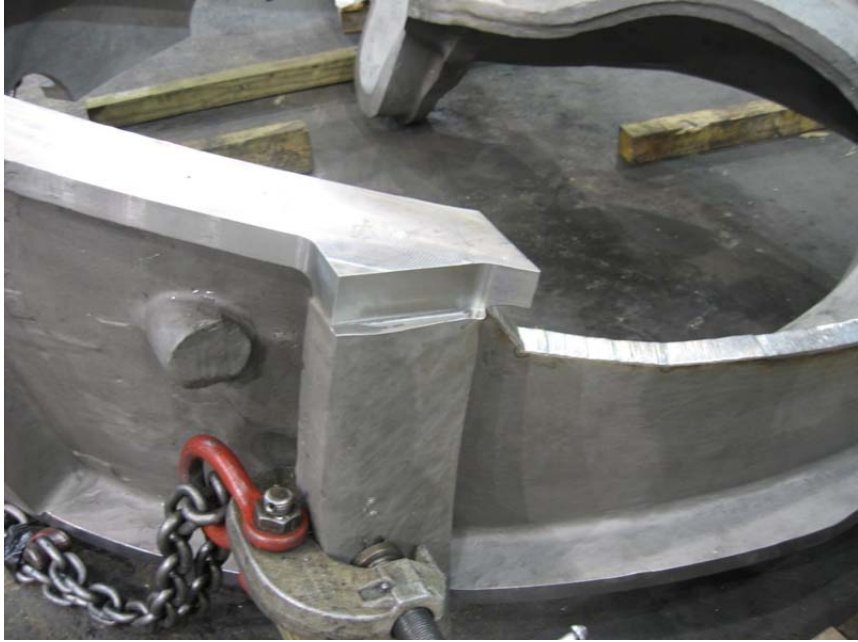
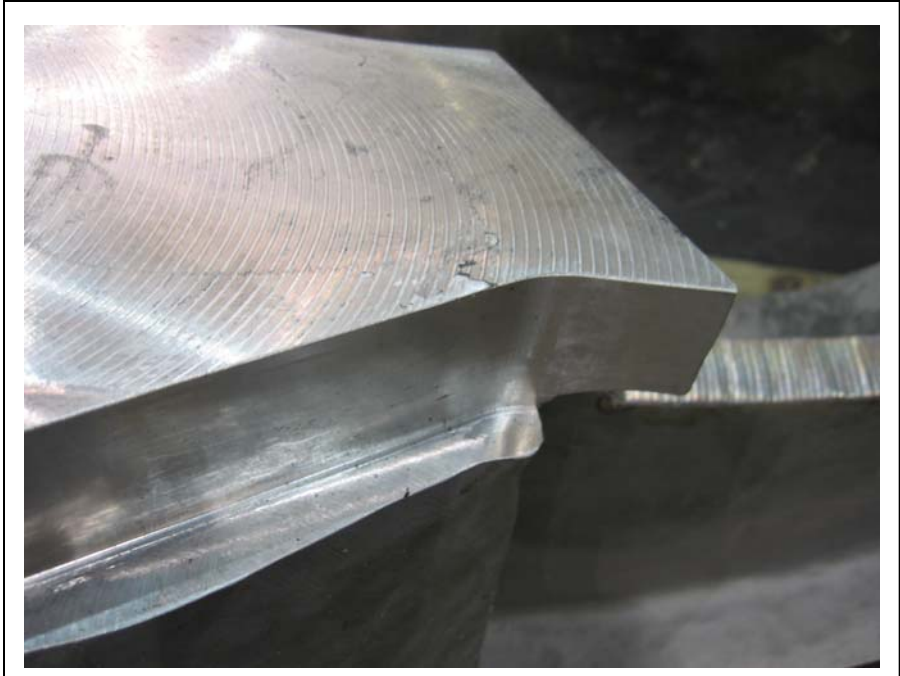
The defects may be lack of fusion and sand inclusion. The area was repaired by welding prior to shipment. RT and LP were acceptable. This area is covered by views 62-63 and 113-114. During the processing of C-3 and A-1 coils problems surfaced with repeated lack of fusion defects. Corrective action reports 1371 and 1403 were issued. The action items were completed are the problem decreased significantly. Both CA are part of this CA report.

Completed.

Monitoring of gas lines and flow rates continues.
