Carondelet Division

8600 Commercial Blvd. • Pevely, MO 63070 USA

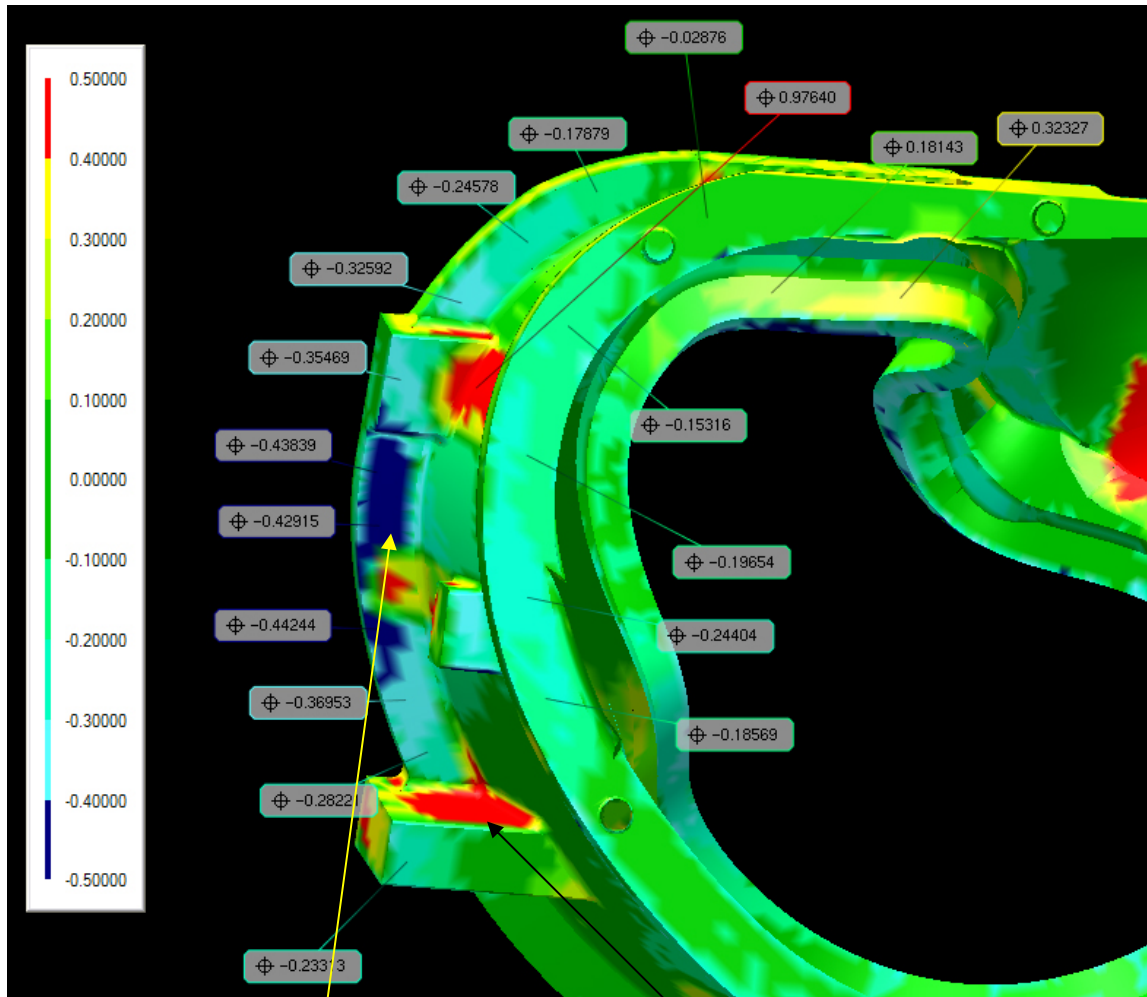
An area on the back-side of the cope flange is showing a surface profile approximately 7/16" below expected. This area will be addressed for Coil B-2 by adding approximately 7/16" stock into this area in corebox #9. On B-1 we will build up this area by welding. The opposite side will require additional machining to remove the excess.
