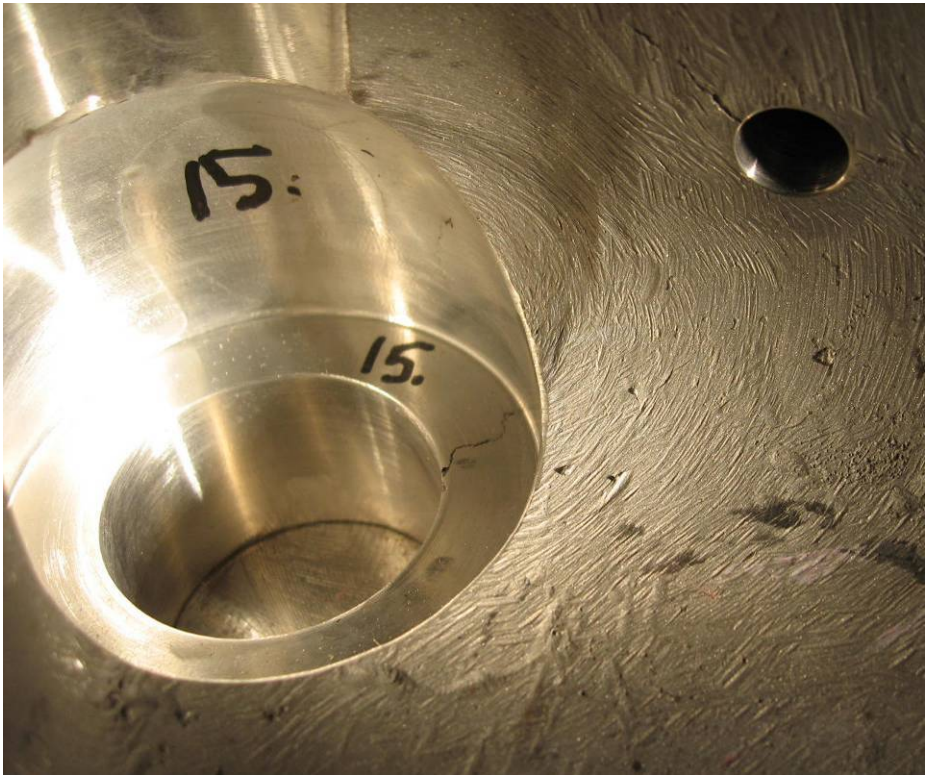
Another view of crack #15.

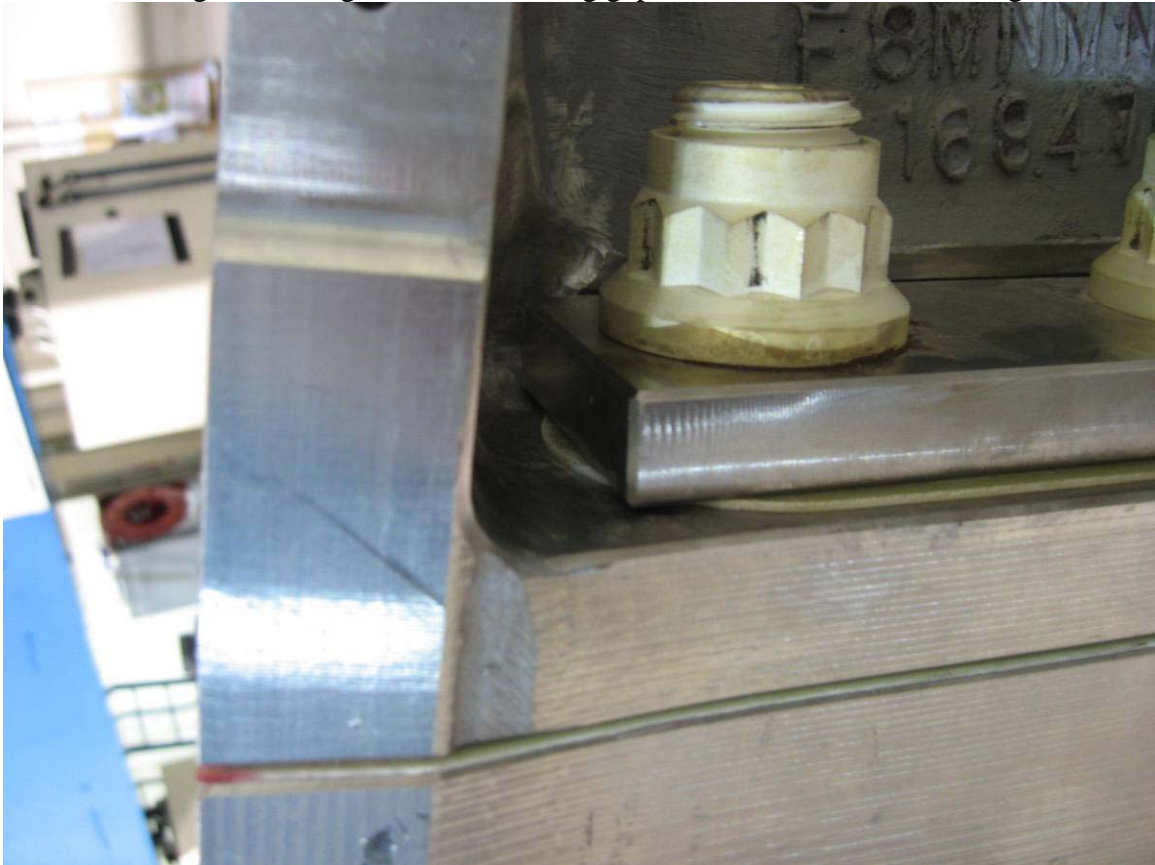
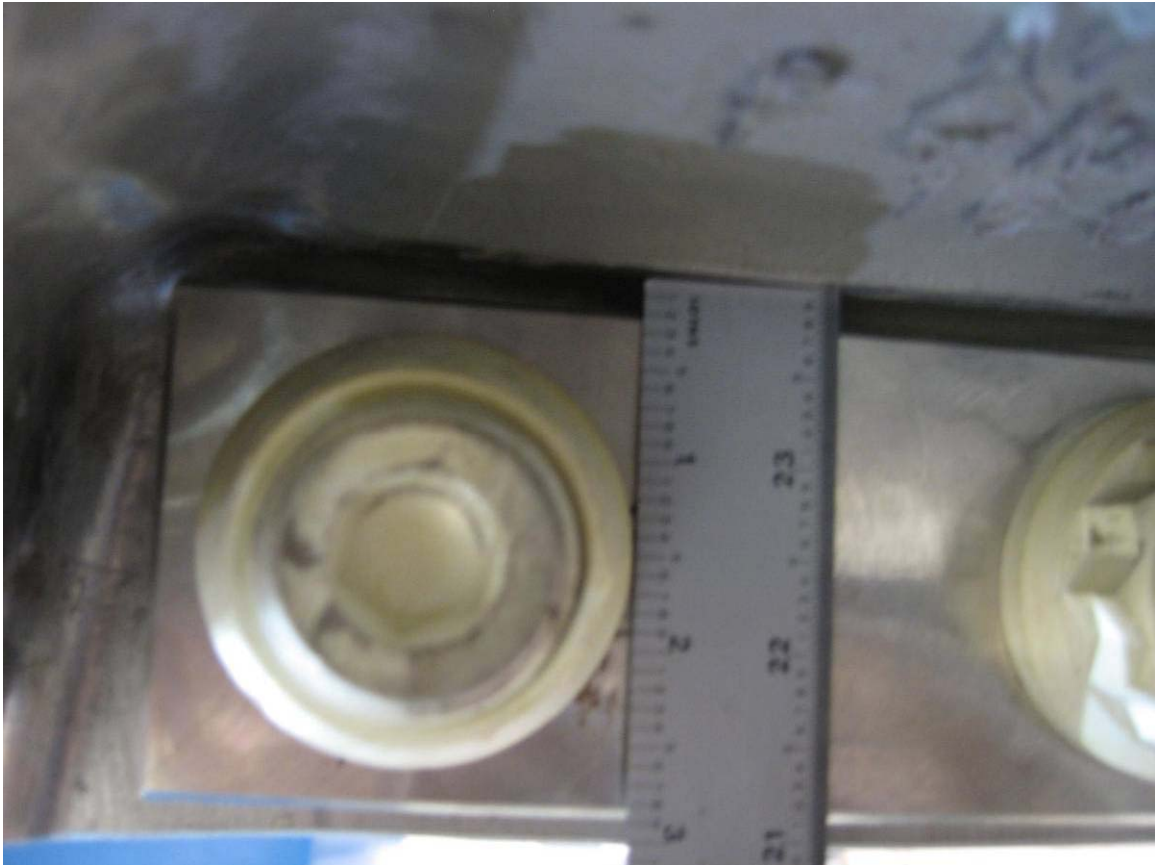
G-11 at Bearing Plate. Edges rounded leaving gap, Also comes close to casting at corner.

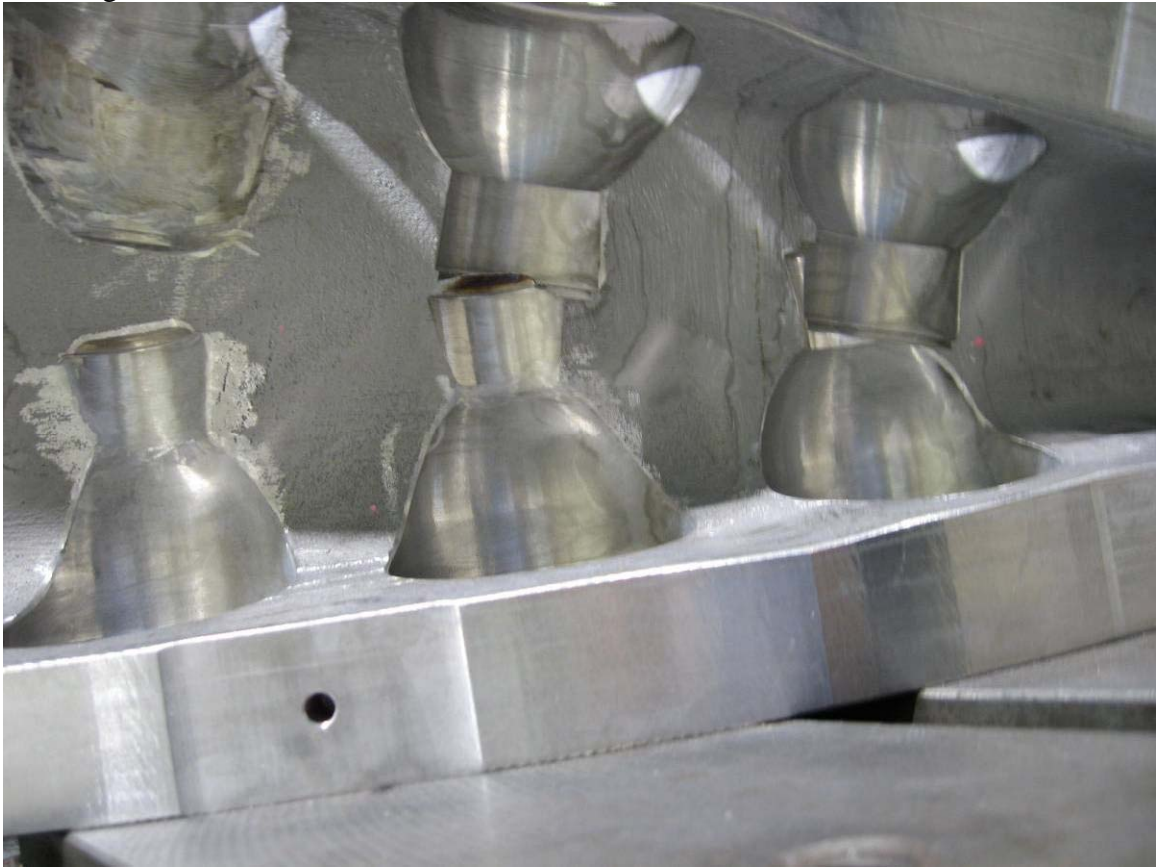
Grinding for counterbores.

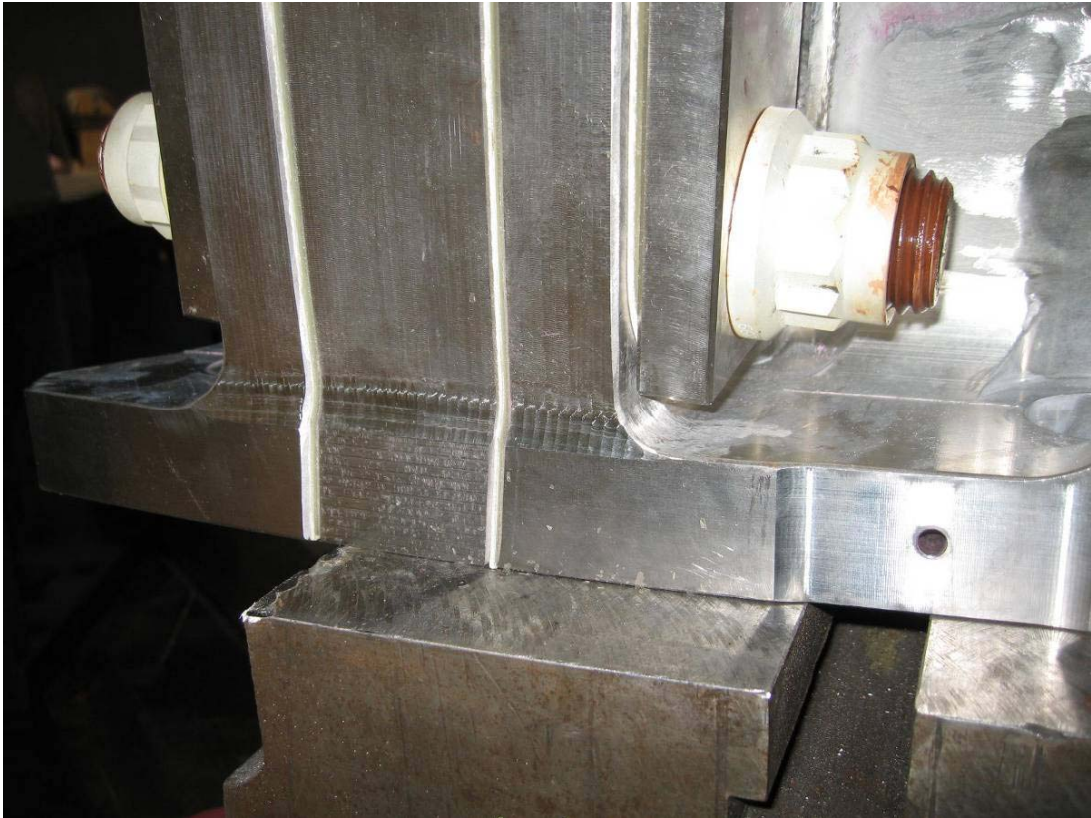
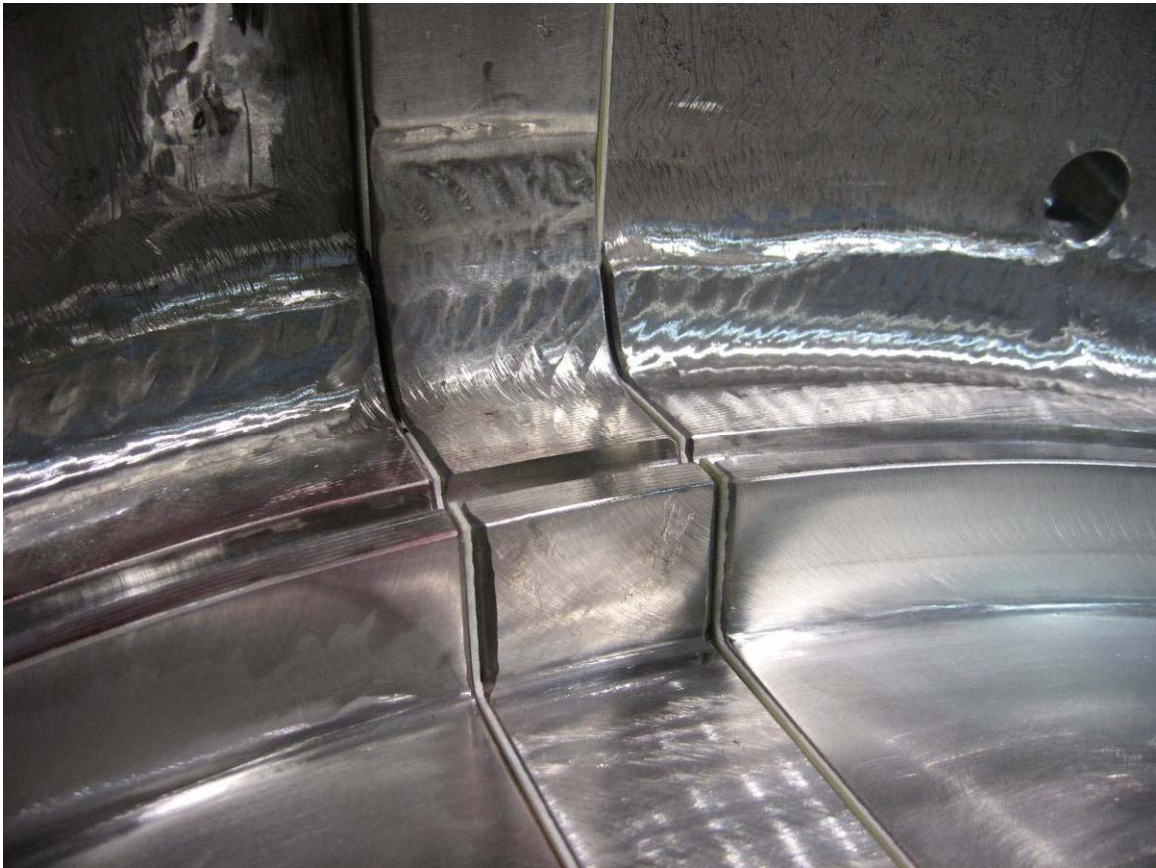
Poloidal Break Fit-Up. Significant gaps where machined-to-print G-11 does not match machined-to-contour Shim.

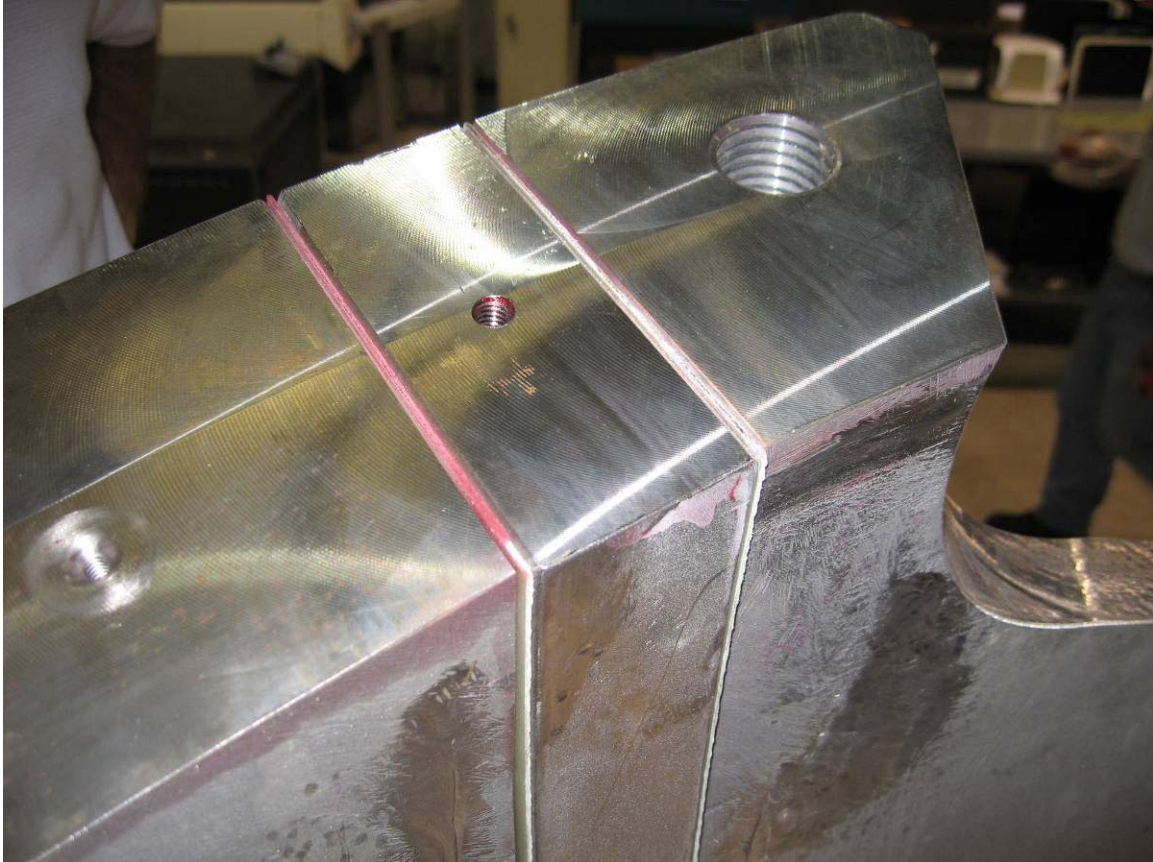
Penetrant on G-11. Break has not yet been tested electrically.

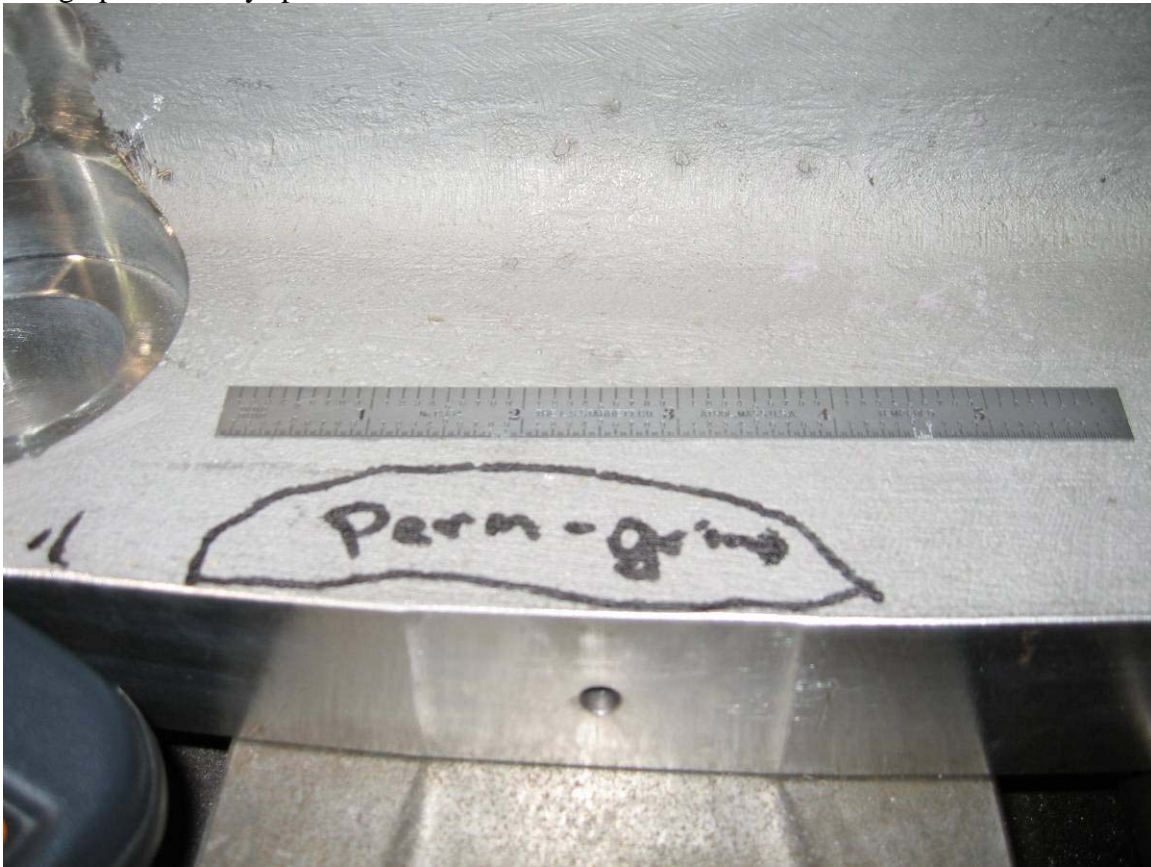
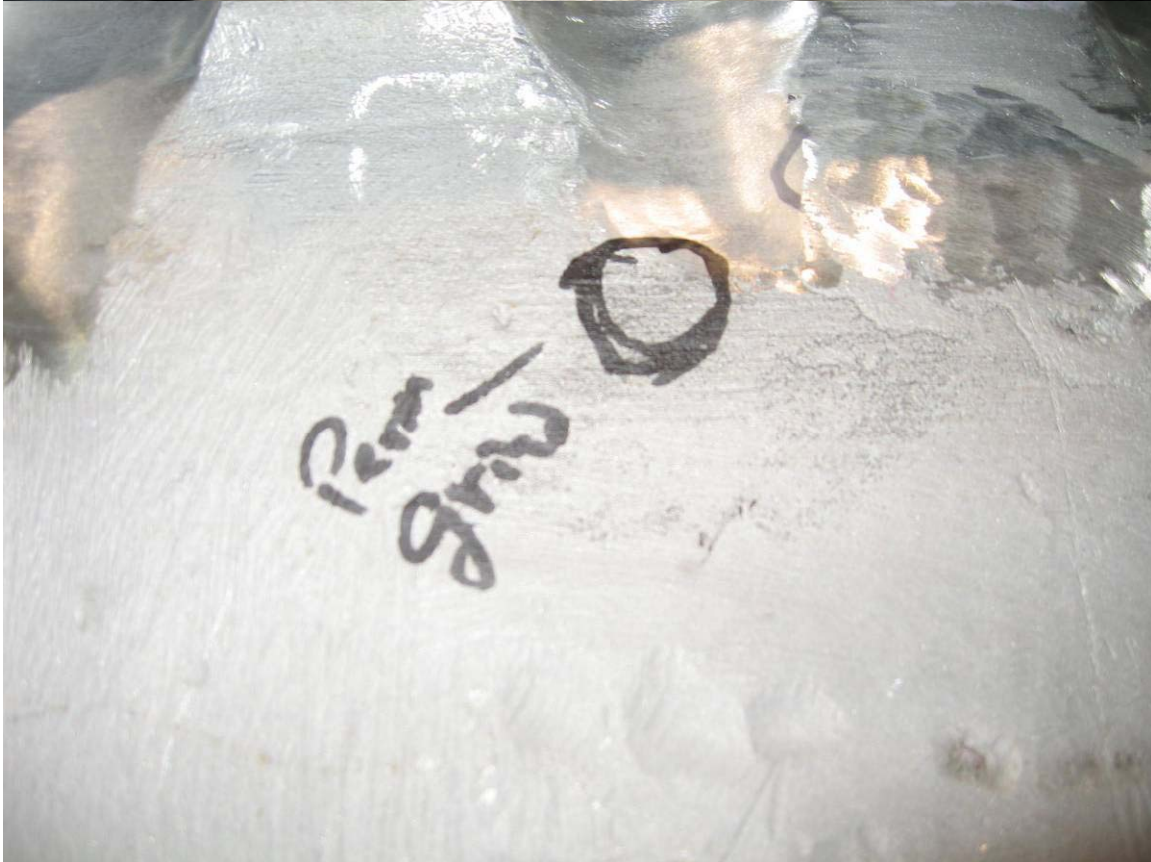
5 High permeability spots found and marked.

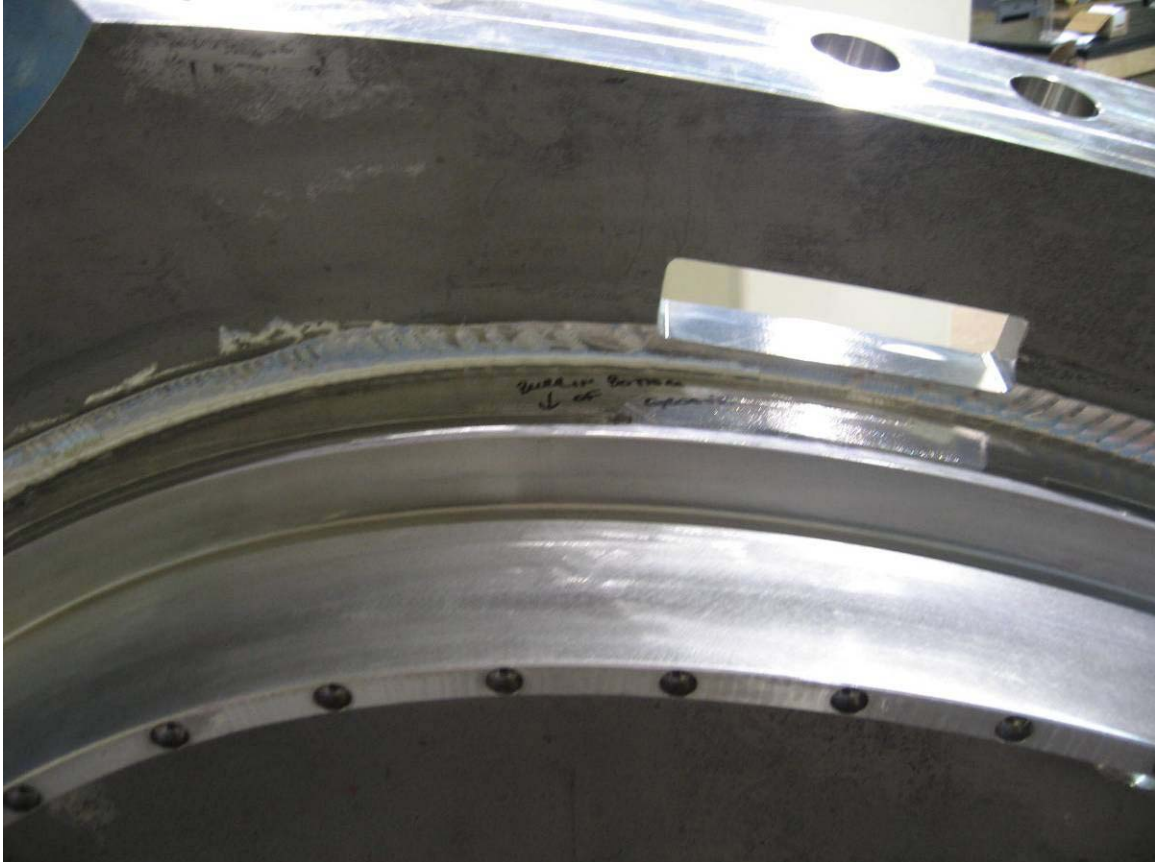
VPI groove looks good other than this one spot already identified.
