Nonconformance Report: Major Tool NC19232

This is for SE120-002 / PPPL NCSX VVSA

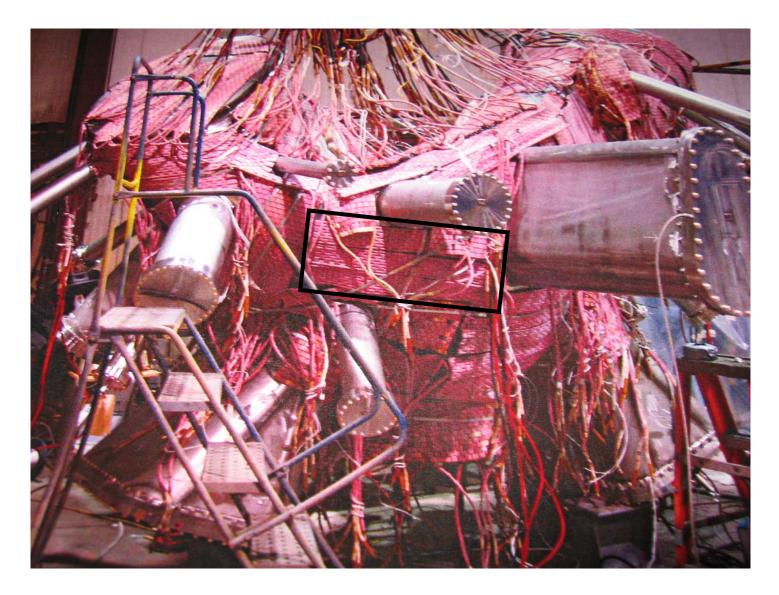
1. During vessel ramp up: One zone (approximately 12 x 29") reached 524F while the rest of the shell was at about 314F. This exceeds the 90 Deg. F maximum temperature gradient (by 130F) allowed during the cycle. Located from the tangent of the large radius of port 12 towards the center region between ports 5 and 7.

Photo added by M. Viola for clarification (Note boxed region of 3 pads):

We acknowledge the thermal cycle deviations and based on the information received so far, project disposition is use-as-is. However, this disposition will need to be revisited if damage from the heat excursions is detected.
