NCSX

Modular Coil Shim Testing

NCSX-CALC-14-004-01

18 Aug 2008

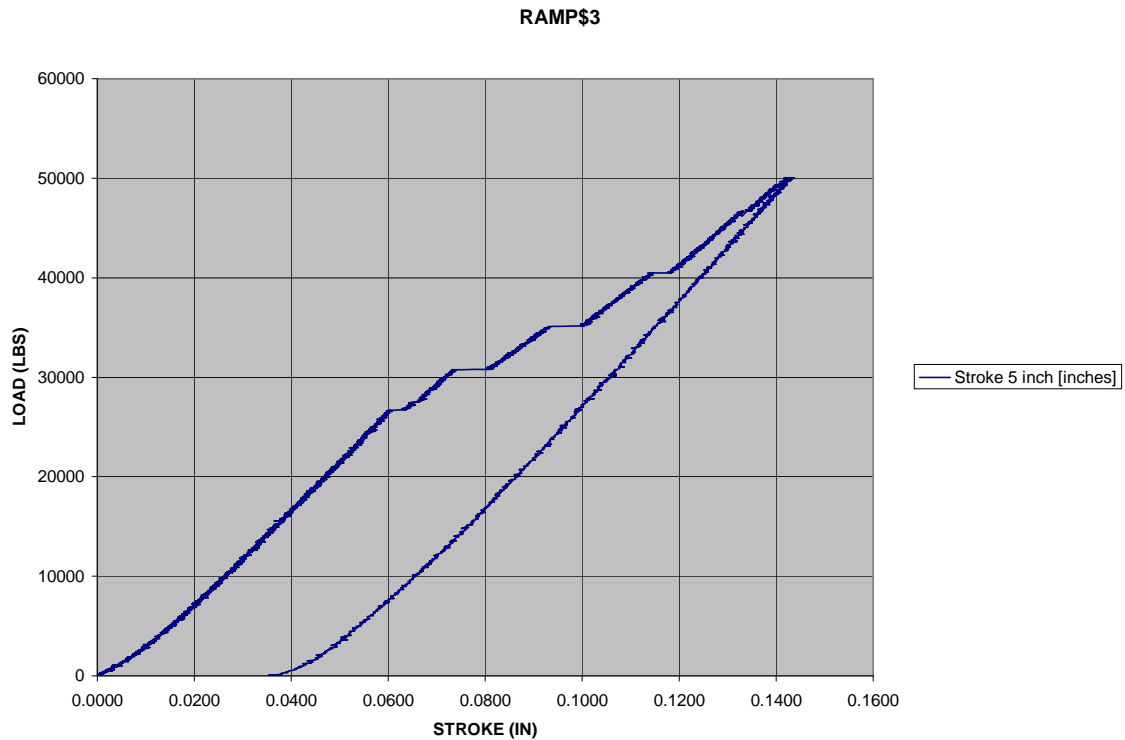
The joint showed a sudden slippage at 26,700 lbs and continued to load to 50,000 lbs with four more slippage events. The first event correlates to a coefficient of friction of 0.59 with an uncertainty of $\sim \pm 0.9$. It was not possible to determine if one side broke free before the other or if subsequent events were the same side or the opposite side of the joint releasing, nevertheless, the results do give a minimum value for the joint friction and it is in close agreement with other testing at PPPL.¹ **Figures 8 and 9** show the load curves for the test. Note the close agreement of the LVDT readout with the load train readout at the slip point. The LVDT readouts show a non-linearity at ~21000 lbs but there

Figure 8. Load train readout showing slippage during the loading.

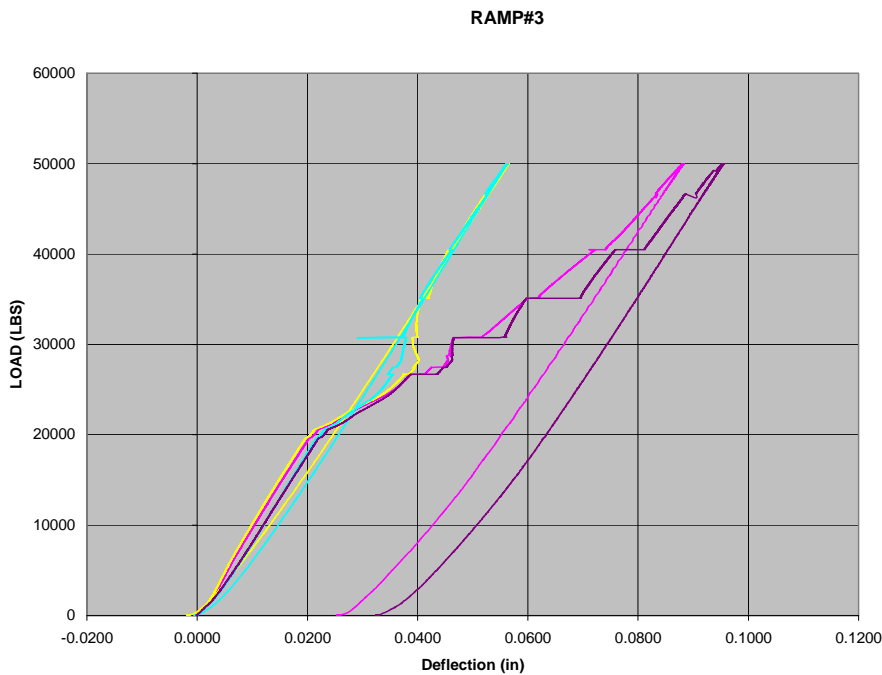
is no relative motion, therefore, no slippage has occurred between the halves of the assembly. The perturbation is probably a thermal effect due to a change in gas flow.

Figure 9. LVDT readout showing slippage during the loading.

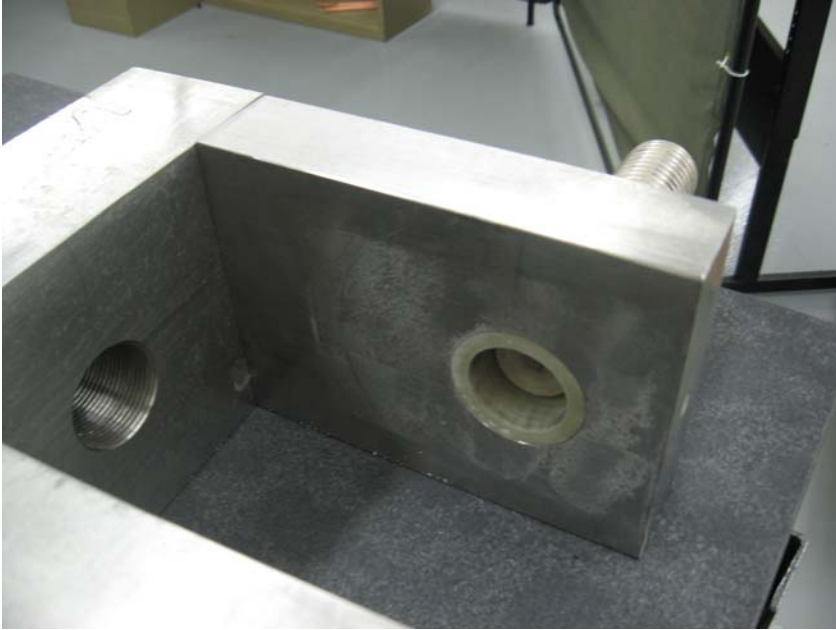
surface. Fine white alumina powder was evident on the matching stainless surfaces. See the photographs in the appendix. The as-coated surface was not perfectly smooth to begin with and showed a rather dimpled or “orange peel” appearance under magnification.

Outer trunnion showing powder after completion of testing.

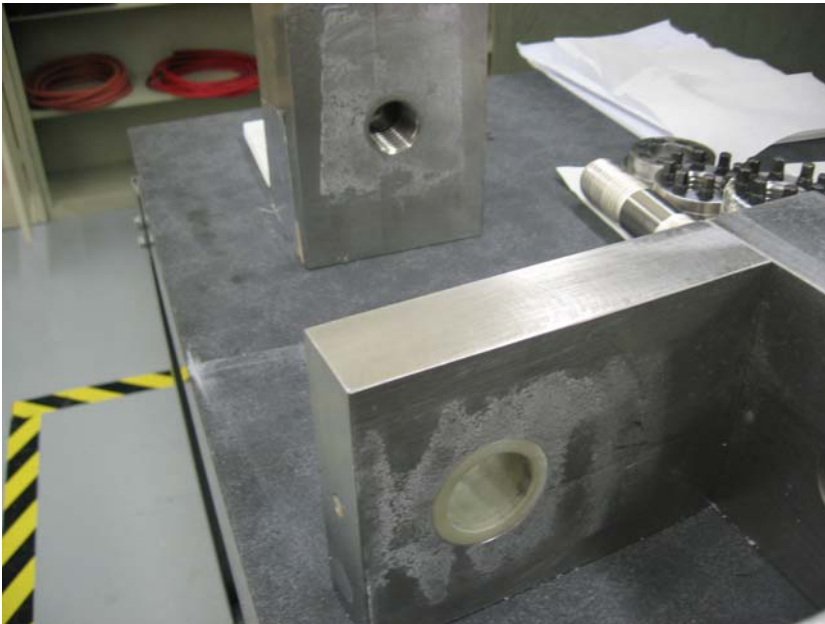
Other half of trunnion.

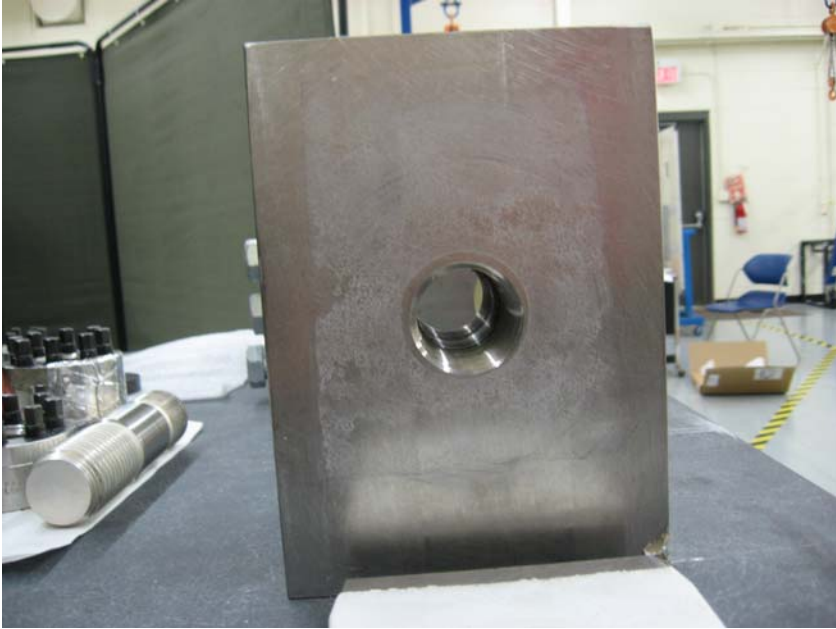
Center trunnion showing powder after completion of testing.

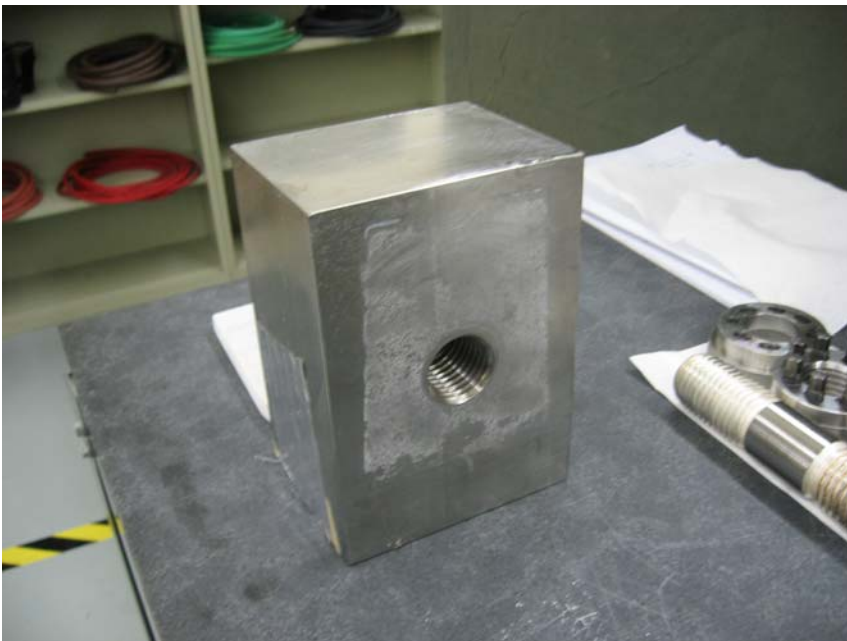
Other side of trunnion.

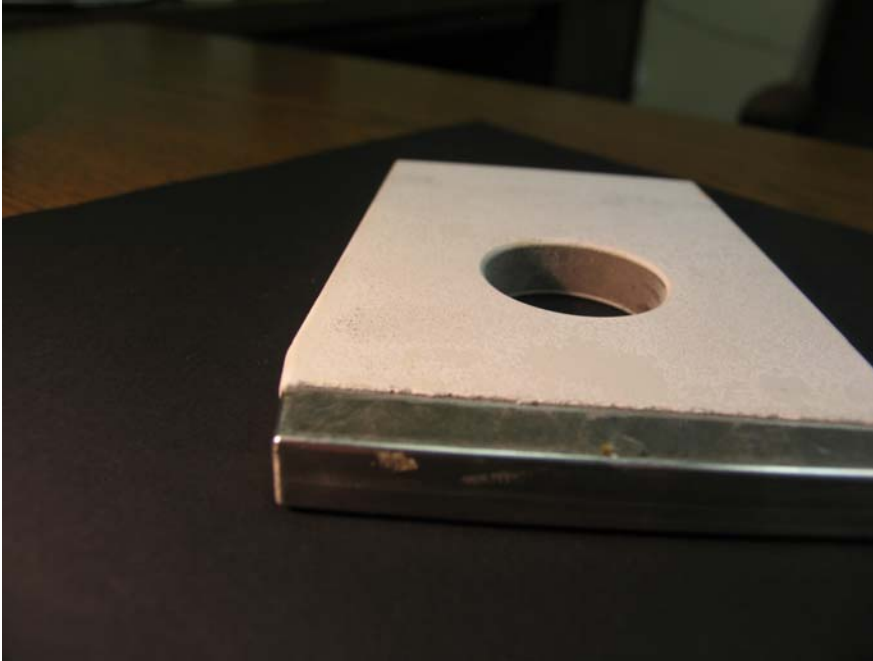
The shims were undamaged but did indicate some wear, with a somewhat frosted appearance in a ‘quilted’ pattern that was not there initially. Under 10 power magnification this pattern seemed to be concentrated on the high points on the alumina

- The slight loss off the alumina surface is probably due to a combination of the stress concentration on the high points of the surfaces and the differential movement during cooling and heating, not slippage during testing, as the data indicated no such events. The alumina may benefit from a smoother (ground) surface to reduce the local stressing of the coating. This would probably change the friction coefficient, however.

Shim after cycling test, showing “quilted” pattern on alumina.

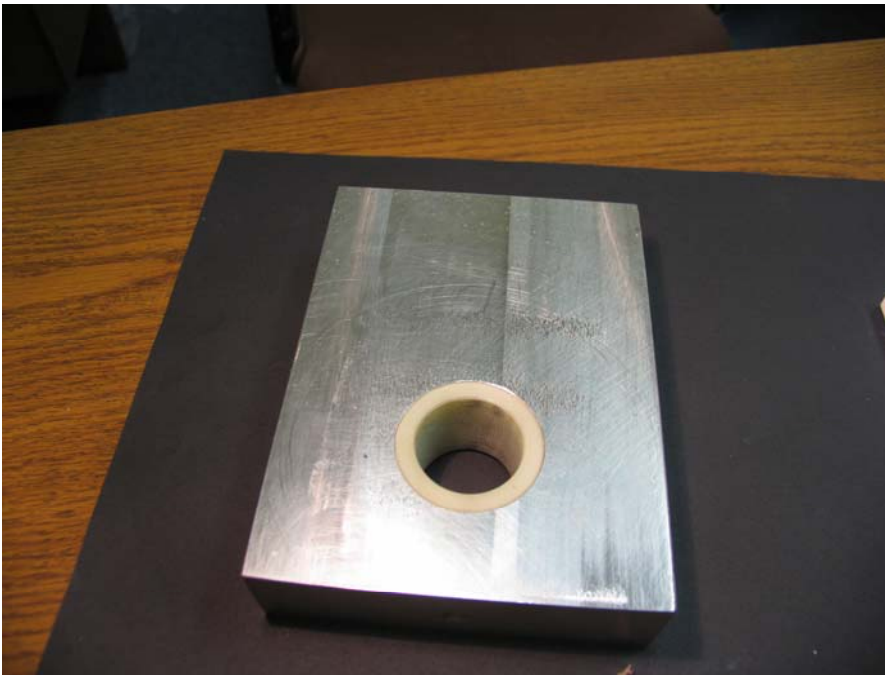
Outer trunnion showing scratch pattern after testing was completed.

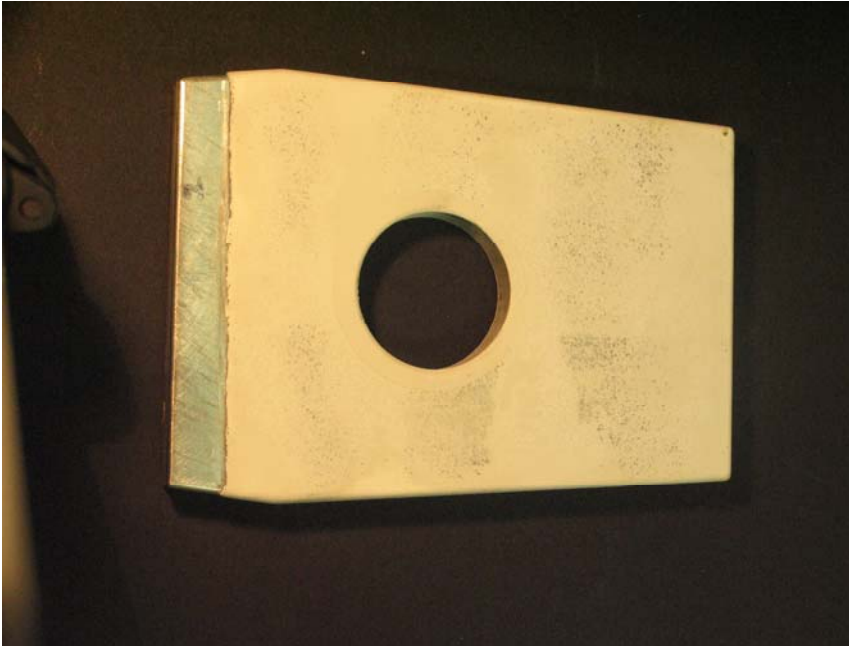
After completion of testing the unit was disassembled and the shims inspected for damage. The only change from the inspection after cycle testing was the presence of stainless steel transferred onto the alumina. The slippage appeared to have sheared off material from the stainless surfaces, leaving a visible pattern of pits and scratches in distinct horizontal stripes (at least 4) on the stainless. A matching pattern was evident on the mating shim surface and the pattern was approximately the same on both sides of the assembly, indicating both shims had slipped during loading.

Stainless material on shim after testing was completed.

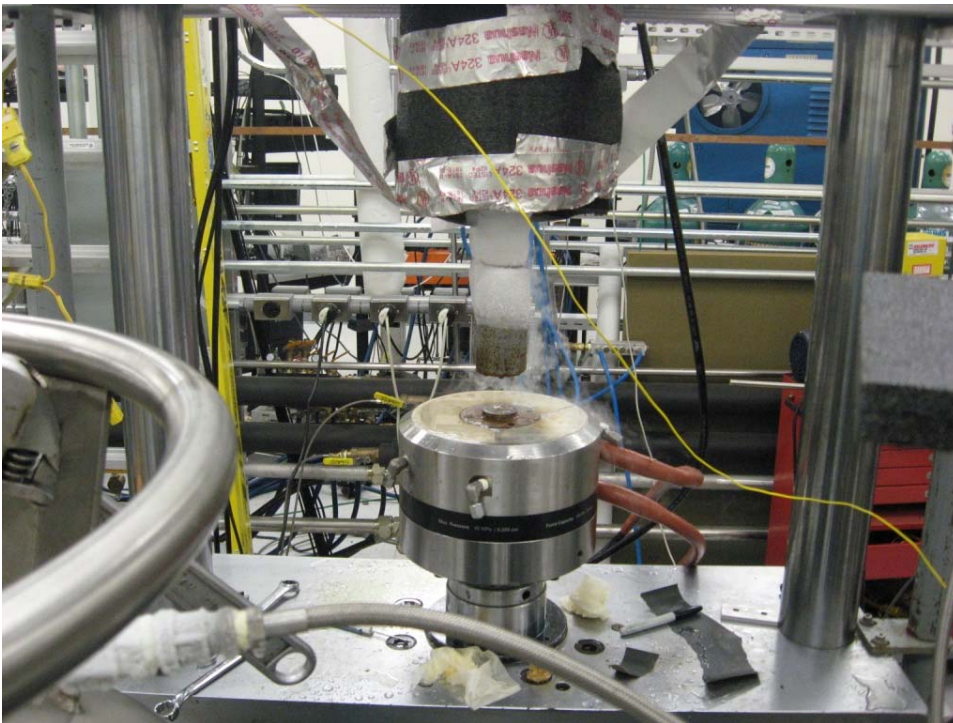
The fatigue (or cyclic) test was performed first with the preload for the jack screws set at 35 ft-lbs of torque (70,000 lbs to 76,000 lbs compression on the joint). The tension load was cycled between 0 and 50,000 lbs at the rate of 1 hertz for 100,000 cycles. The test was interrupted due to the breakage of a threaded adapter at approximately 17,000 and 60,000 cycles. The adaptor was located at the top of the pull rods and did not impact the test when it failed.

First Breakage of Coupler

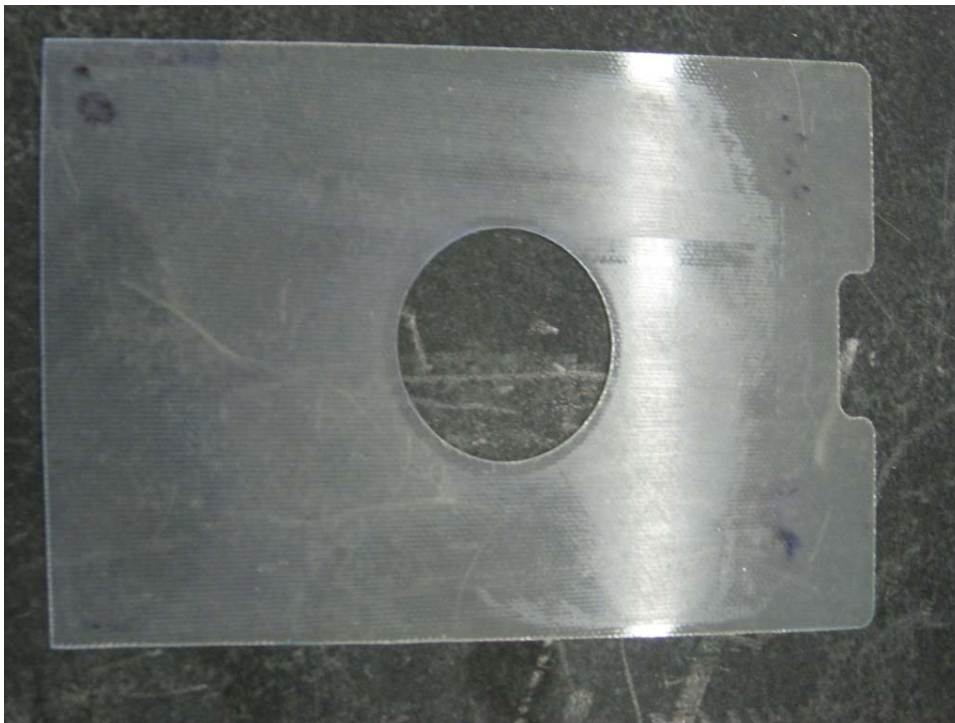
The assembly was allowed to return to room temperature and disassembled. Visual inspection of the g-10 material showed only a slight "scuffing" of the surface (see pictures). There was no cracking or breakage of the g-10 material and there was no visible g-10 residue on the stainless steel surfaces as there had been with the alumina shims.

Scuffing on g-10 shim after testing

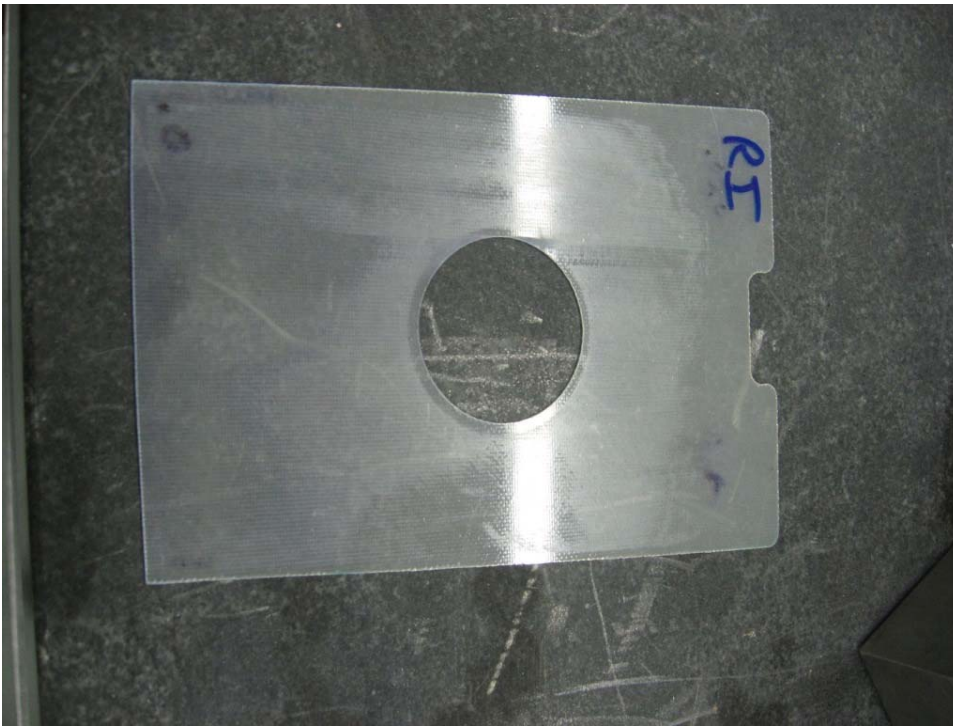
Scuffing on g-10 shim after testing
