SE141-115 B2  
NC20670 attachment

*Major*  
Tool & Machine, Inc.

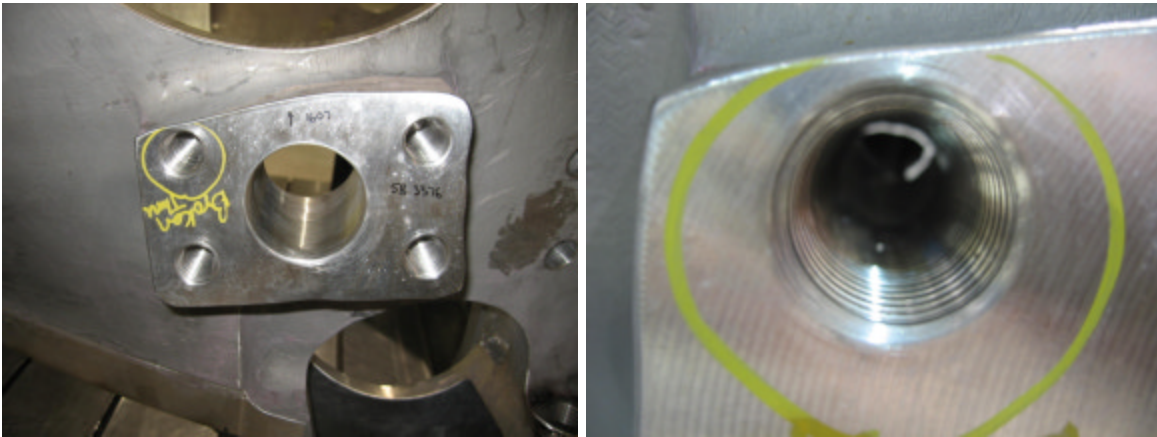
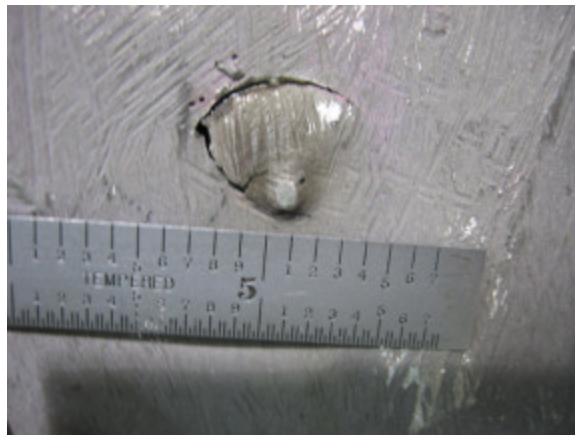
1. Tapped hole broke thru inner casting wall. This pad is located on sheet 3, zone C6 of the drawing.

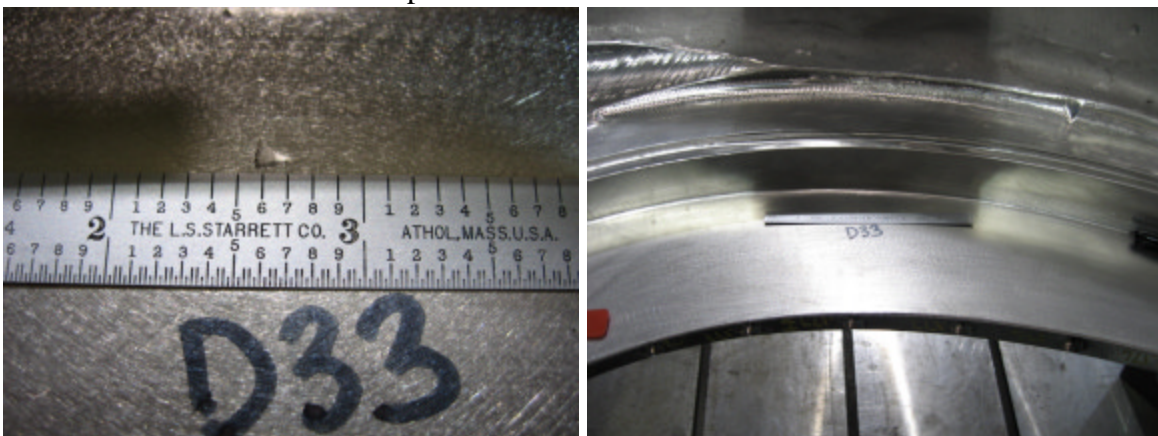
2. Small tooling gouge on long leg of T on D side near hole 33. Gouge is approx. .120" x .08" and less than .010" deep.

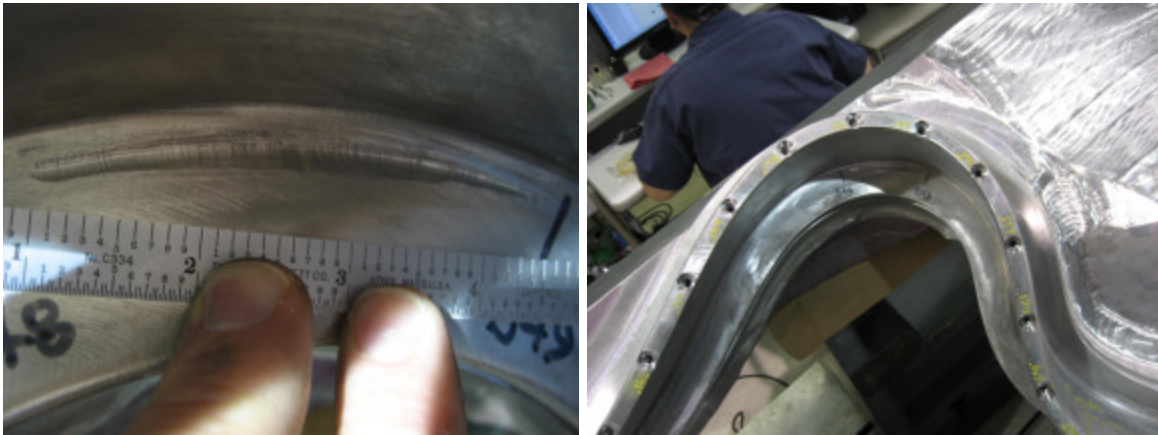
3. Tool gouge located on short leg of T on the D side between T holes 48 and 49. The gouge is approx. 3.5" in length and is .03" - .04" deep.

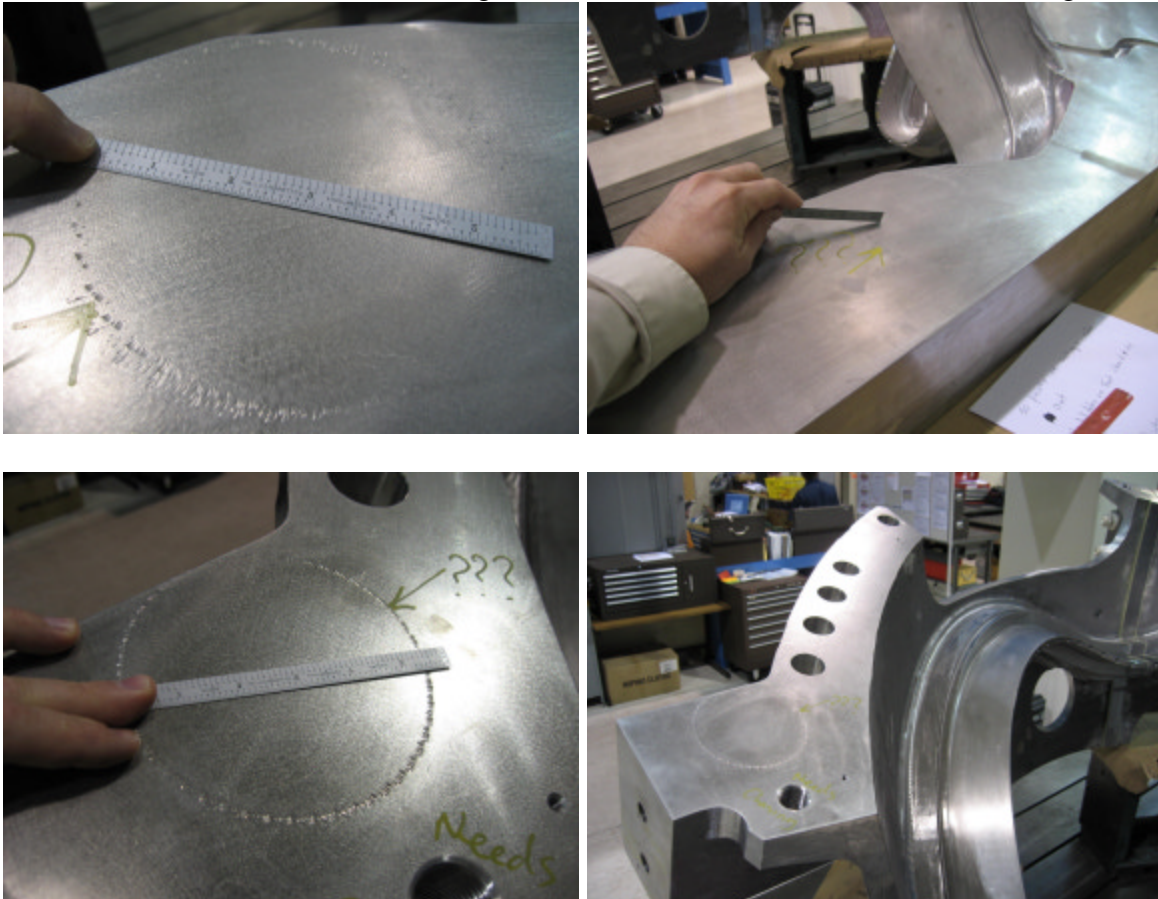
4. There are two areas on the D flange face that have chatter marks from the facing tool.

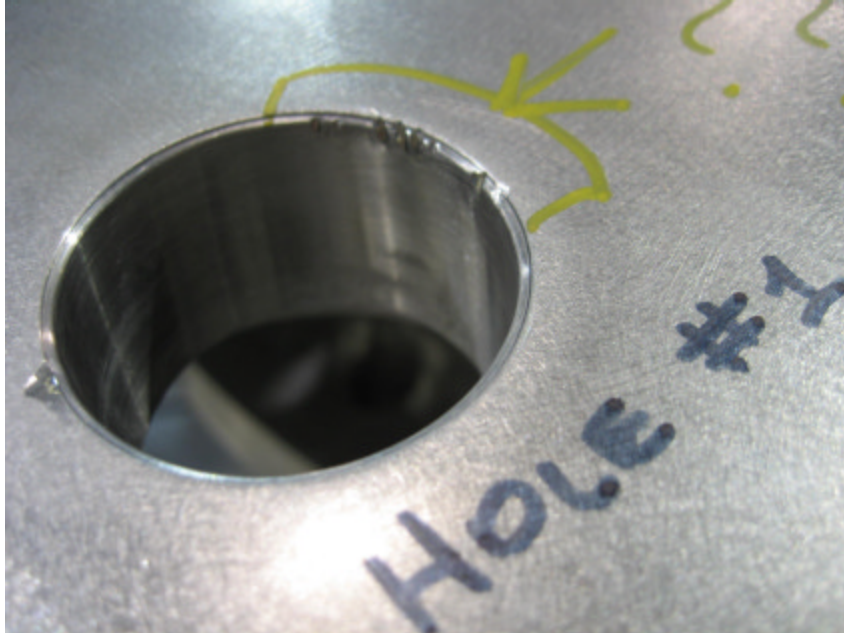
5. Gouges around the chamfer of the 1.885 thru hole located on D flange hole 1.

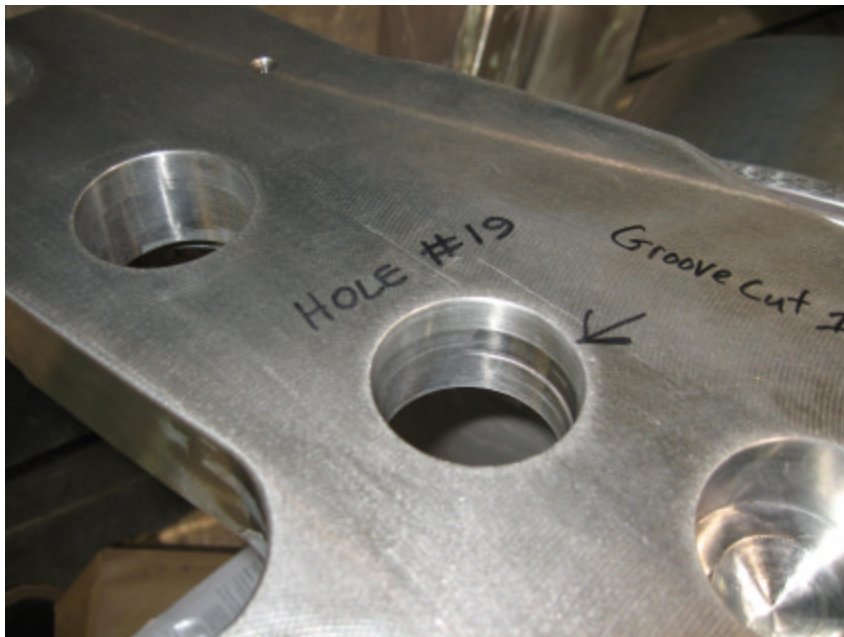
6. Groove in the 1.885 thru hole located at D flange hole 18. The groove is approx. .018" deep x .400" wide and is visible on 50% on the diameter.

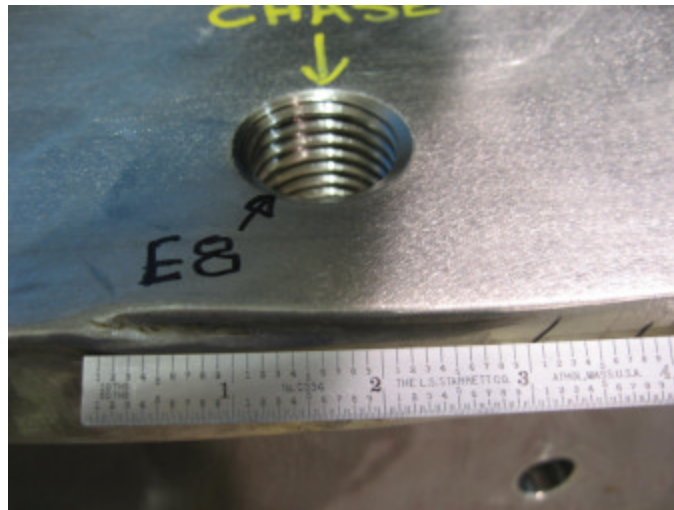
7. Gouge on outer edge of E flange perimeter near hole #8.. Defective area has been blended smooth and all raised metal removed.

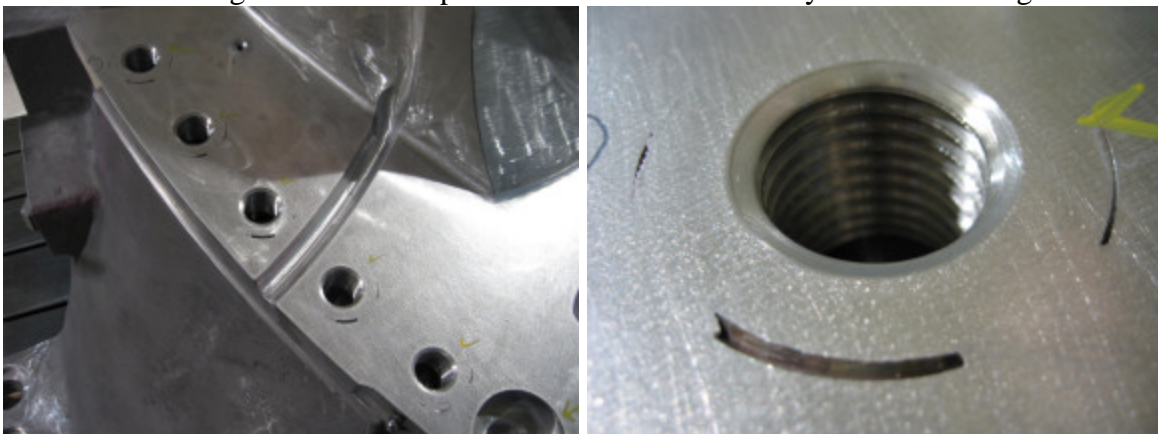
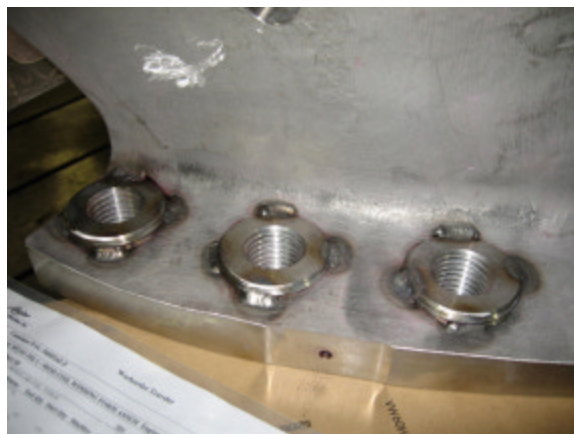
8. The pictures below are of the flange holes repaired under NC20449. There is no nonconforming condition to report but I felt this was worthy of documenting.

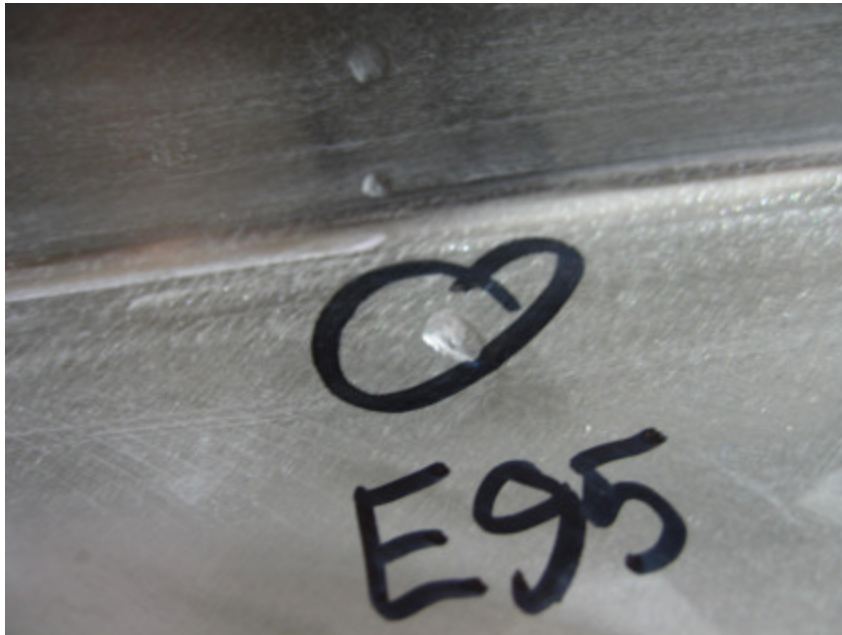
9. Small tooling gouges located on long and short legs near hole 95 on the E datum side of part. Largest defect is on long leg (.200" x .100" .010" deep).

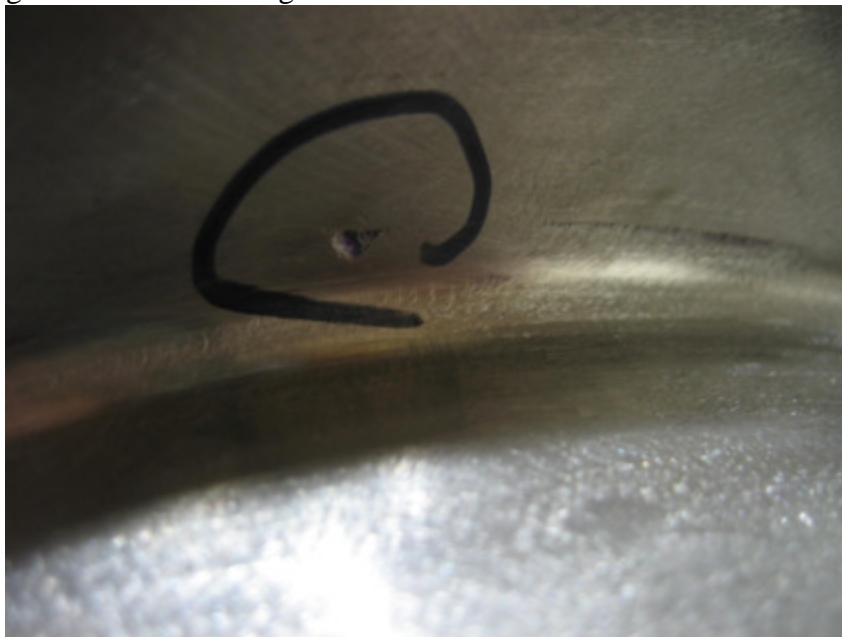
10. Tool gouge located on short leg of T near hole 77 on E datum side.
