NC21265 – A5 Visual Review

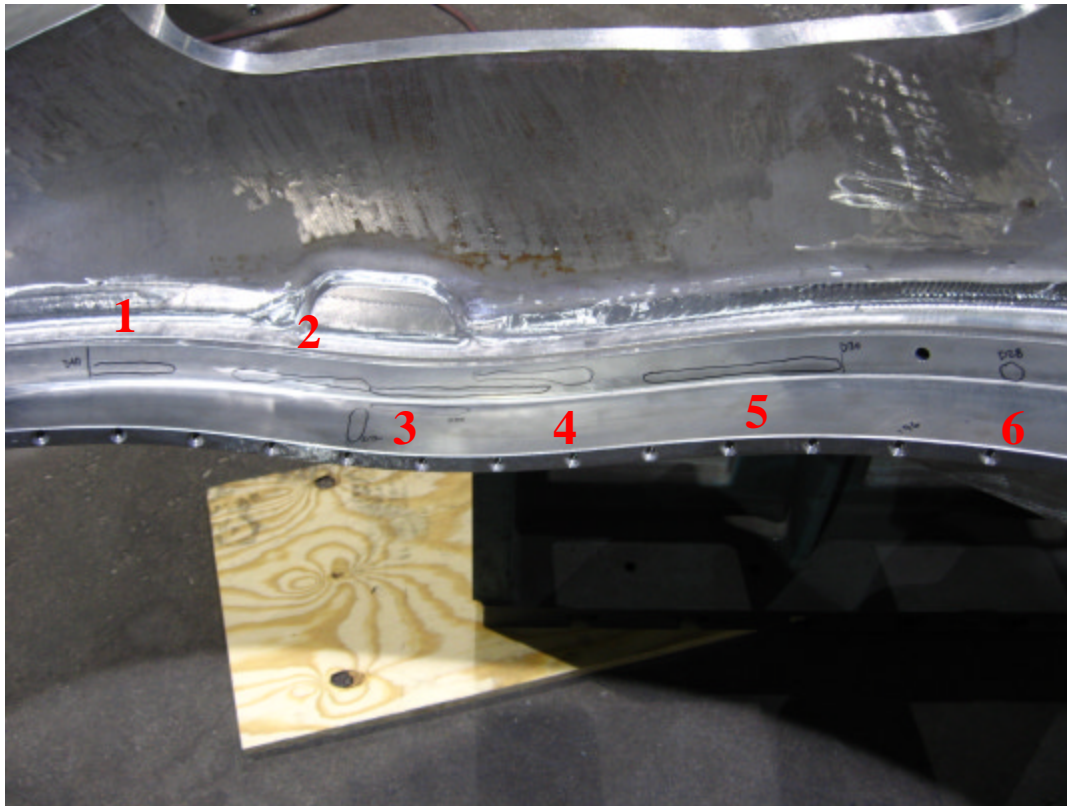
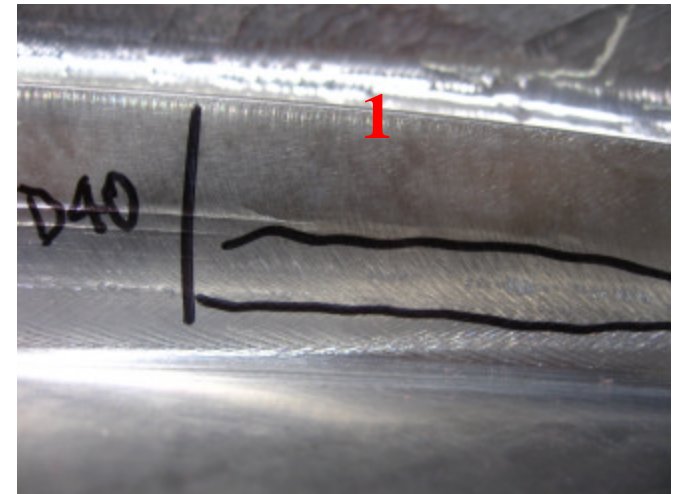
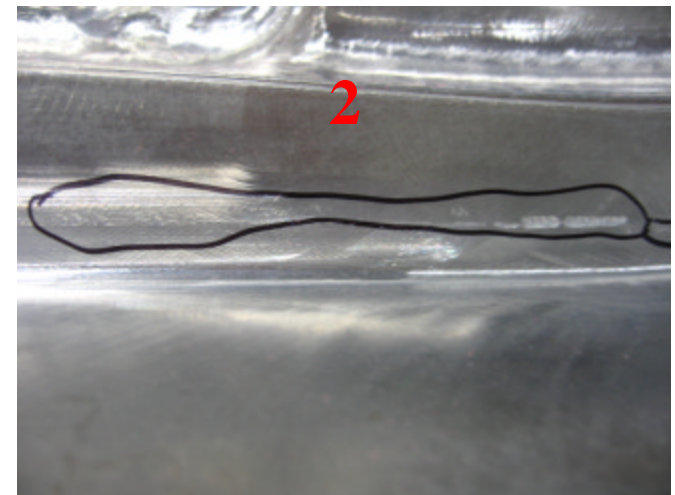
There are several shallow tool marks (<.010”) on the datum D side between T holes 28 and 40. These are shown on slides 1 and 2.

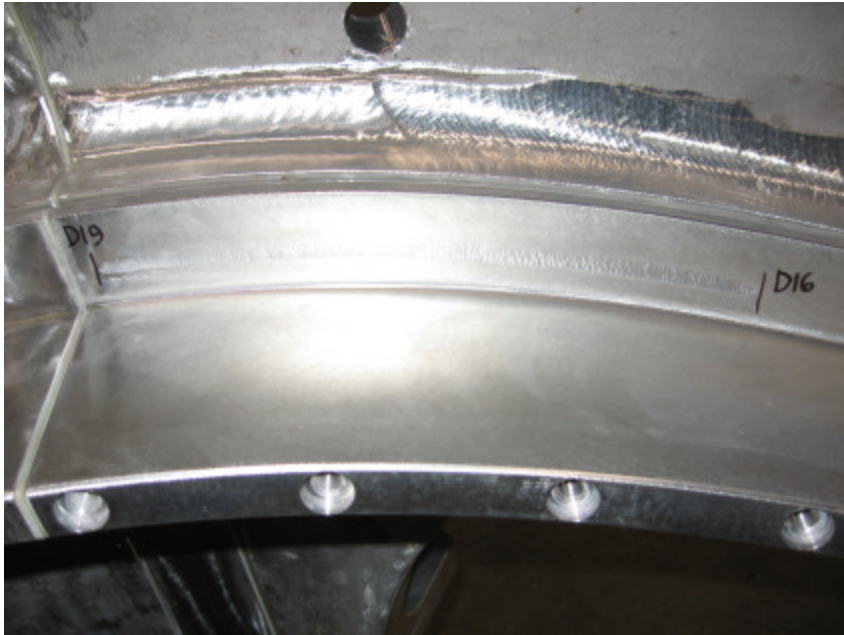
Shallow tool mark on D side short leg, between T holes D16 and D19.
Tool mark is $<.005$ " deep.

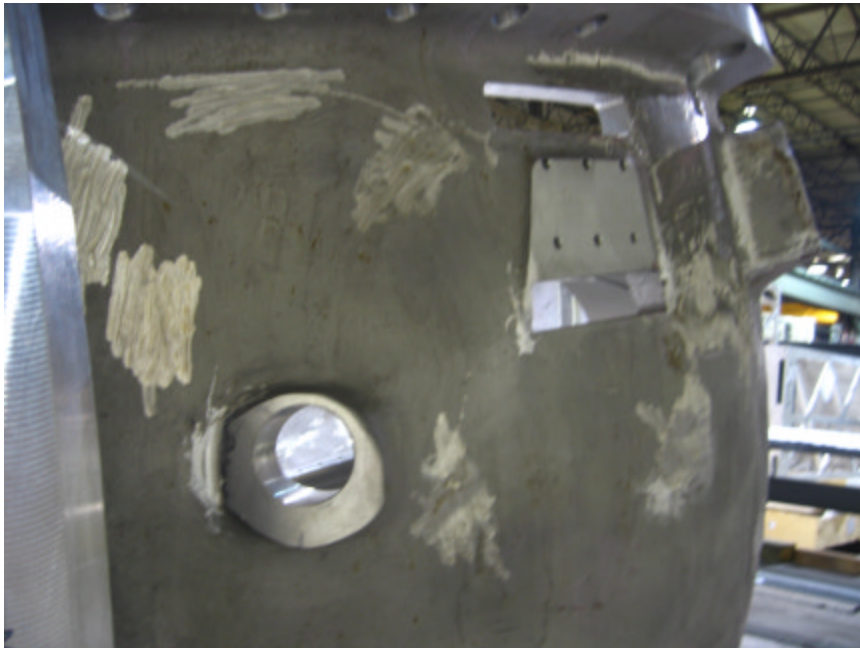
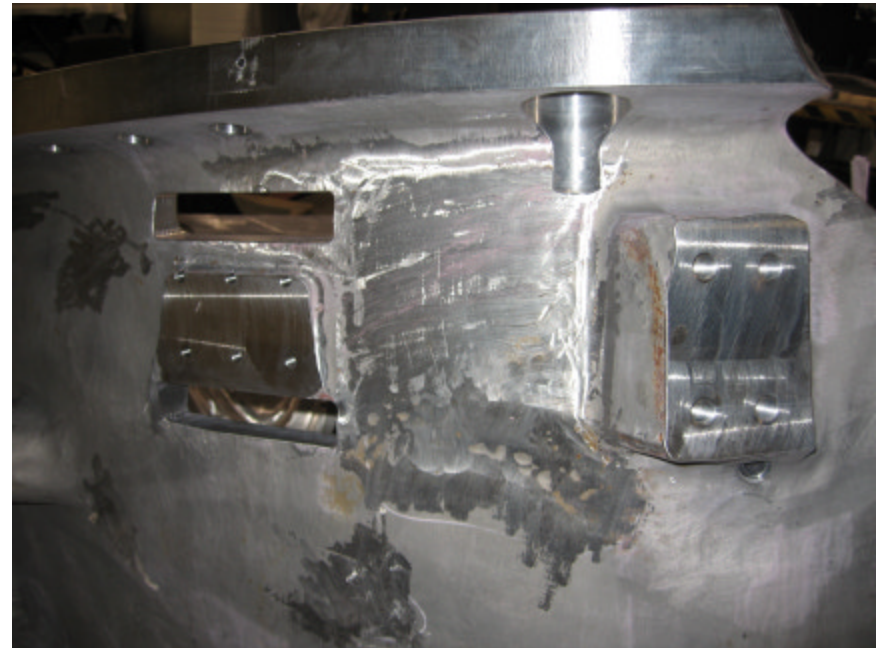
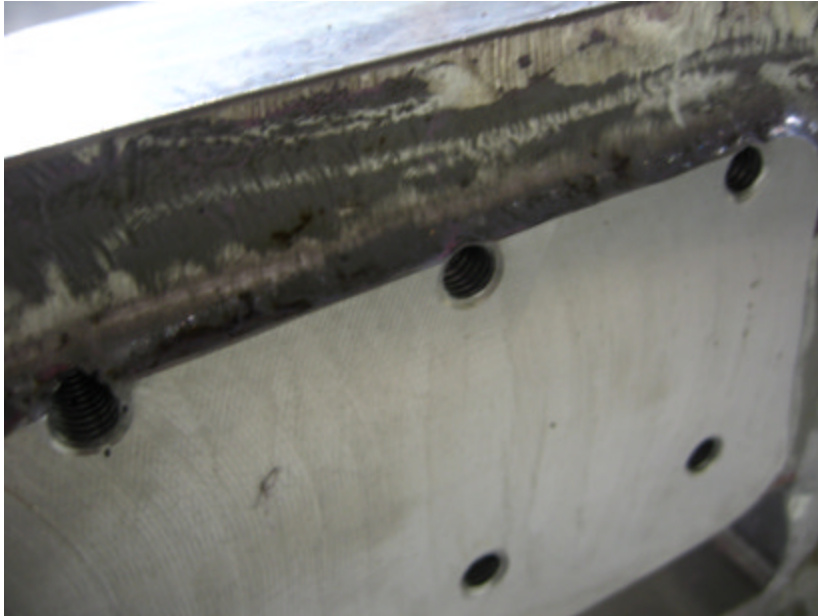
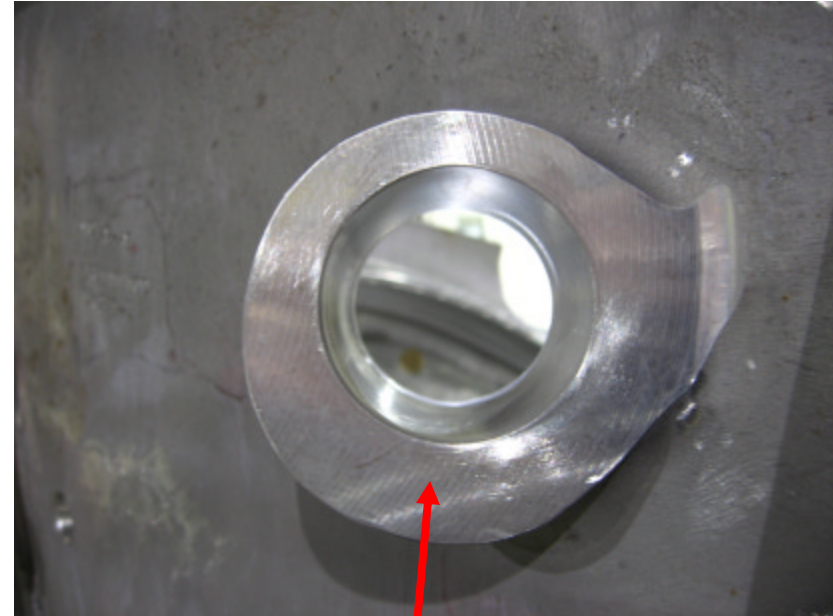
It appears that the casting stock was not balanced as well as it could have been when the casting was qualified on the 1st roughing operation at MTM. A rotation of approximately .400" near the lead block area would have improved this condition. This resulted in a thicker flange on datum D and a thinner condition on datum E (as reported in previous slide). This also affected the lead pad and the cast stock around the 2.5" holes (see next slide).

The picture above and the one in the previous slide show how the hole is shifted relative to the cast stock.

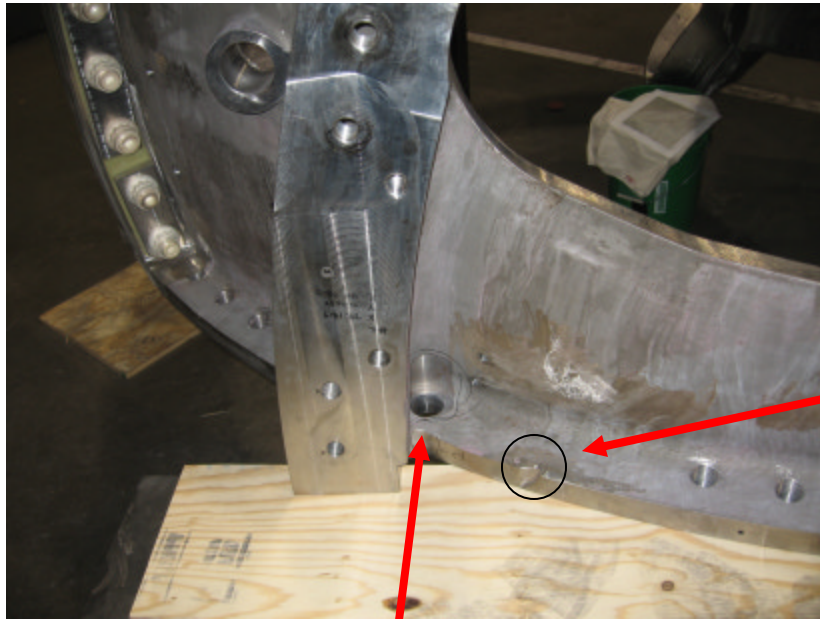
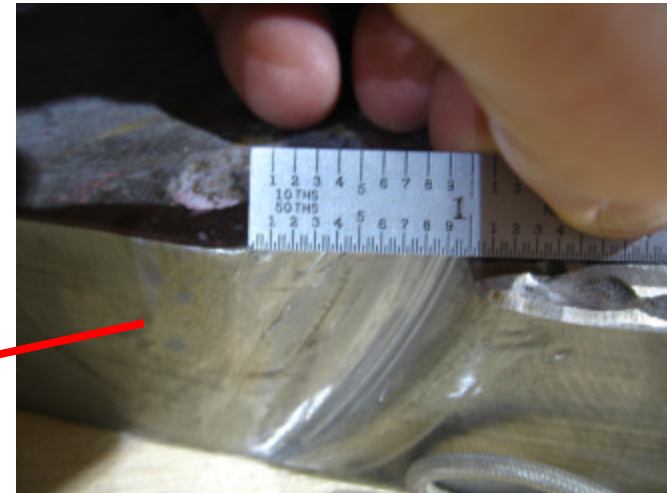
Tool Gouge on perimeter of Datum E flange, approximately 1" wide by .50" deep.

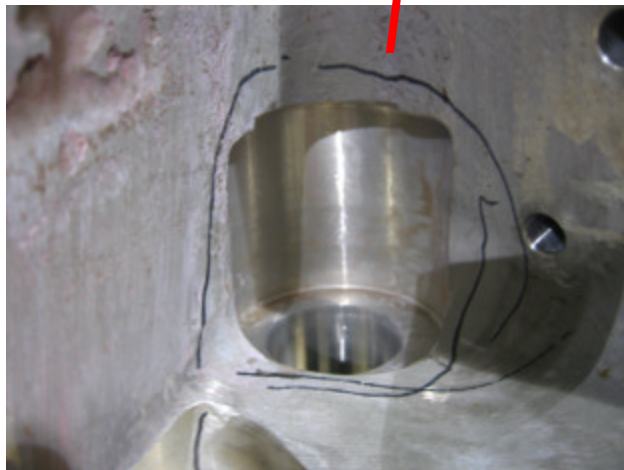
Picture to the left is of the 3" counterbore in the datum E flange as reported on NC21252 step 810. Area shows heavy stock around hole (too much to grind).

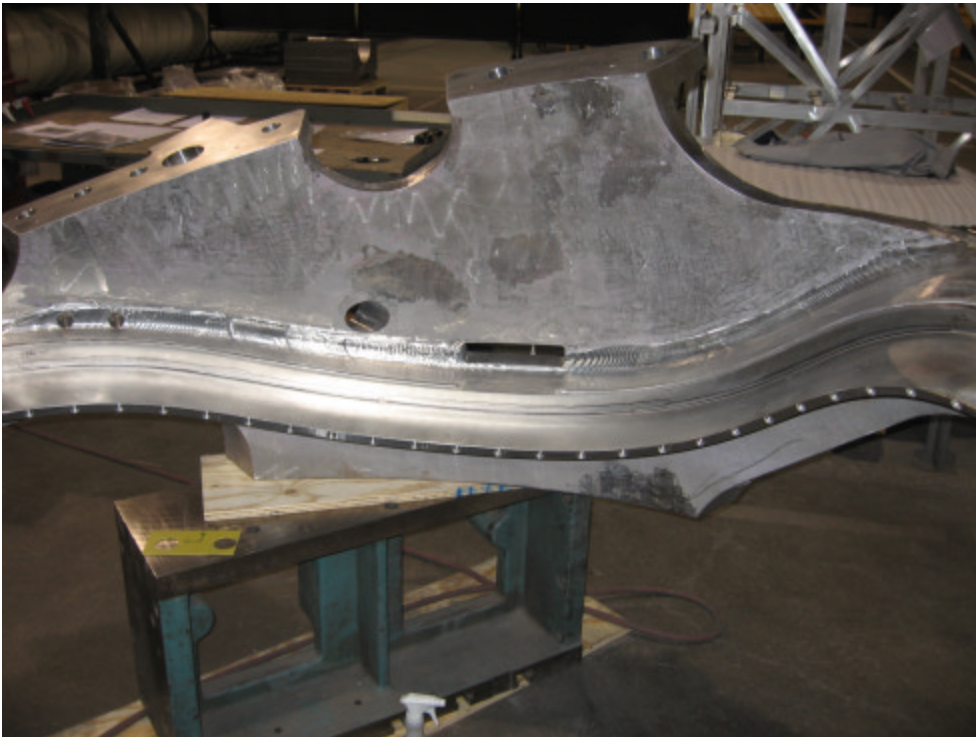
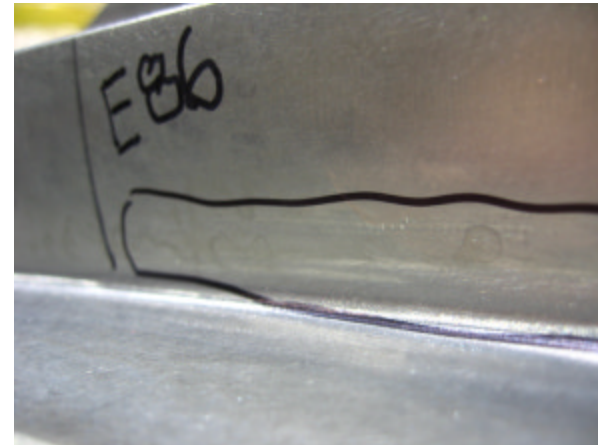
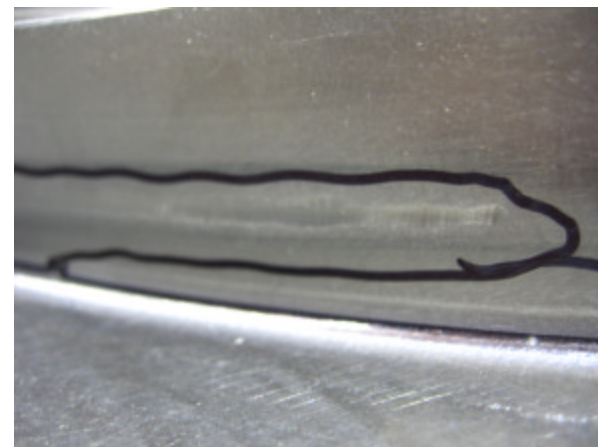
Shallow tool marks on short leg of E side from T hole E86 to E1 thru E12. Marks are less than .005” but in too big of an area to try to blend out. Pictures to the right are close-up of the tool marks but even in the picture they are hard to see

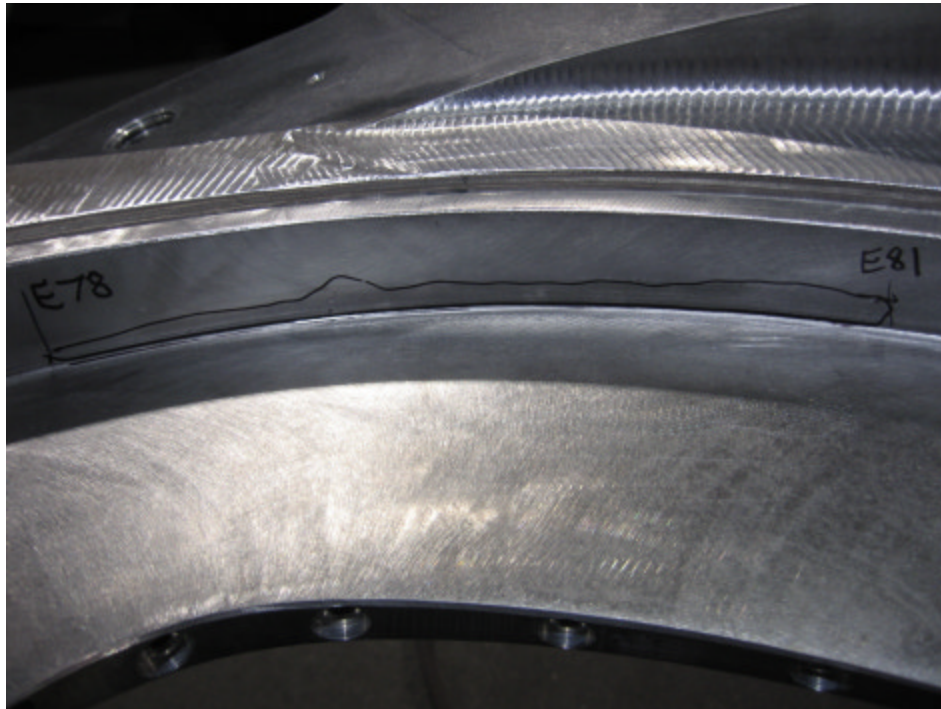
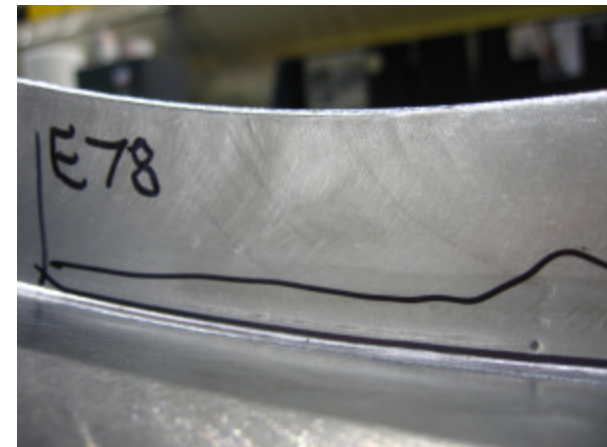
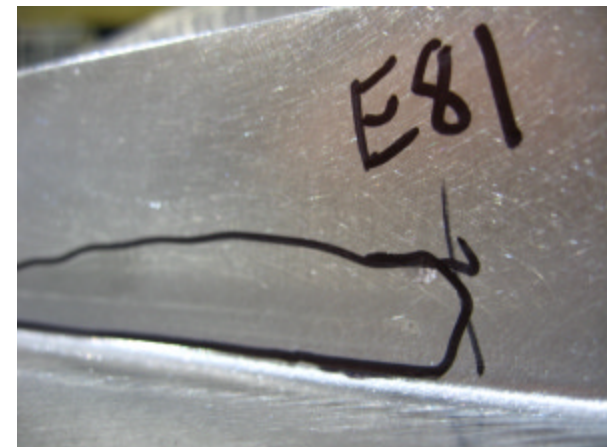
Another area of tool marks between holes 78 and 81 on the E side short leg. Again, very shallow (<.005”).
