**Customer: PRINCETON PLASMA PHYSICS LAB**

Drawing ID: SE120-004

Nonconformance Report: Major Tool NC19562

This is for SE120-004 VVSA #2 end flange fit up and weld.

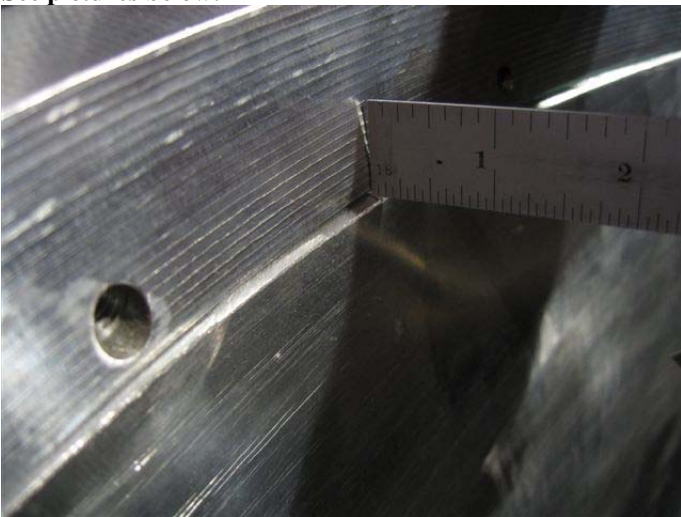
8 O'clock Inside of Flange B

THE RESULT OF PROFILE DEVIATION ON THE VESSEL ENDS CAUSES A MIS-ALIGNMENT TO THE VESSEL FLANGES. REFER TO PHOTOS FOR ADDITIONAL DESCRIPTION.

RECOMMEND LEAVING THE VESSEL WALL IN ITS CURRENT POSITION AND ALTERING THE WELD SCHEME TO BLEND THE TWO SURFACES TOGETHER IF NO ASSEMBLY OR PLASMA INTERFERENCE EXIST

Rework as Recommended by MTM.  
Ensure weld size is equal or greater to original.

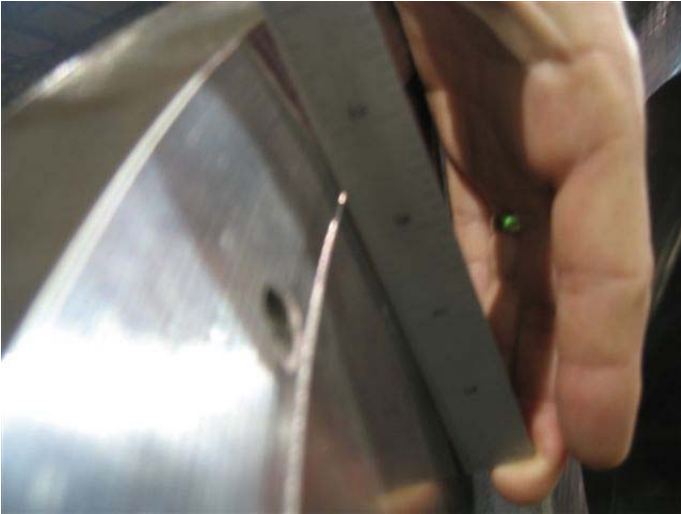
**8 O’Clock Inside of Flange A (nearly flush)**
