SUMMARY OF ELECTRICAL ARC FLASH INJURY AT THE STANFORD LINEAR ACCELERATOR CENTER

October 11, 2004

ACCIDENT SUMMARY

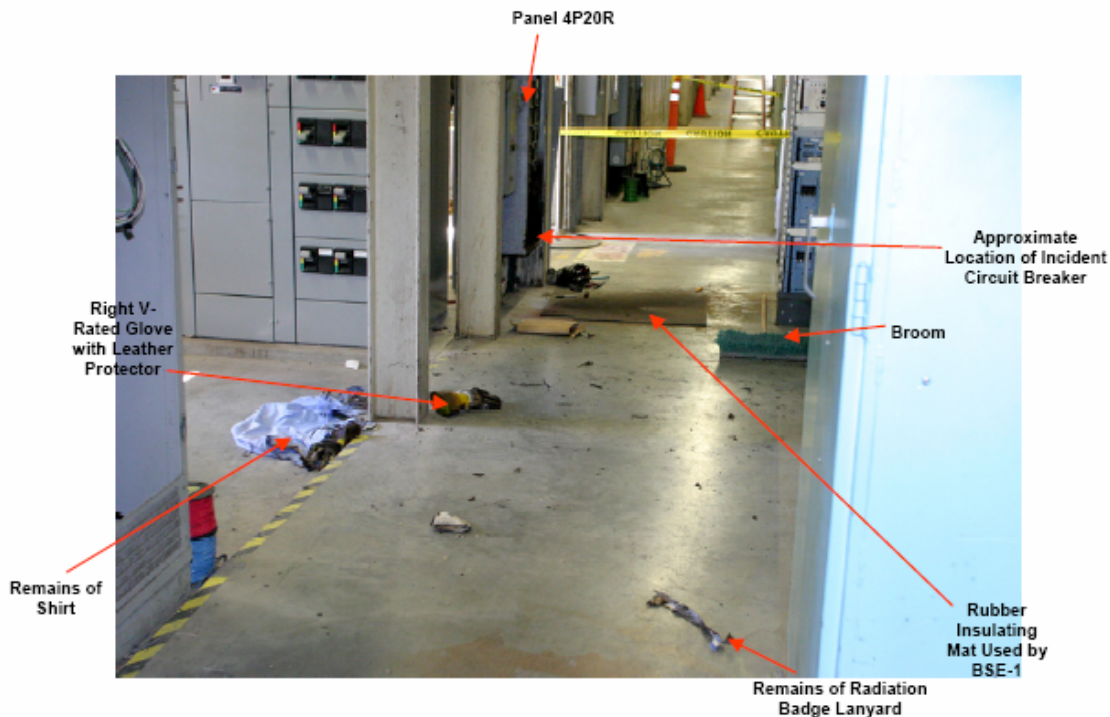
Figure 2-1. Scene immediately after the accident

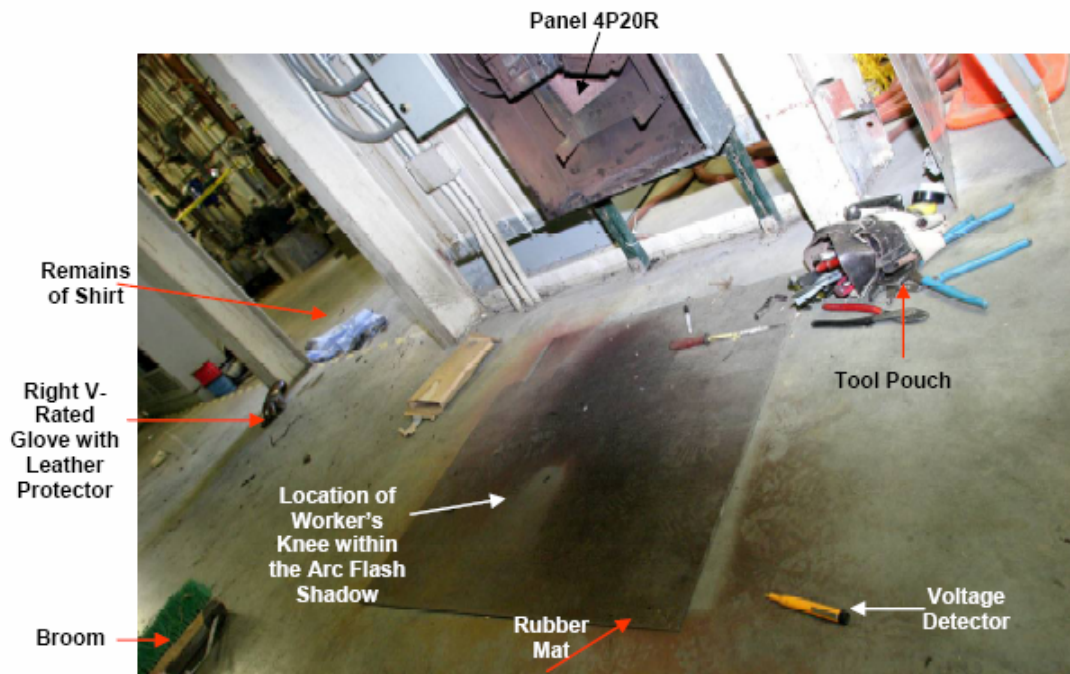
Figure 2-3. The insulating mat with the outline of BSE-1's knee in the arc flash shadow

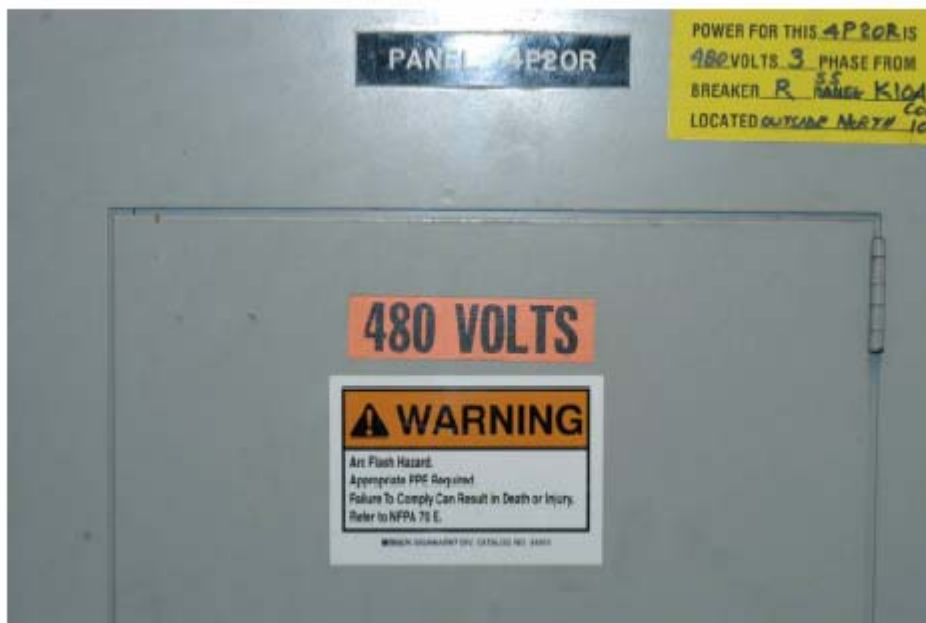
Figure 2-4. Warning label on Panel 4P20R

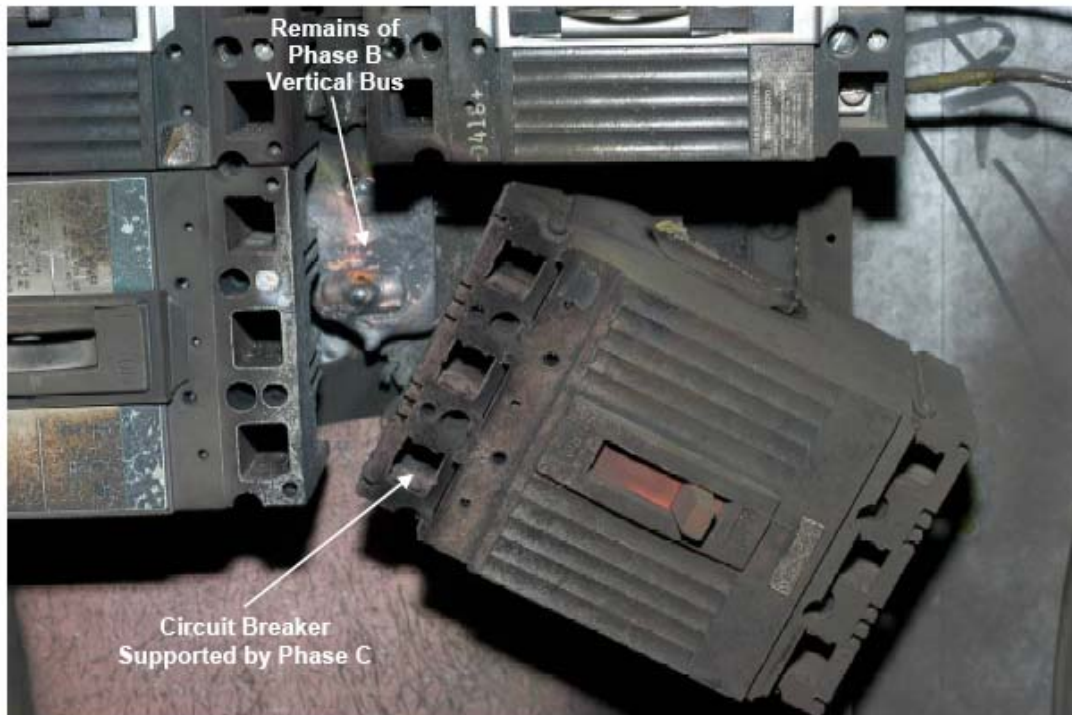
Figure 2-10. Closeup 1 of the damaged circuit breaker panel

The direct cause of the accident was the electricians attempt to install a circuit breaker in an energized Panel. Violations of OSHA, DOE, SLAC, and Bay Span electrical safe work practices increased both the probability that an arc flash could occur and the severity of the resulting consequences.

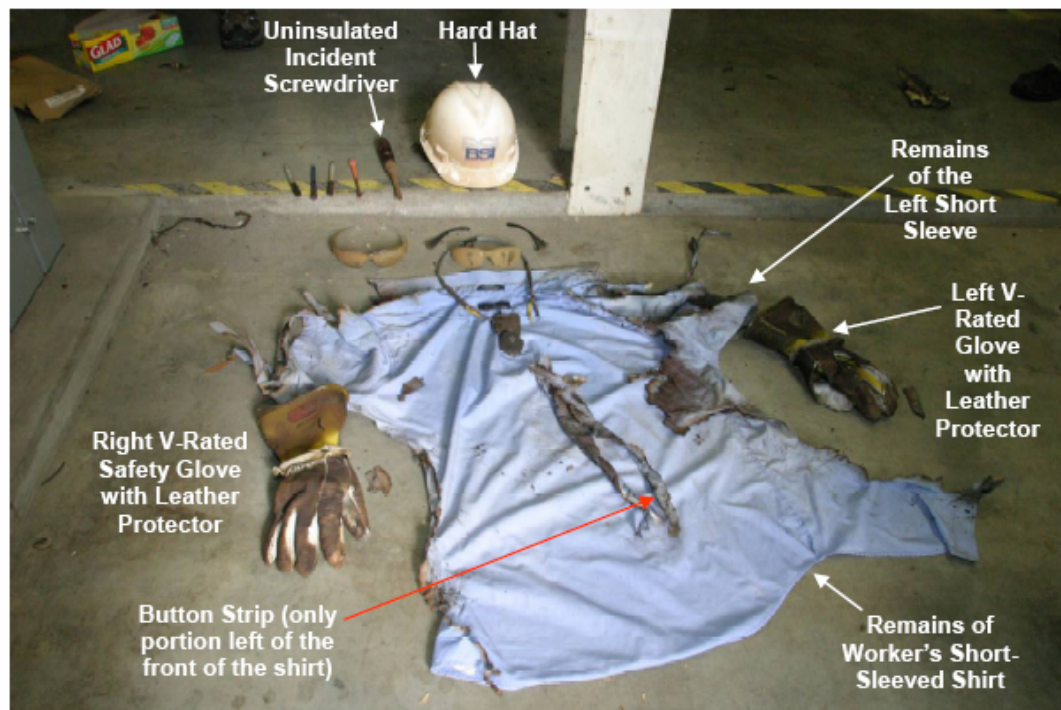
Figure 2-6. BSE-1's burned shirt and his flash-damaged PPE and tools

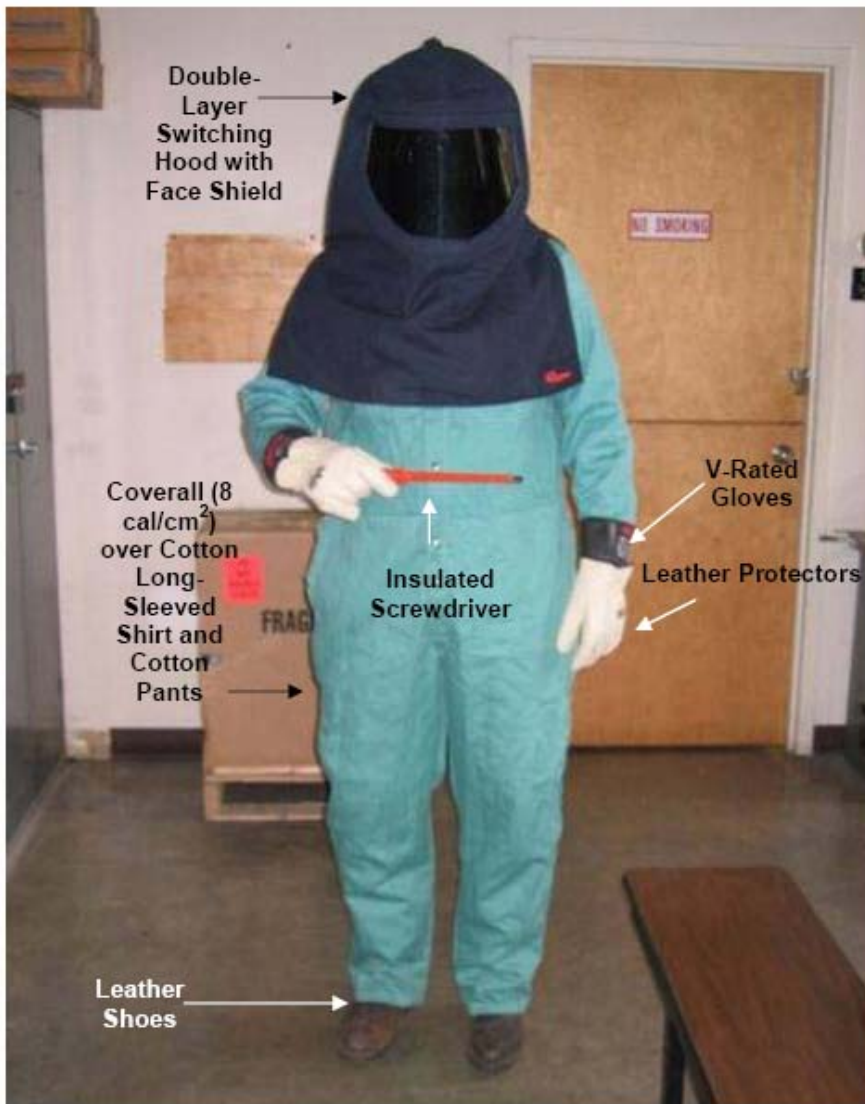
Figure 3-4. Worker wearing the correct protective clothing and PPE

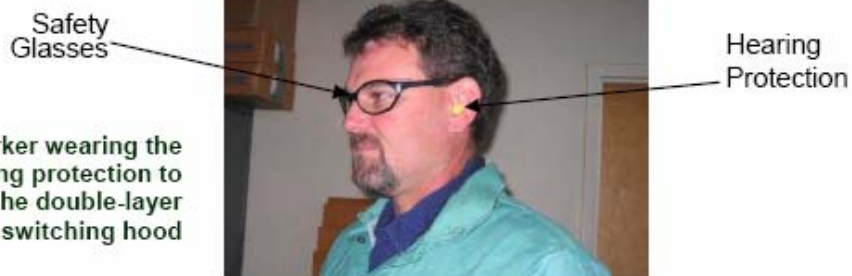
Figure 3-5. Worker wearing the eye and hearing protection to be worn under the double-layer switching hood
