# **C3 Results from Visual Inspection**

J. H. Chrzanowski  
March 7, 2006

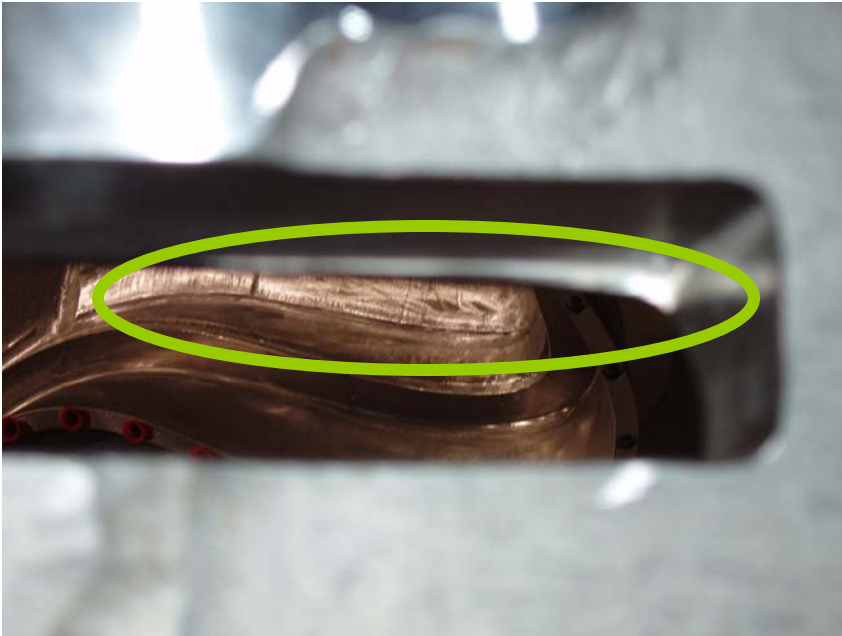
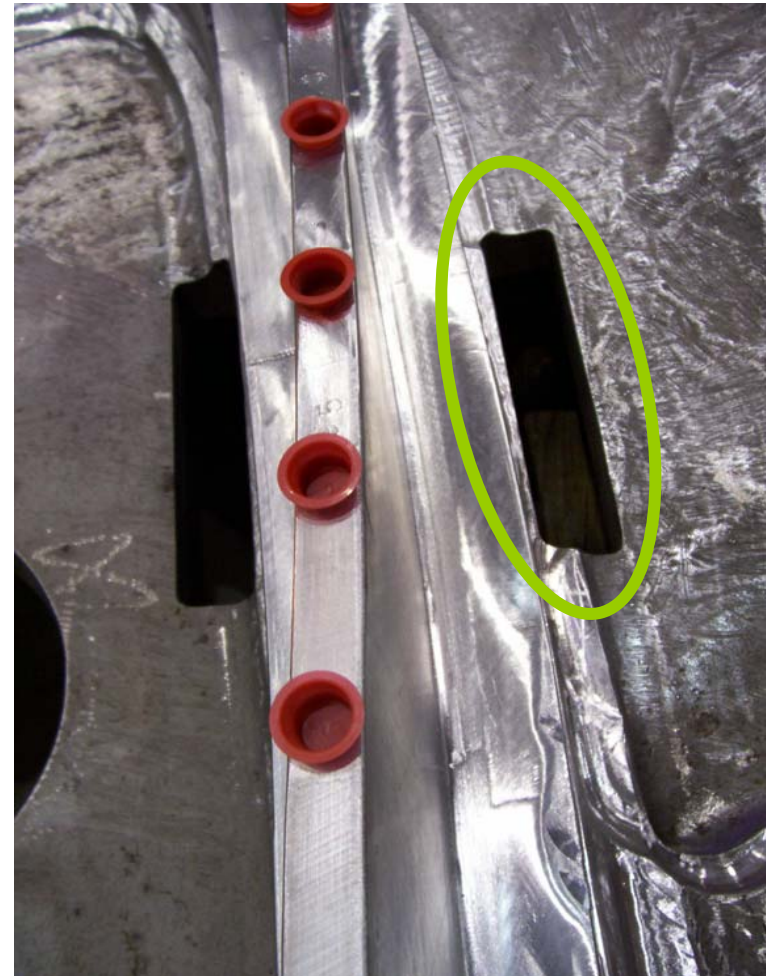
# Lead Area- Slot

- Significant edge was left in lead slot
- Cannot use as is G-11 lead filler will not fit due to clearance
- **This item not identified on NCR**
- Grinding required

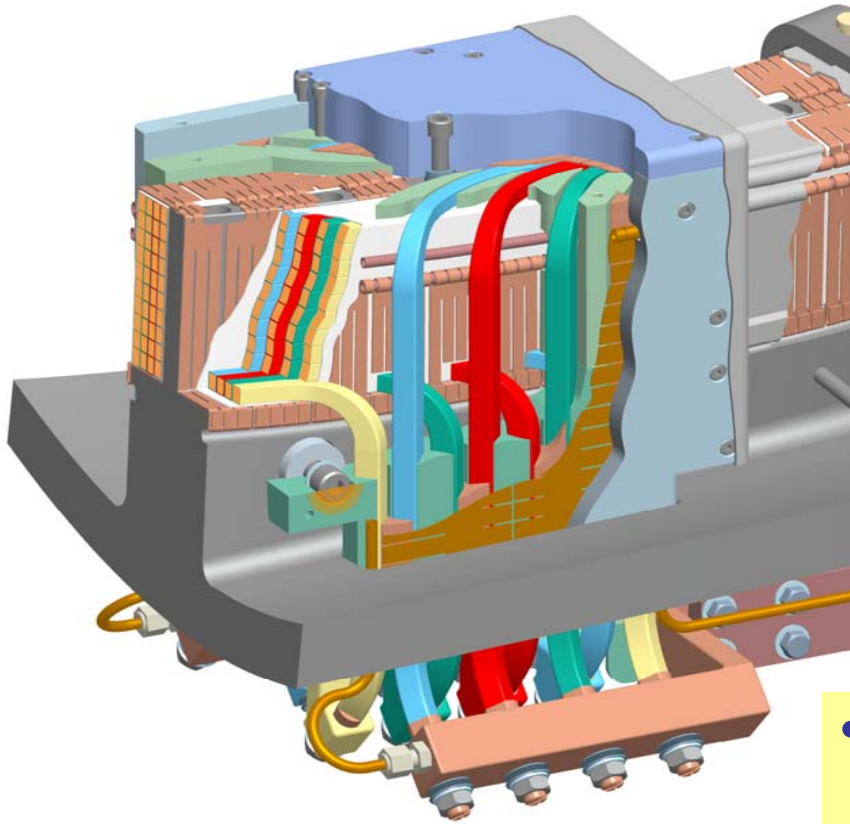
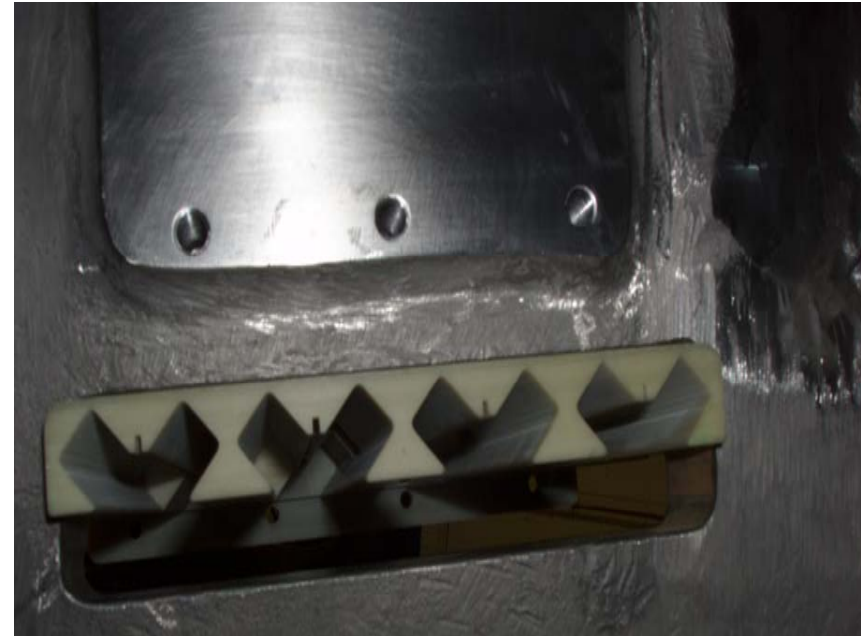
# Lead Area

- G-11 Lead fillers fit tight to the lead opening clearance

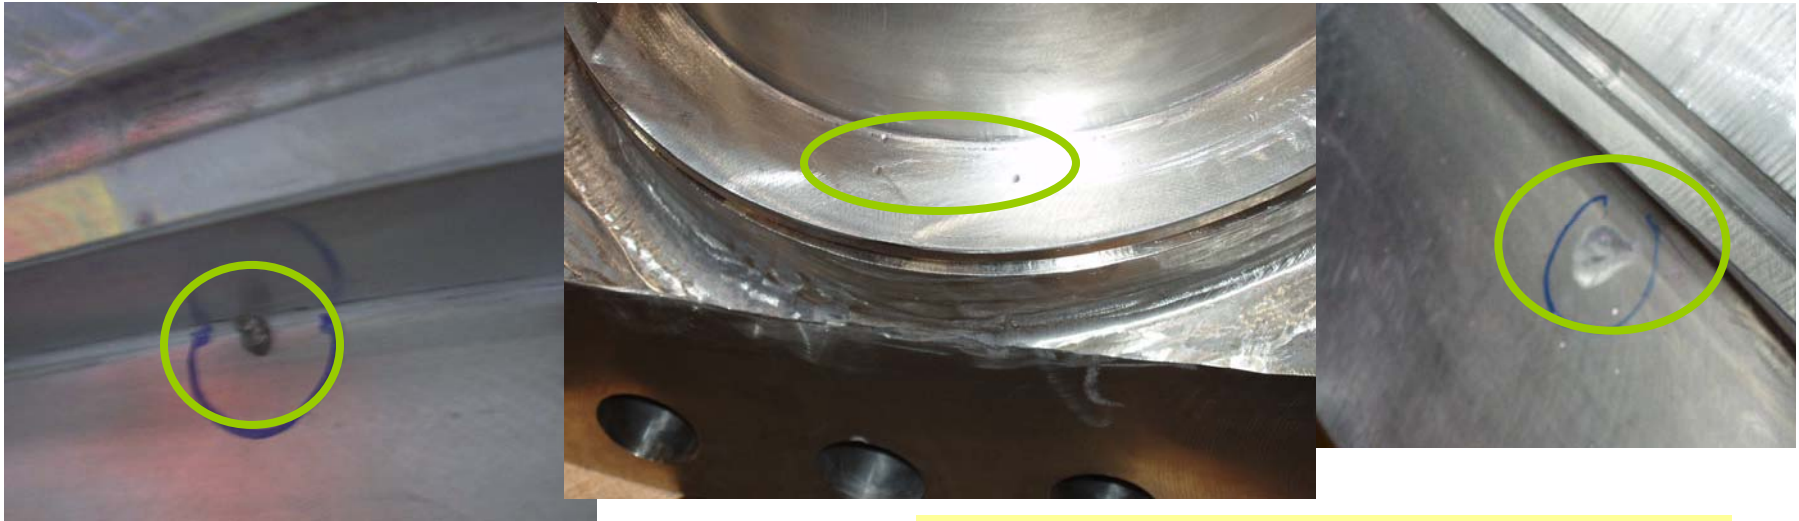
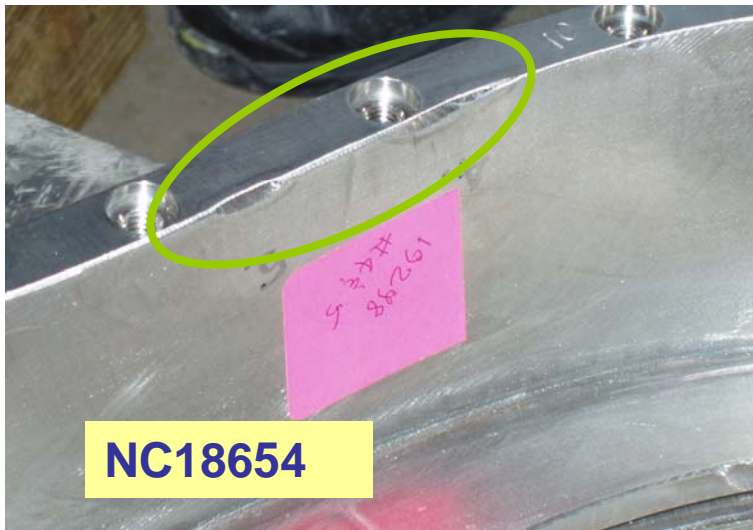
# Divots/ Machining Flaws

Surface divots on winding faces, need to be epoxy/glass bead filled to minimize locking/keying of the VPI'd coil to the winding form

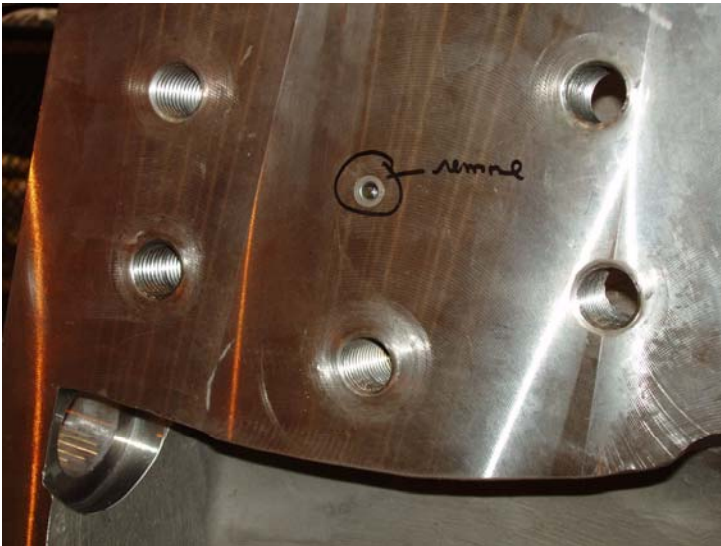
- Carbon steel bushings left in casting (4)
- Need to be drilled out

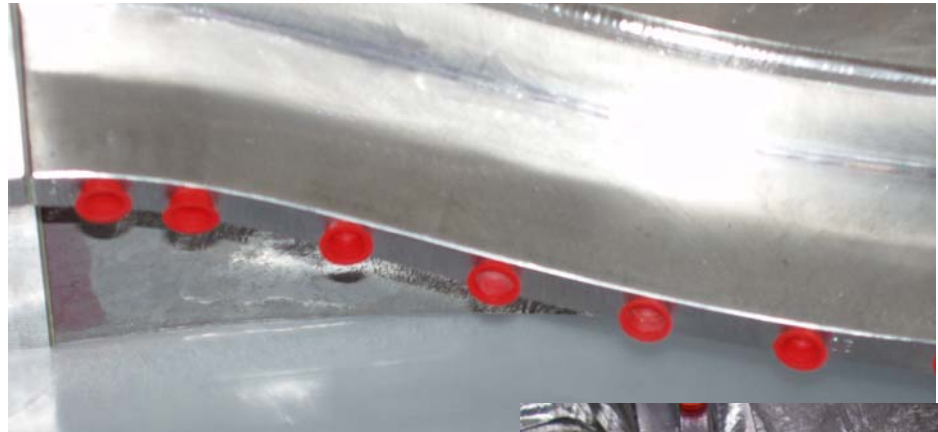
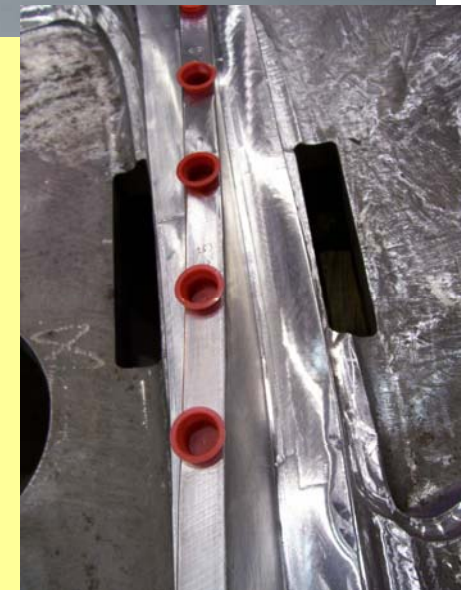
- 35 c'bored holes too deep
- New bushings need to be manufactured

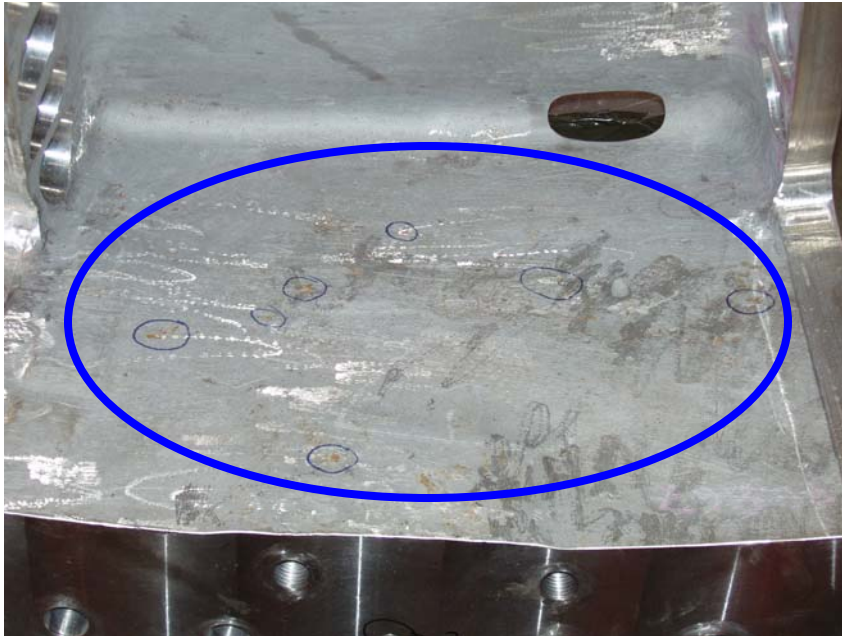
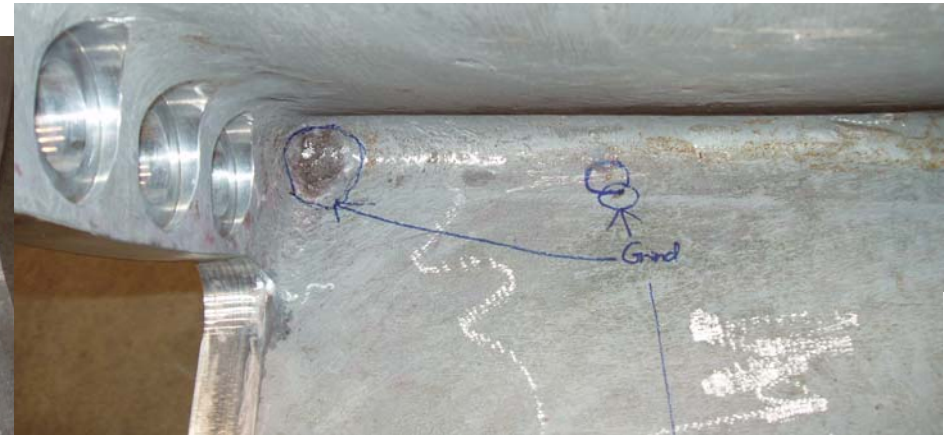
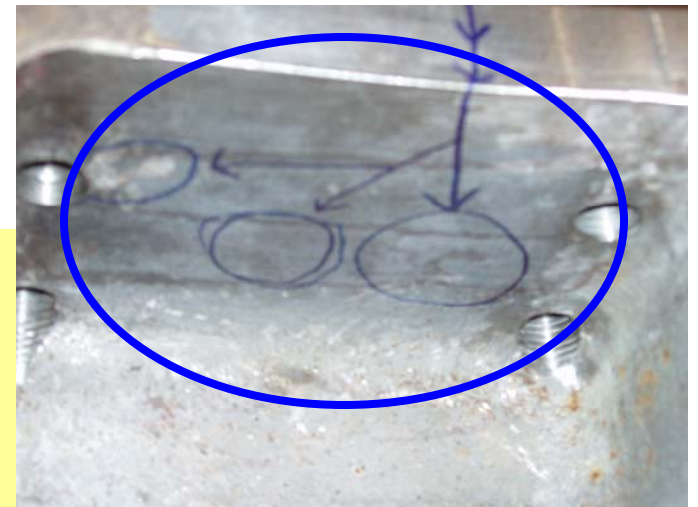
# Permeability Concerns

- A number of areas were identified with high Permeability [dark areas]
- Permeability  $>1.02 \mu$
- In-house grinding is required
- This was not an inspection requirement but foundry and Major tool needs to aware of contamination from ferrite lifting chains etc.

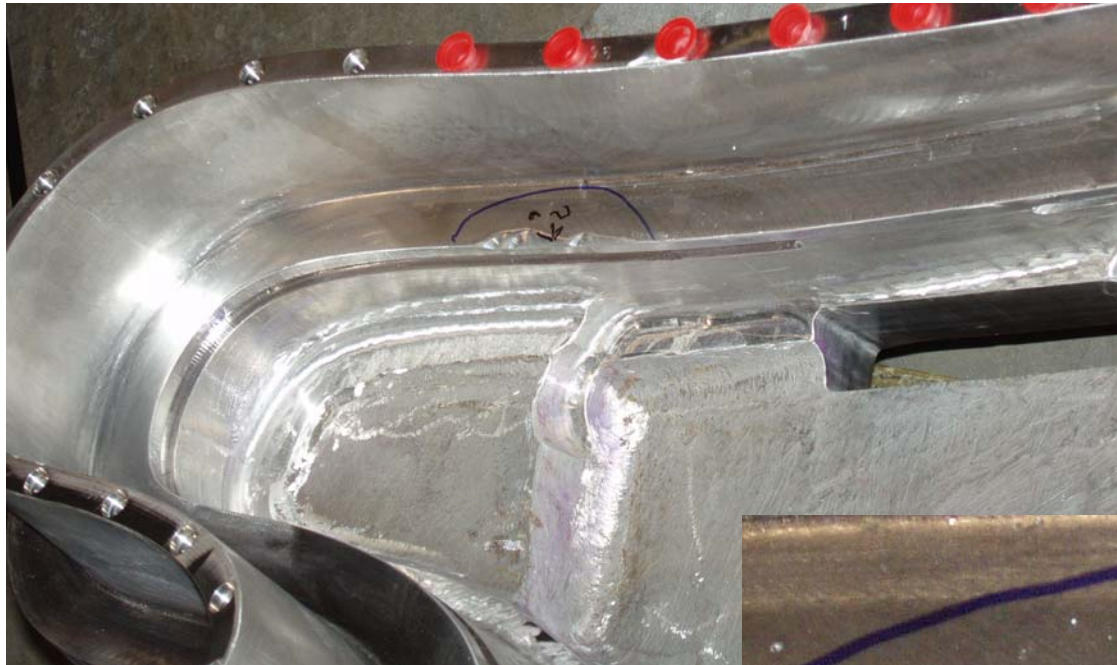
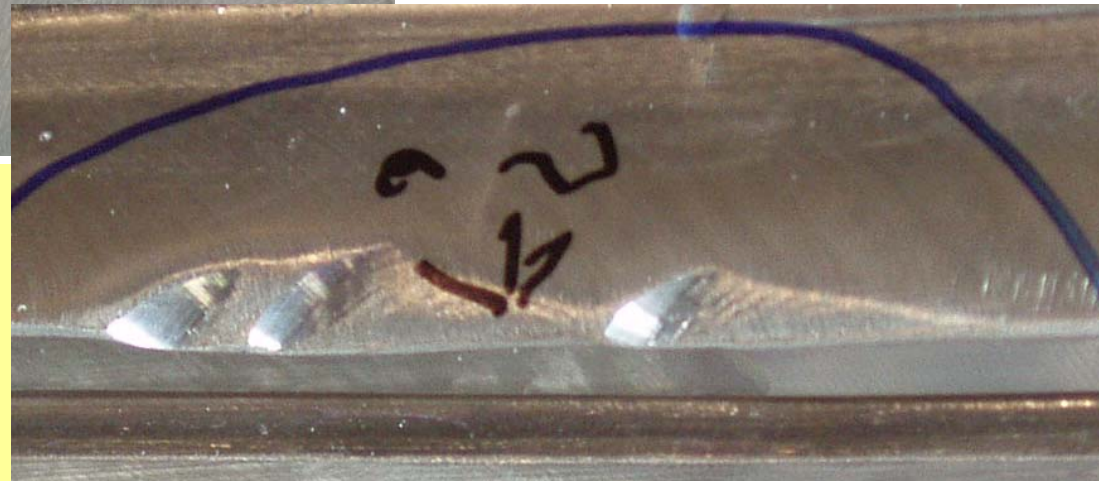
# Edge Tool Cutting Errors- **Critical**

- Edge tool cutting error near hole #95
- Approximately 4 ¼ in. long x 3/8 in. wide 1/8 in. deep
- **Not identified on NCR**

- Requires repair prior to using coil form
- Suggest taking video or digital shoots of entire surface for review prior to shipping

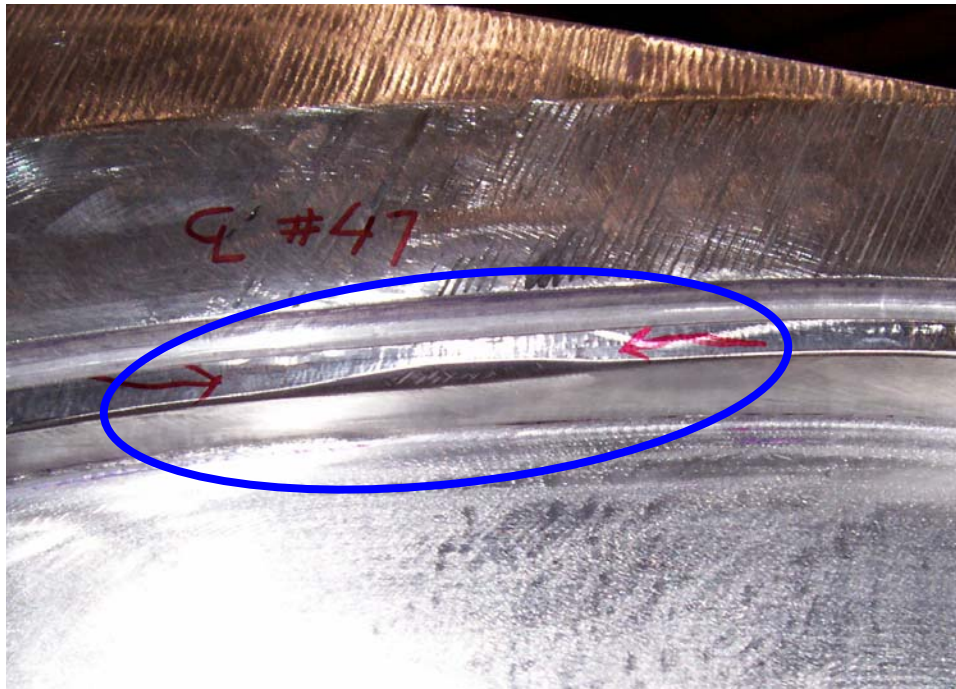
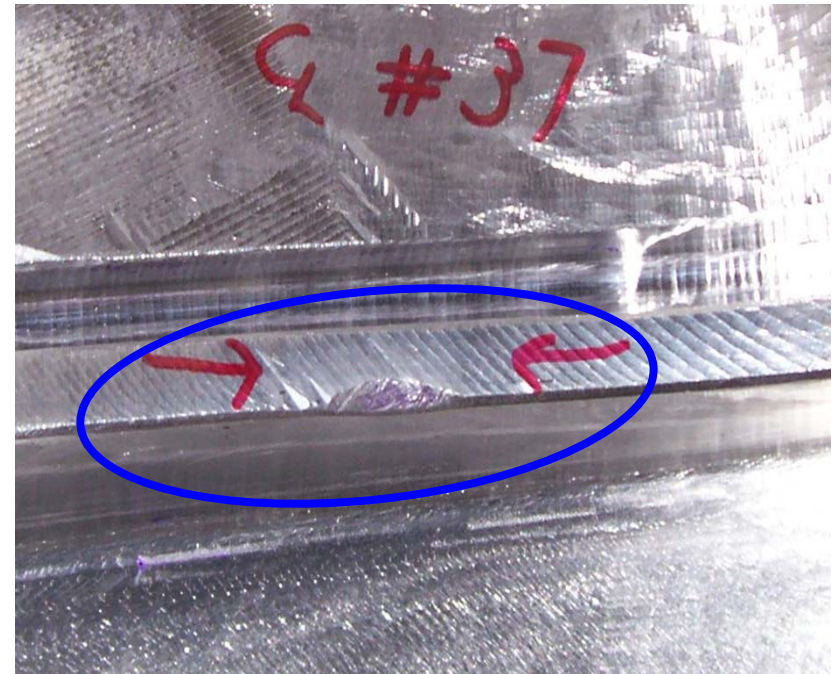
# Edge Tool Cutting Errors- Critical

- (2) additional undocumented edge tool cutting errors were observed
- Bolt hole locations # 37 [ $\frac{3}{4}$  in. long x  $\frac{1}{8}$  in. deep x  $\frac{3}{32}$  in. wide]
- Bolt hole location # 47 [ $2\frac{3}{4}$  in. long x  $\frac{3}{16}$  in. wide x  $\frac{3}{16}$  in. deep]
- **Not identified on NCR**

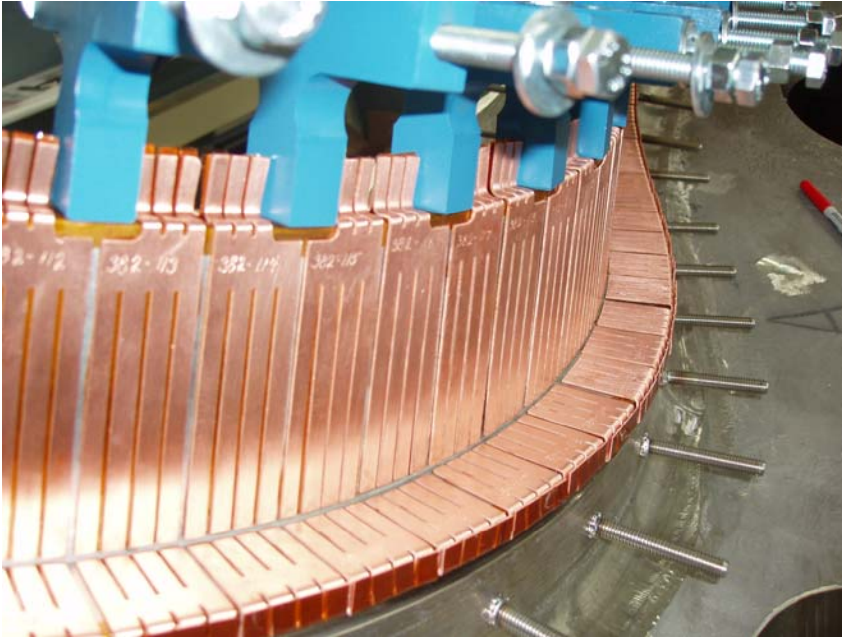
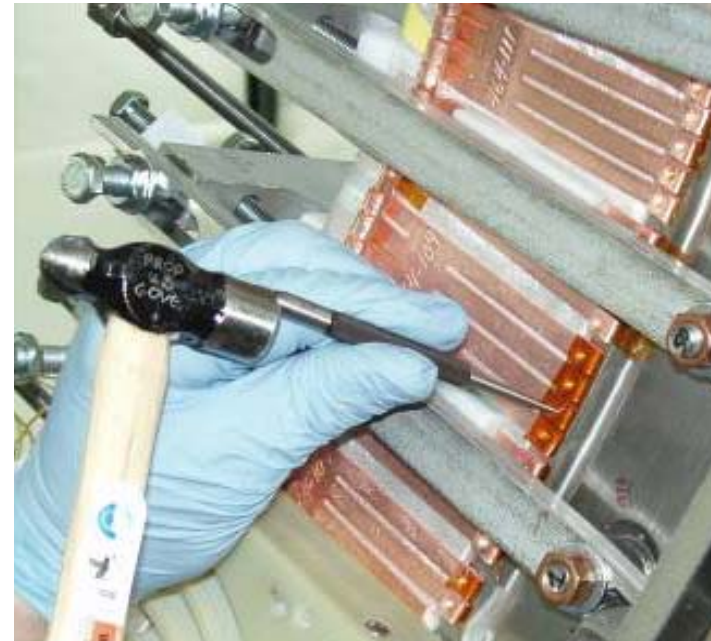
# Cladding Installation

- Edges need to be true to allow for cladding installation and dimensional control
- Major edge flaws do not allow for cladding to be properly positioned and secured
- Electromagnetic loads as high as 4500 pounds per inch must be reacted by the casting.

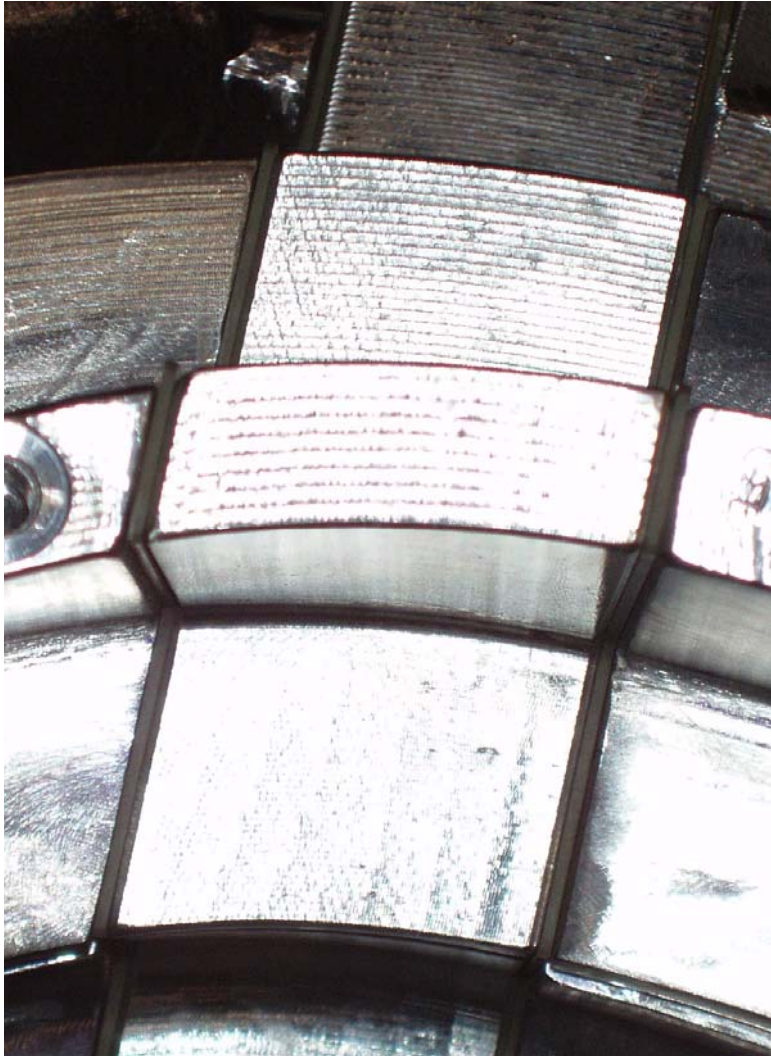
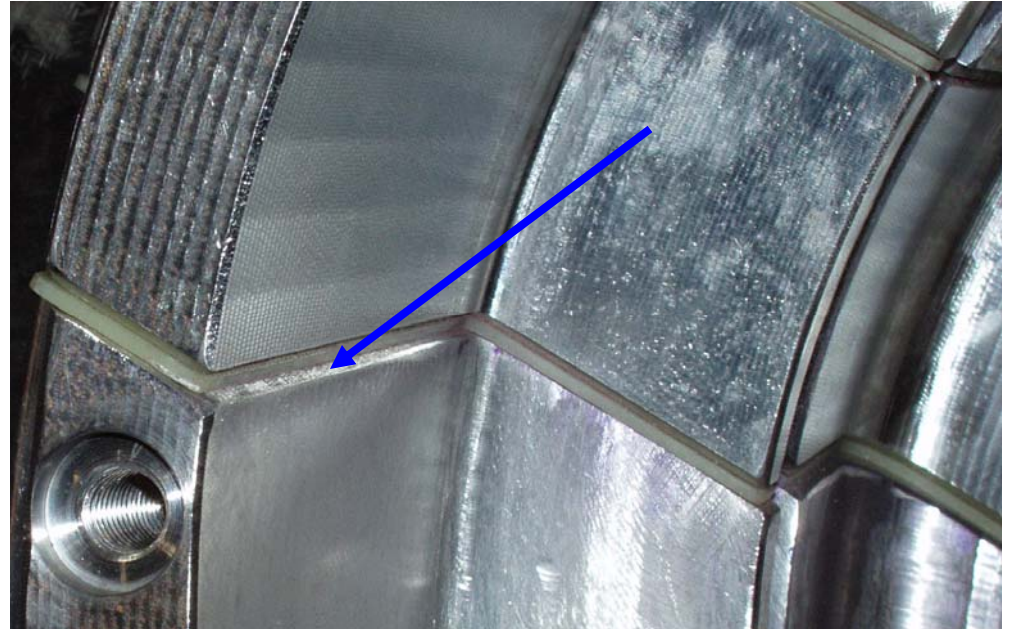
# Poloidal Break

- Poloidal break insulator and shim is shifted
- Adjacent surfaces do not align
- Some rework will be required
- **Not identified on NCR**

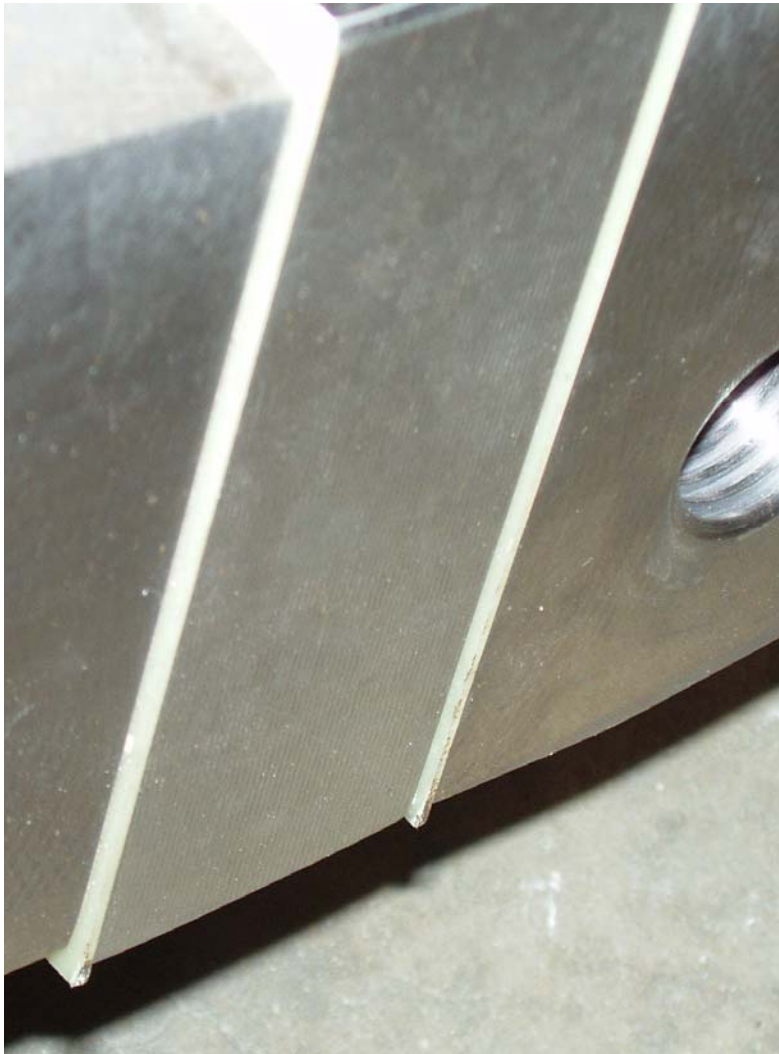
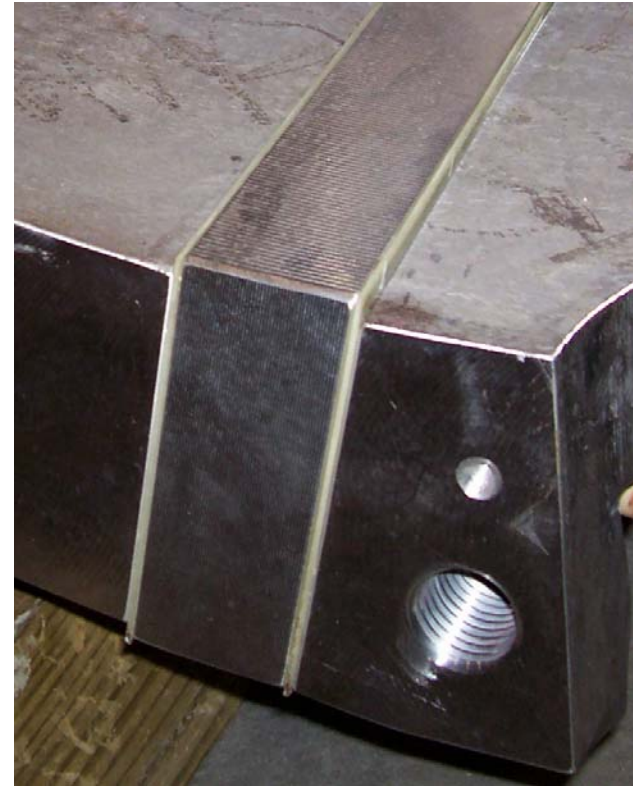
# Poloidal Break- continued

- G-11 insulator extends beyond flange [one side]
- Insulators need to be trimmed

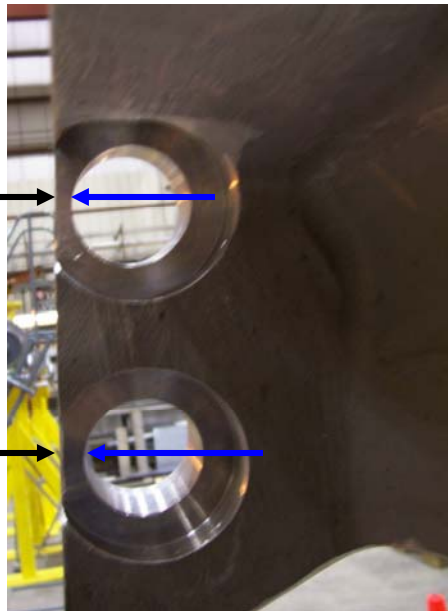
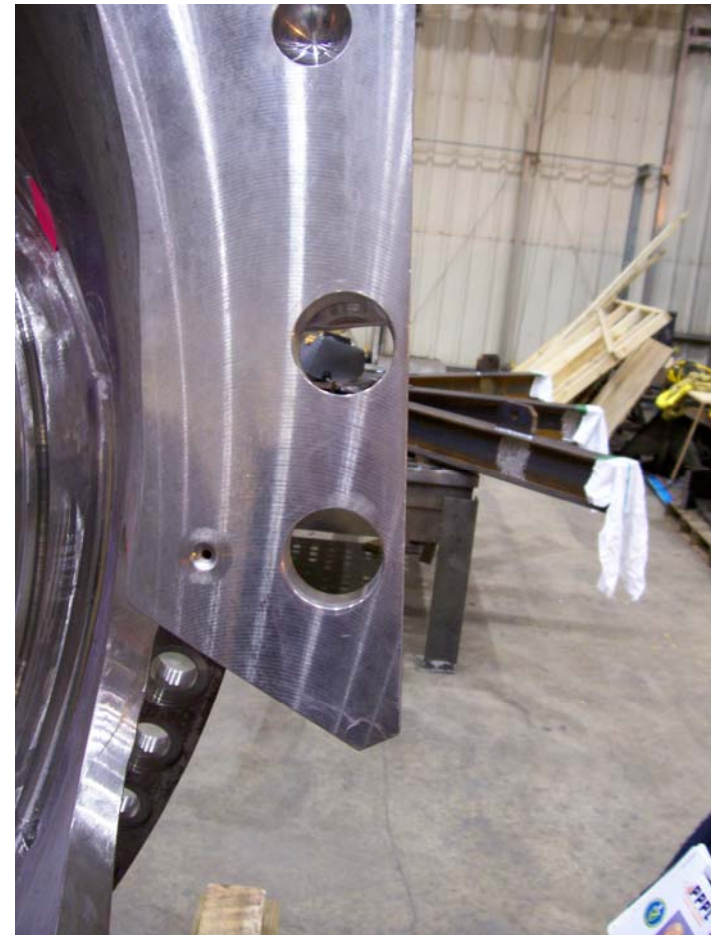
# Misaligned Holes

1/4 in. hole  
to edge

3/8 in. hole  
to edge

- Flange holes appear to be too close to edge
- Cause unknown?

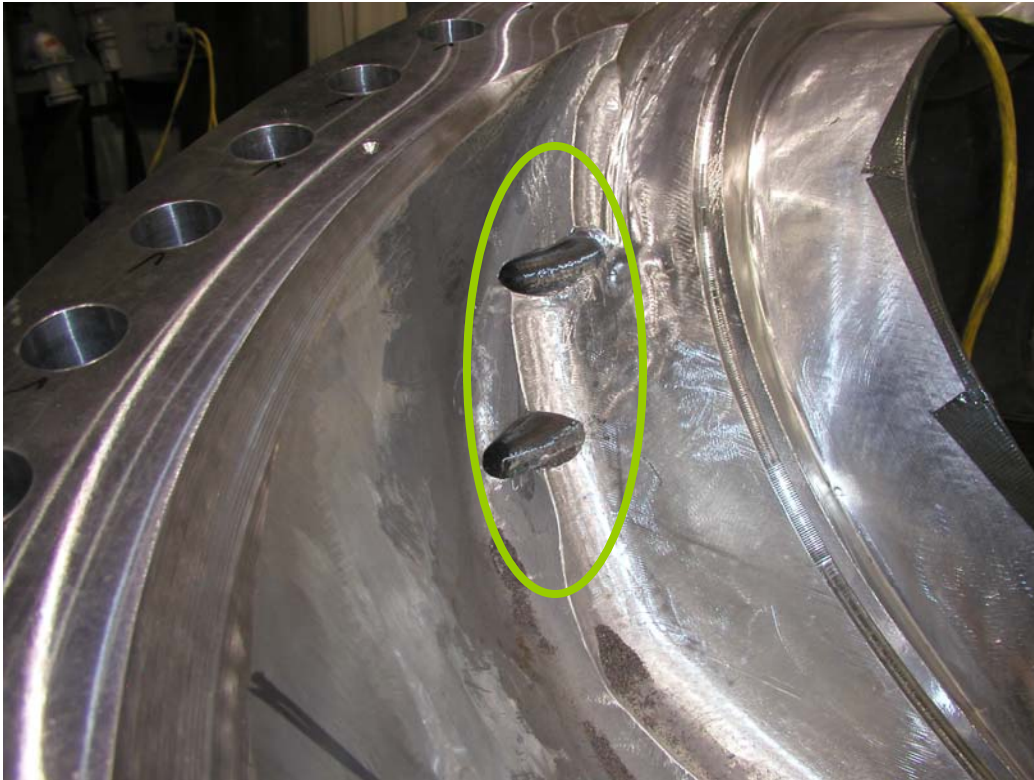
# Excess material

- Excess material remained overhanging holes preventing straight line of sight
- Excess material had to be ground to provide clearance
- Should have been found

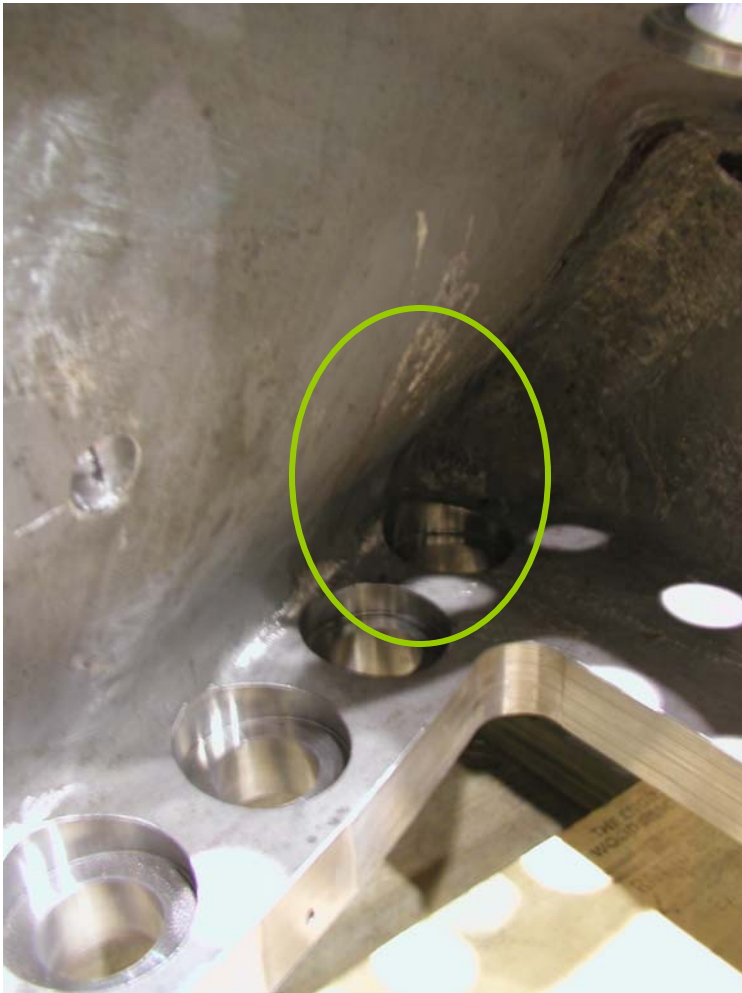
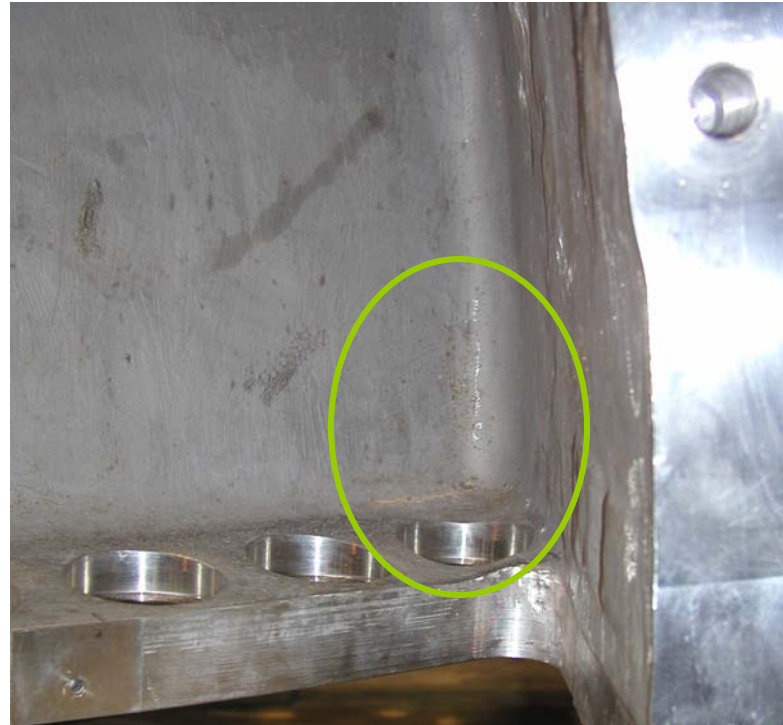
# Flange Hole Clearances

**It appears that there is over cast material on the C3 winding form in some of the flange bolt area, causing potential problems during assembly.**

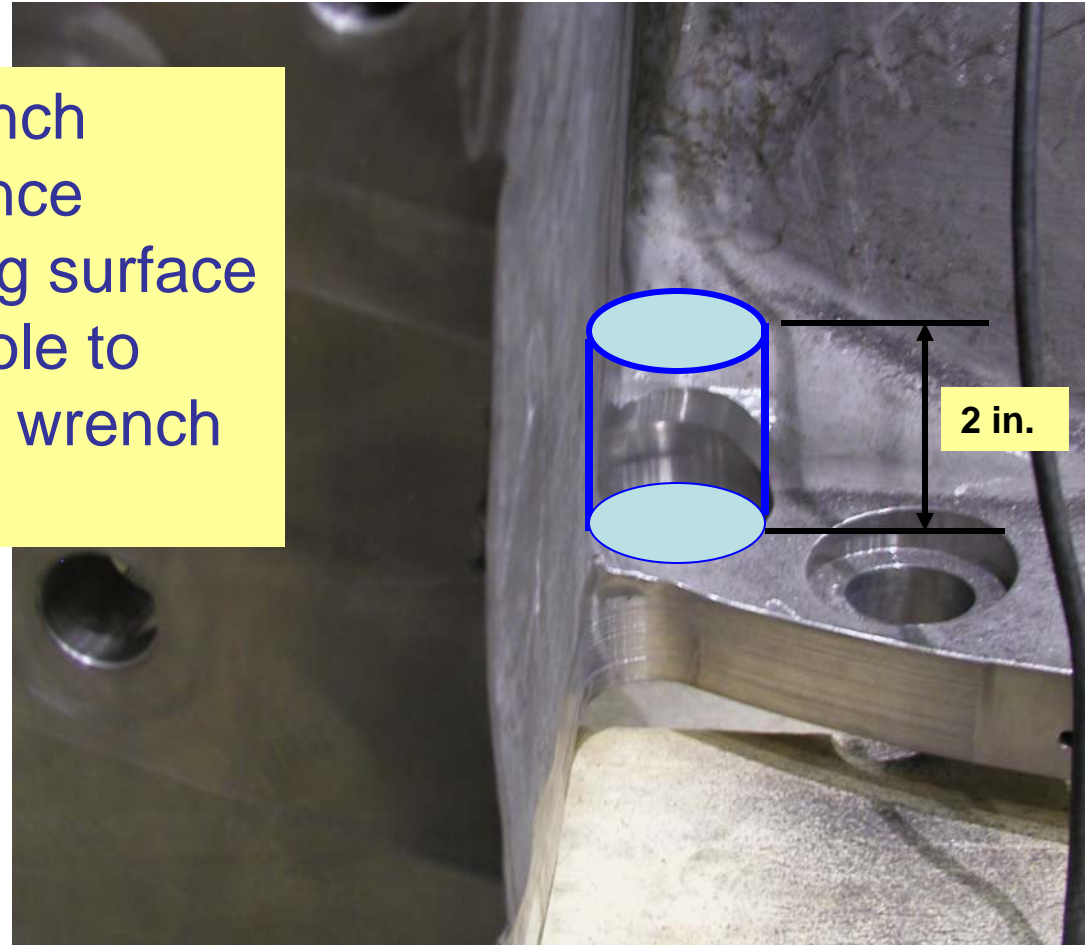
# Clearance Requirements

- NCSX needs 2 inch minimum clearance above the casting surface at each flange hole to allow for nut and wrench clearances
