NCSX Vacuum Vessel Fabrication

Major Tool and Machine – S005243-F

November Lehman Review

May 9, 2006

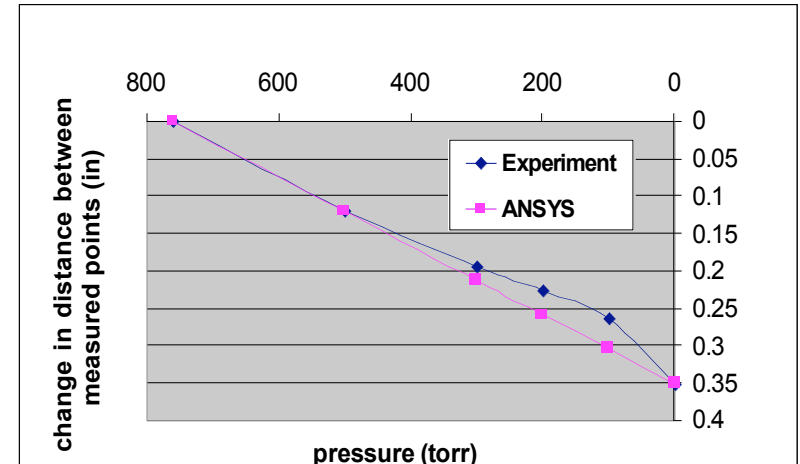
Deflection vs pressure

- No leaks detected, $P < 1e-7$ torr
- Distance between points on end flanges measured during leak test
- Deflection matches calculation (points move closer together by .35 inches)

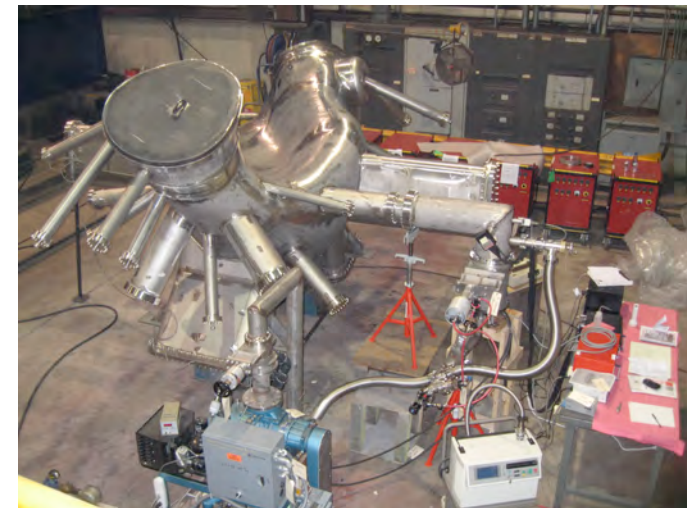
VVSA #1 during leak check

Leak check successful, deflect. confirms analysis

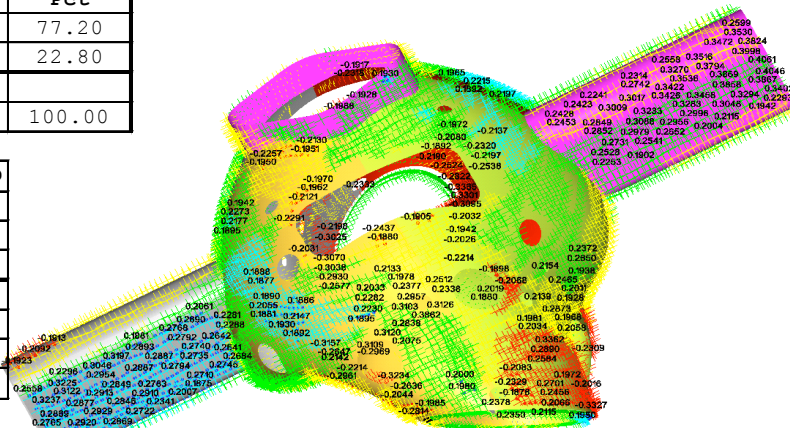
FULL SCAN - 3-14-06

- 8% Out of Tolerance (OOT) after shell welded

- 19% OOT after ports attached

Total Points: 10998
 Number of OOT: 2508
 Average Deviation: 0.02861
 Maximum Deviation: 0.48600
 Minimum Deviation: -0.39600
 Deviation Range: 0.88200

Neg	Nom	Pos	Total	Pct
In Tolerance:	3956	3	4531	8490	77.20
Out of Tolerance:	844		1664	2508	22.80
Failed Points:					
Total Points:	4800	3	6195	10998	100.00

- 23% OOT after ports cut off – no encroachment on internal first wall envelope or external modular coil assembly.
- Conditions acceptable.

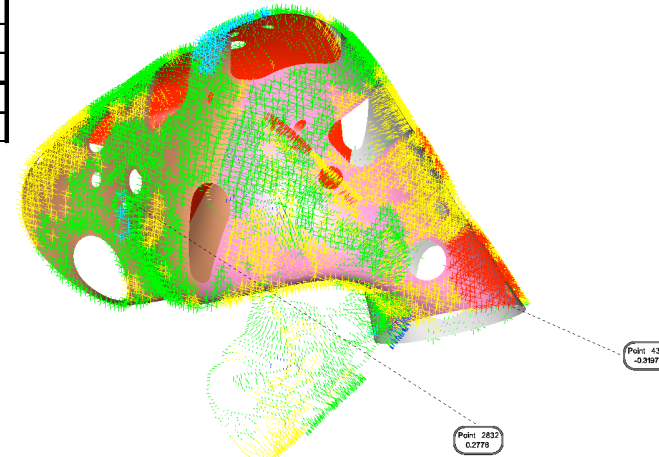
VESSEL HALF B SKIN

- 5.7% Out of Tolerance after shell welded.
- 8% Out of Tolerance after holes machined.

JOB NUMBER	65678/2 sub 5 OP 241	DATE:	1/16/2006
PART NUMBER	VESSEL AFTER REMOVING BRA		
PART NAME		STAMP:	
INSPECTOR	ROB DURHAM		
Probe Radius:	0.750	Total Points:	4865
Upper Tol:	0.188	Number of OOT:	380
Lower Tol:	-0.188	Average Deviation:	0.00342
		Maximum Deviation:	0.27760
		Minimum Deviation:	-0.31970
Report Output:	Actual Points	Deviation Range:	0.59730

Neg	Nom	Pos	Total	Pct
In Tolerance:	1891	2	2592	4485	92.19
Out of Tolerance:	254		126	380	7.81
Failed Points:					
Total Points:	2145	2	2718	4865	100.00

- Tolerance conditions are improved over VVSA #1.
- Conditions acceptable.

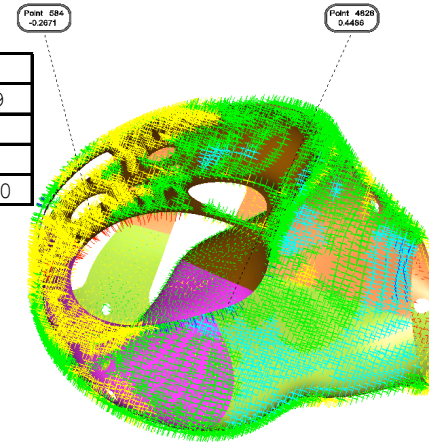
PROFILE OF VESSEL

• <1% Out of Tolerance after shell welded.

• 7% Out of Tolerance after holes machined.

Total Points: 7310
 Number of OOT: 527
 Average Deviation: 0.02315
 Maximum Deviation: 0.44860
 Minimum Deviation: -0.26710
 Deviation Range: 0.71570

Neg	Nom	Pos	Total	Pct
In Tolerance:	2375	3	4405	6783	92.79
Out of Tolerance:	284		243	527	7.21
Failed Points:					
Total Points:	2659	3	4648	7310	100.00

• Conditions acceptable.
