Review of “B1” to “C1” interface Response to NCR 3735 and Deviation Request to Address Remaining B-C Coil Interfaces

B1 - C1 Fit-up 12/18/07

Disposition to NCR 3735

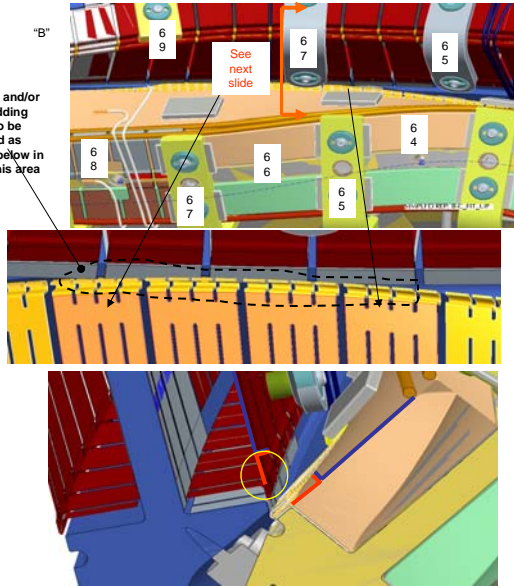
On B coil, between clamp holes 65 & 69; and on C coil, between clamp holes 64 & 68:

The "B" and/or "C" cladding needs to be modified as shown below in red in this area

- Unbend copper crimps & straighten copper.
- Form the copper as shown in the yellow circle. Bent out leg should be $\sim 1/8"$.
- Form the upper copper to meet the bent out leg and form a crimp U section over the lower piece.
- Crimp the copper U.
- Epoxy the copper to the coil and overlay the repaired region with glass - epoxy.

Every attempt should be made to avoid copper breakage. However IF the copper breaks during the unbending operation, abandon that piece. Uncooled continuous lengths up to 8' are acceptable. Record the actual as repaired condition and append to the NCR.

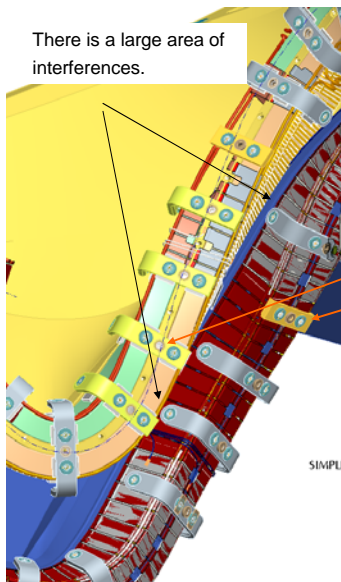
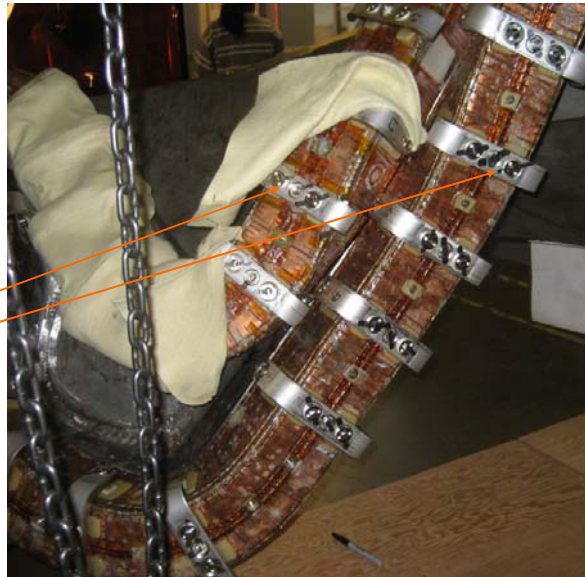
There is a large area of interferences.

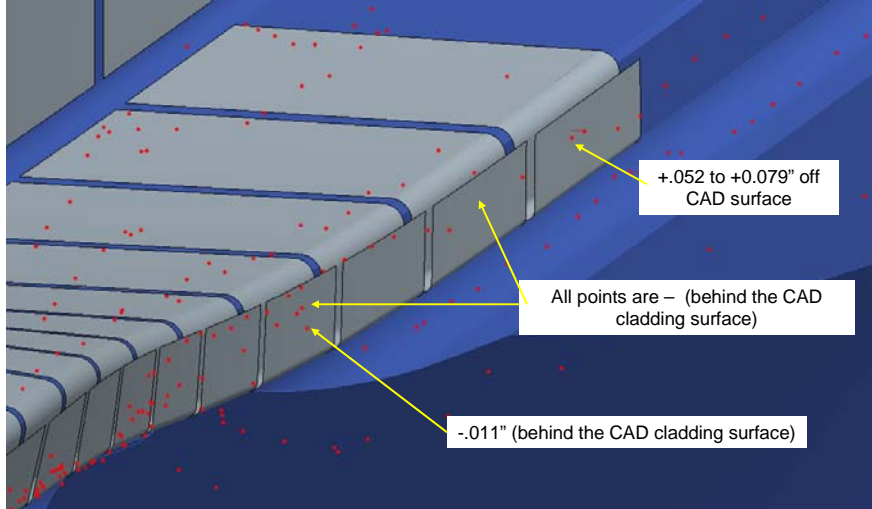
"B" MC is shown along with B1 scan points

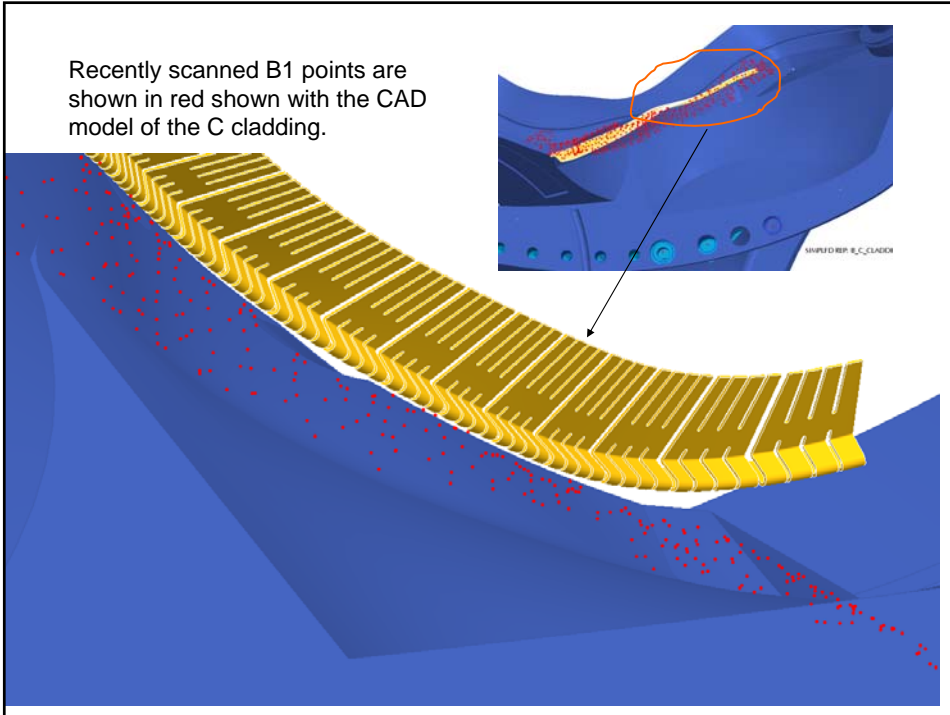
Recently scanned B1 points are shown in red shown with the CAD model of the C cladding.

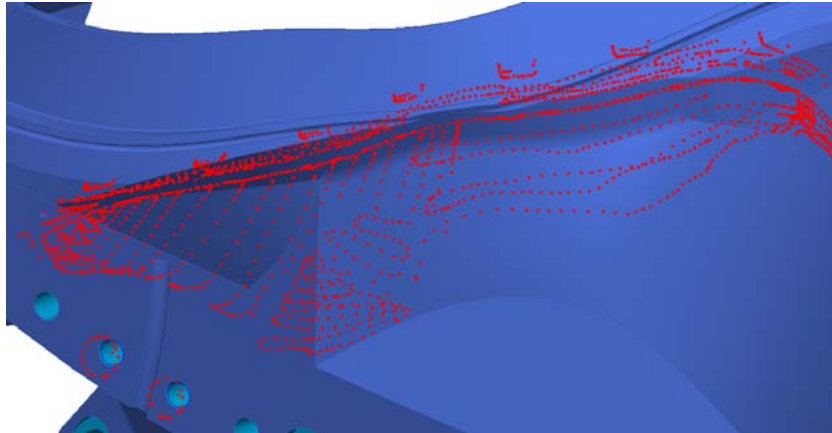
The "B" MC is the blue part shown with the recent scanned points of the "C1" MC.

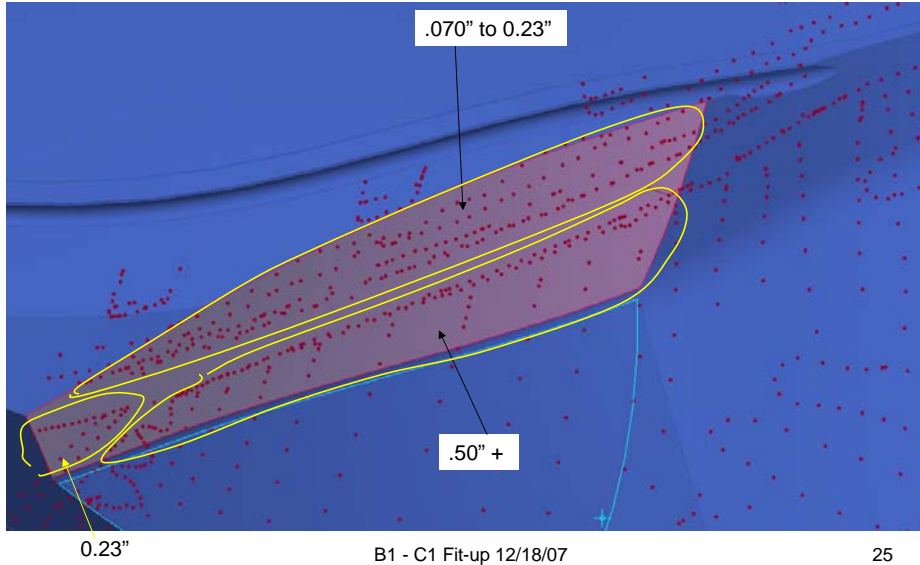
The recent C1 scanned points are shown as red points off the CAD model of the "B" MC.

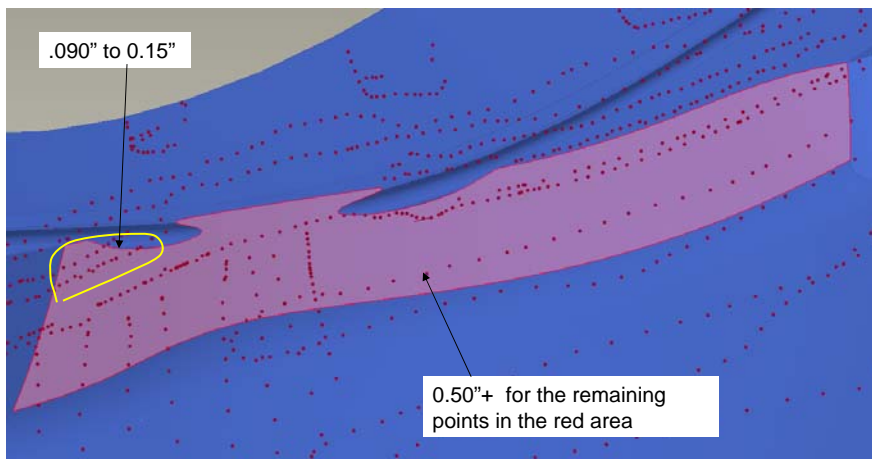
The recent C1 scanned points are shown as red points off the CAD model of the "B" MC.

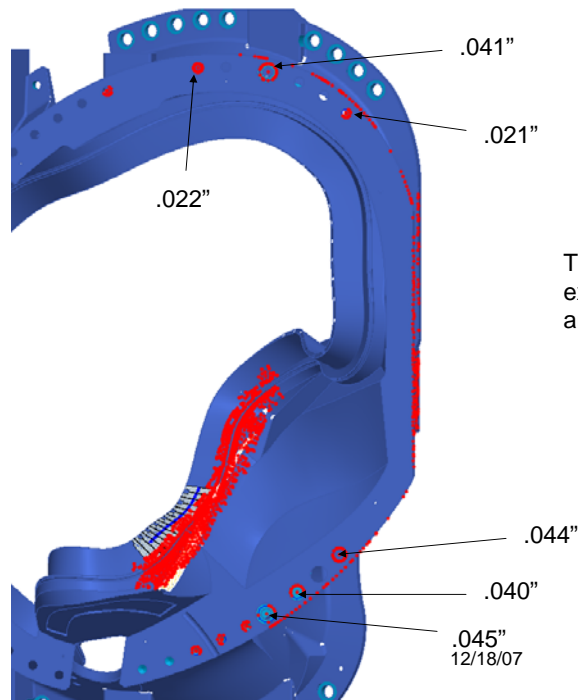
The values show the extent that the hole CL are out of tolerances.

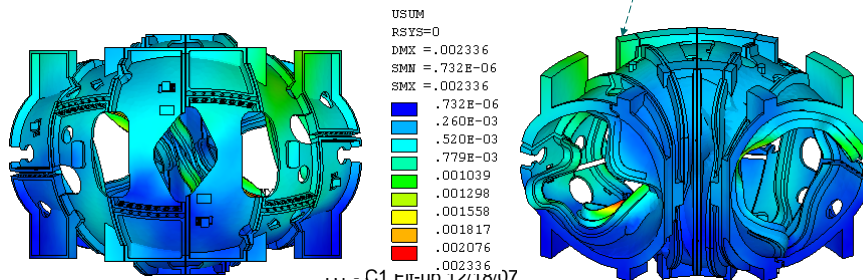
Total Displacements of Shell - Usum

- The maximum displacement, 2.336 mm, occurs on tee in shell type B due to lateral deformation of web caused by the lateral force of the modular coil.
- Because of net vertical forces are equal and opposite with respect to the mid-span, the deformation at bottom of the mid-span is small.
- The smaller deformation at the inboard than the outboard is the result of higher shell stiffness in the inboard.
- The unit of the displacement is in meter

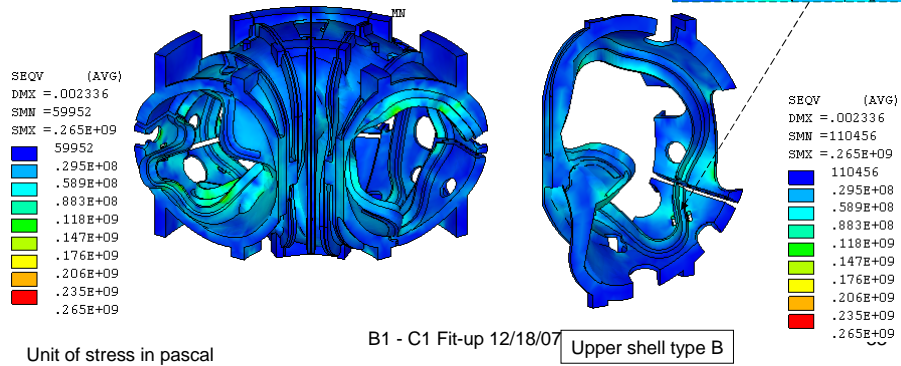
Von Mises Stress of Shell Structure

- The maximum local von Mises stress, $Seqv$, occurs at the corner of lead opening in shell type B.
- The model was built without chamfers at the lead openings. With chamfer, the local stress will be greatly reduced.
- The next slides will display some high stress areas
