Customer: ENERGY INDUSTRIES OF OHIO

Contact: NANCY HORTON
 E-Mail: NKHFlowen@aol.com

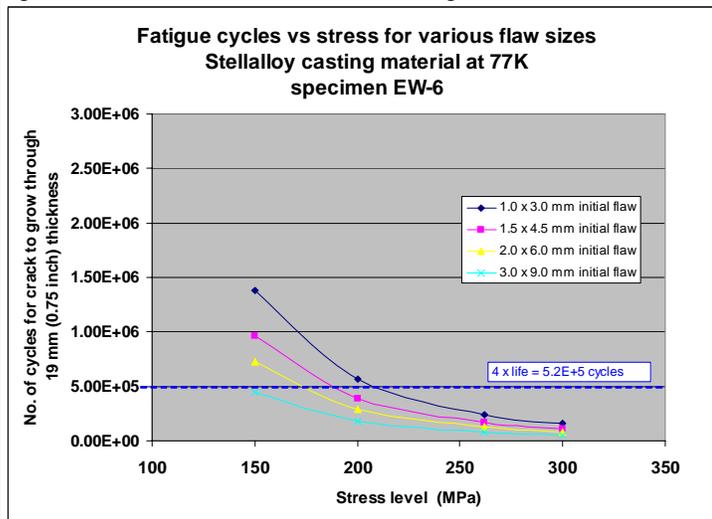
Photo 5 shows a 2" to 2.5" indication below hole #28. This defect is shown in Shot 26-30; EIO believes it is a hot tear. The depth of the defect (which we consider a crack) is unknown. However, Williamson reviewed the stress in this area and found it to be very low (~16 MPa) and compressive, which inhibits crack growth; therefore it is accepted as is.

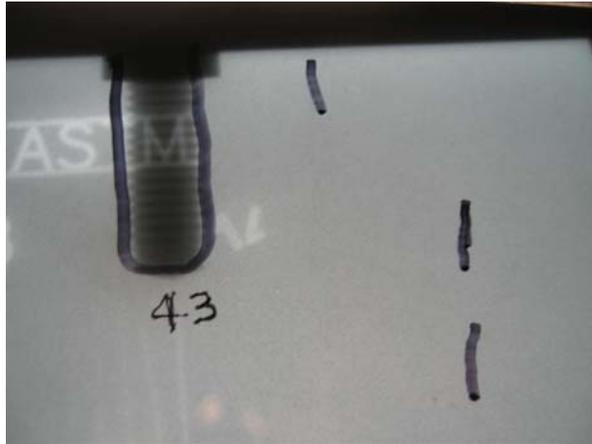
The picture to the left is of an overlay that shows the three .25" long rejections between holes 43 and 44.

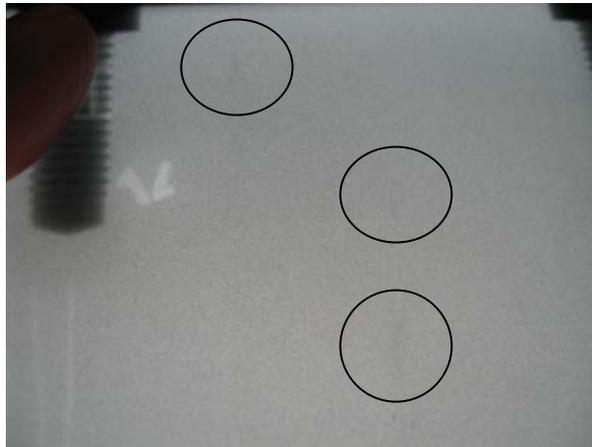
NC20741 Attachment – A4 RT Failures

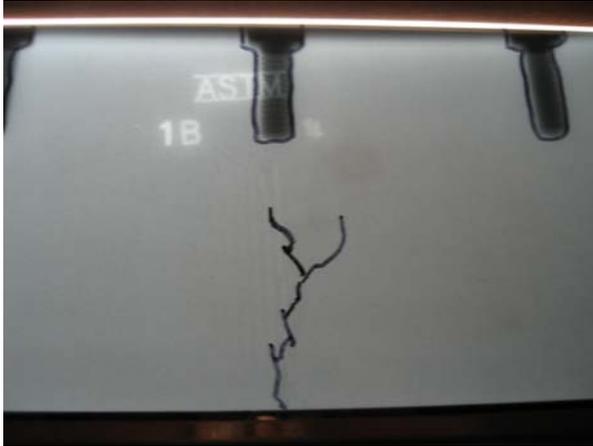
The picture to the left is of an overlay that shows the reject directly below hole 28. This indication did show up during the PT inspection on the D side of the T but it has a “Y” shape to it that we did not see during PT.

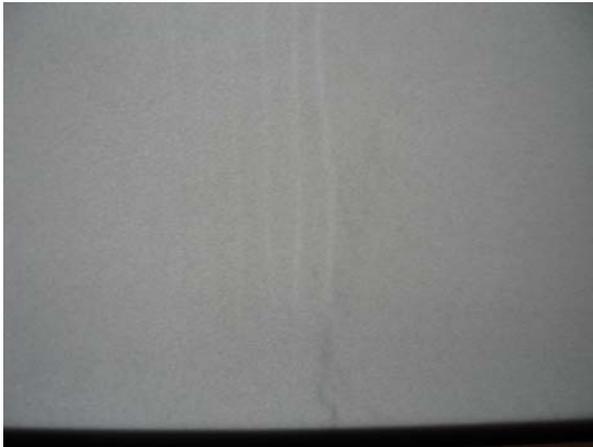
The length of this defect is 2” – 2.5” from the base upward.
