Nonconforming Condition (include requirement(s) violated):

NCR 3735 - Attachment 1 - 11/15/07

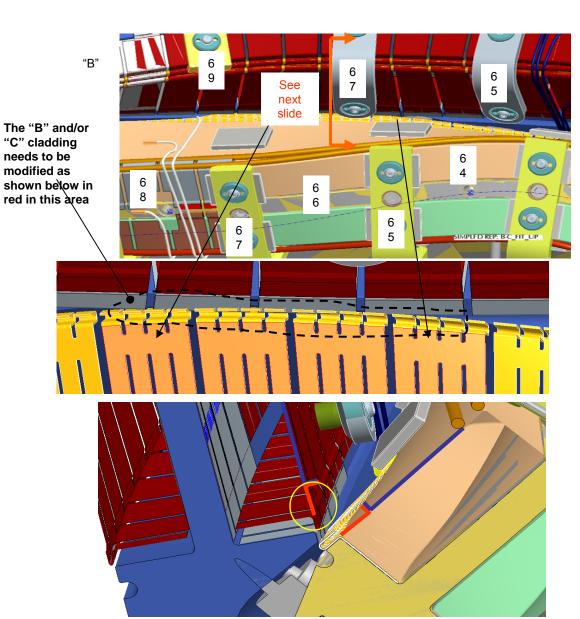
- On B coil, between clamp holes 65 & 69: and on C coil , between clamp holes 64 & 68:
 - Unbend copper crimps & straighten copper.
 - Form the copper as shown in the yellow circle. Bent out leg should be ~1/8".
 - Form the upper copper to meet the bent out leg and form a crimp U section over the lower piece.
 - Crimp the copper U.
 - Epoxy the copper to the coil and overlay the repaired region with glass – epoxy.
- Every attempt should be made to avoid copper breakage. However IF the copper breaks during the unbending operation, abandon that piece. Analyses (see slide 14) indicates that breakage of every other finger has a negligible effect on dT; if more than two adjacent fingers break, work shall be stopped and a NCR shall be written and dispositioned before proceeding.
