SE141-115 B1
NC20519 attachment

2. There is a tool gouge (eyebrow shape) near the poloidal break flange just underneath the datum D flange. The gouge is approx. 1.4" across.

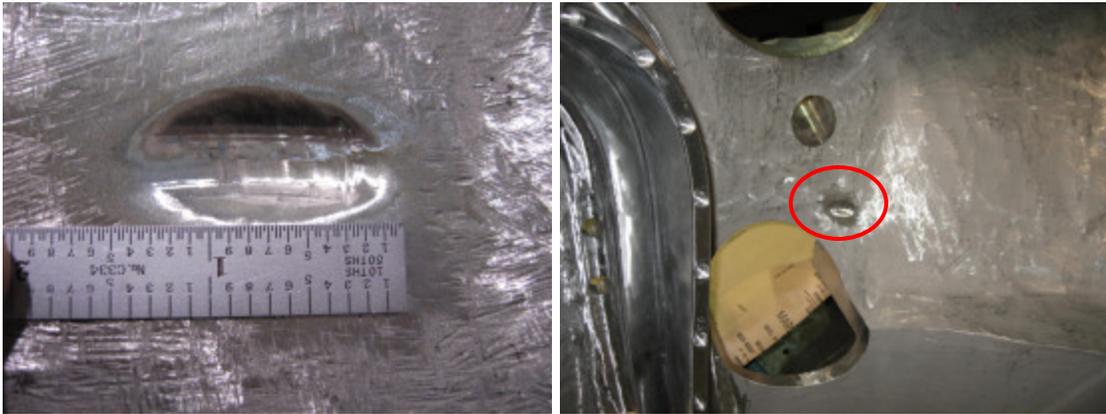
7. The scribe marks do not match the drawing requirements as described on sheet 7, zone E6. The scribing was performed prior to notification of the revision 9 changes. The scribing is to be aligned with sections U2 and U3 of the drawing (perpendicular and parallel to the base of the T). The scale in the below pictures show what would be the correct orientation (This conditions exists on both the D and E sides).

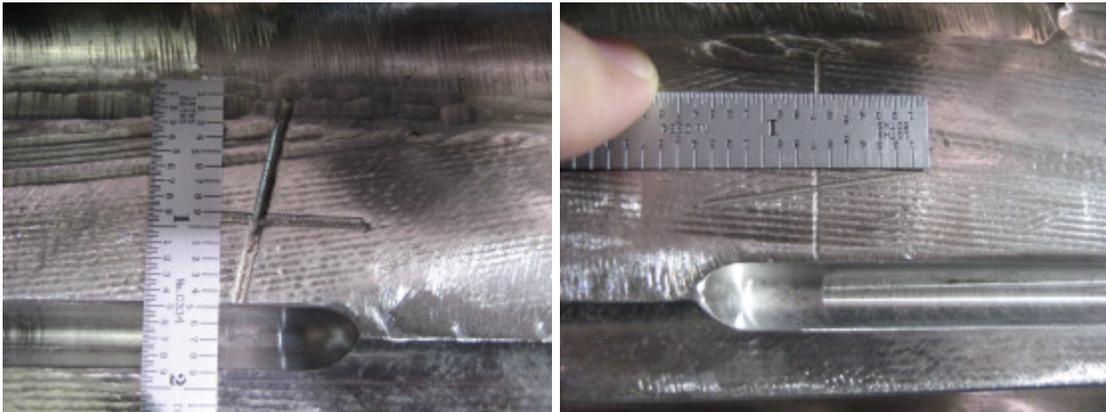
SE141-115 B1
NC20519 attachment
