## PPPL ENGINEERING CHANGE NOTICE (ECN) ECN # 5145

## ECN TITLE: MCWF Type-B Modifications

#### AREA OR PROJECT: NCSX

DRAWING(S)	NEW	TITLE
<b>AFFECTED NUMBER:</b>	Revision	
SE141-115	9	Production Winding Form Type-B

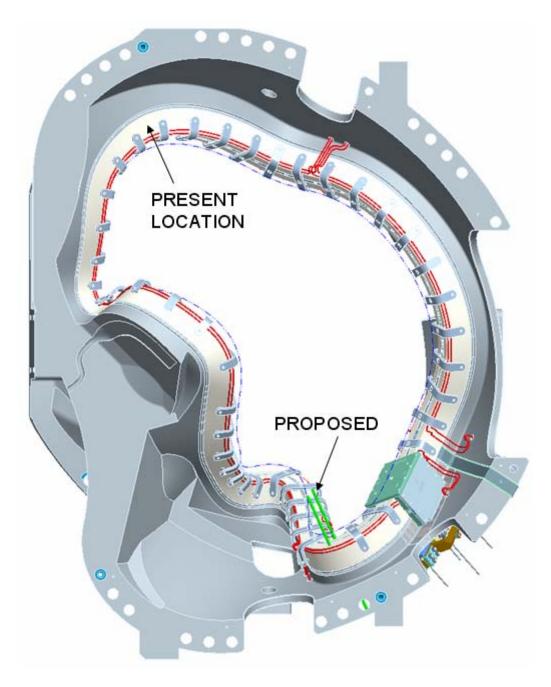
Type-B, Flange Datum -D, Coil Side -A

1) Change location of VPI bleed holes shown on SE141-115, Rev 8, Sht 9, D6.

Current location of bleed holes does not provide sufficient clearance with flange for fitting attachment. Upon review, it was decided to make holes adjacent to leads area so the leads can be positioned at the highest point during VPI operations.
